2006 ANNUAL REPORT

**PRIMARY INDUSTRIES AND
RESOURCES SA
(Petroleum and Geothermal Group)**

**Pipeline Licence 6
RIVERLAND PIPELINE**

March 2007

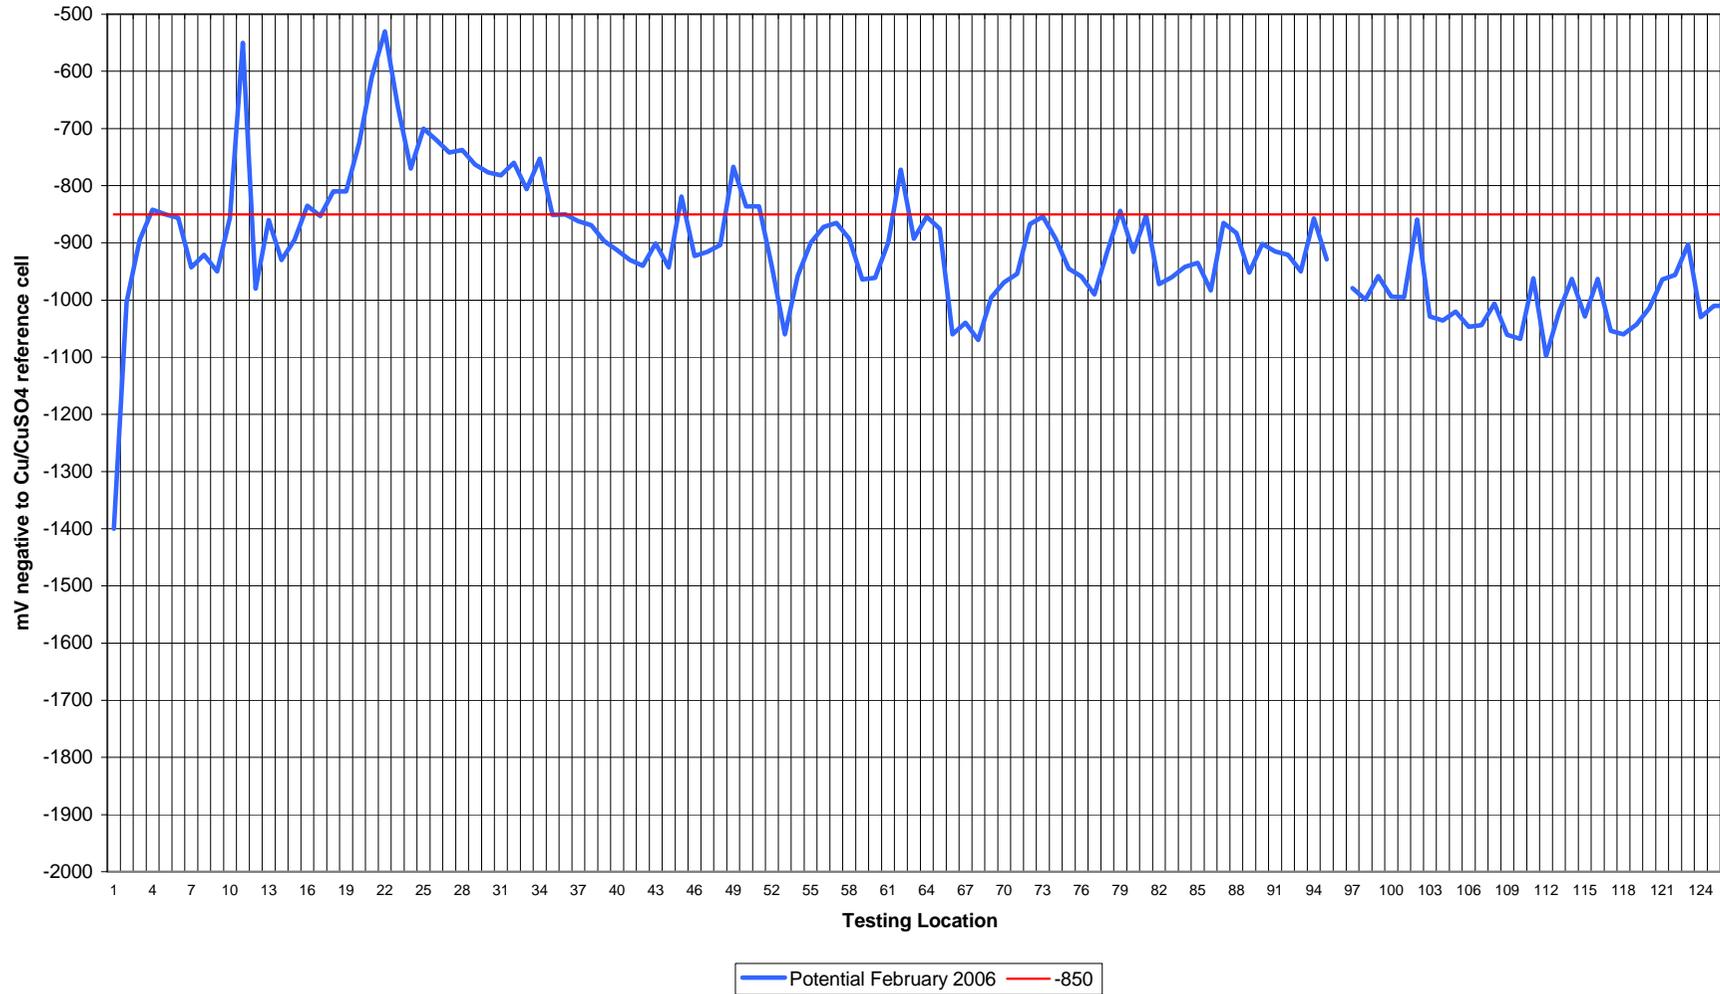
Potential Summary and Graph for Berri Lateral February 2006

Results from the survey indicate protection levels decreased at the Angaston end of the pipeline due to faulty anode connections at KP12.1 and KP15.6, together with significant voltage fluctuations caused by telluric effects. The pipeline therefore did not meet the protection criteria for AS 2832.1:2004. Faulty current shunts were subsequently removed at KP12.1 and KP15.6 and the anodes were bonded directly to the pipeline. Following the anode reconnections and the cessation of telluric activity, levels of protection substantially increased. At KP141.6 the magnesium anode was disconnected as its potential was -780mV.

Interference testing was conducted in conjunction with SA Water and revealed that test locations at KP0.0, KP5.5 and KP7.1 were outside the criteria as set out in AS 2832.1:2004 and unit outputs may need to be reduced. Further contact is required with SA Water to determine what mitigative measures are required subject to South Australian Electrolysis Committee guidelines.

The Epic Energy Impressed Current Cathodic Protection unit (ICCP) at the Angaston Metering Station was also considered to be potentially affecting pipeline protection levels at this location.

- An investigation was carried out which confirmed that the close proximity of the Epic ground bed at the Angaston metering station has an effect on pipeline potentials at this location. This will continue to be monitored.
- New anodes were installed at KP 48.9, KP 56.2, KP 70.8 and KP 82 on the Berri Lateral.
- New anodes were installed at KP 9.2, KP 48.9, KP 57.1 and KP 62.6 on the Murray Bridge Lateral.

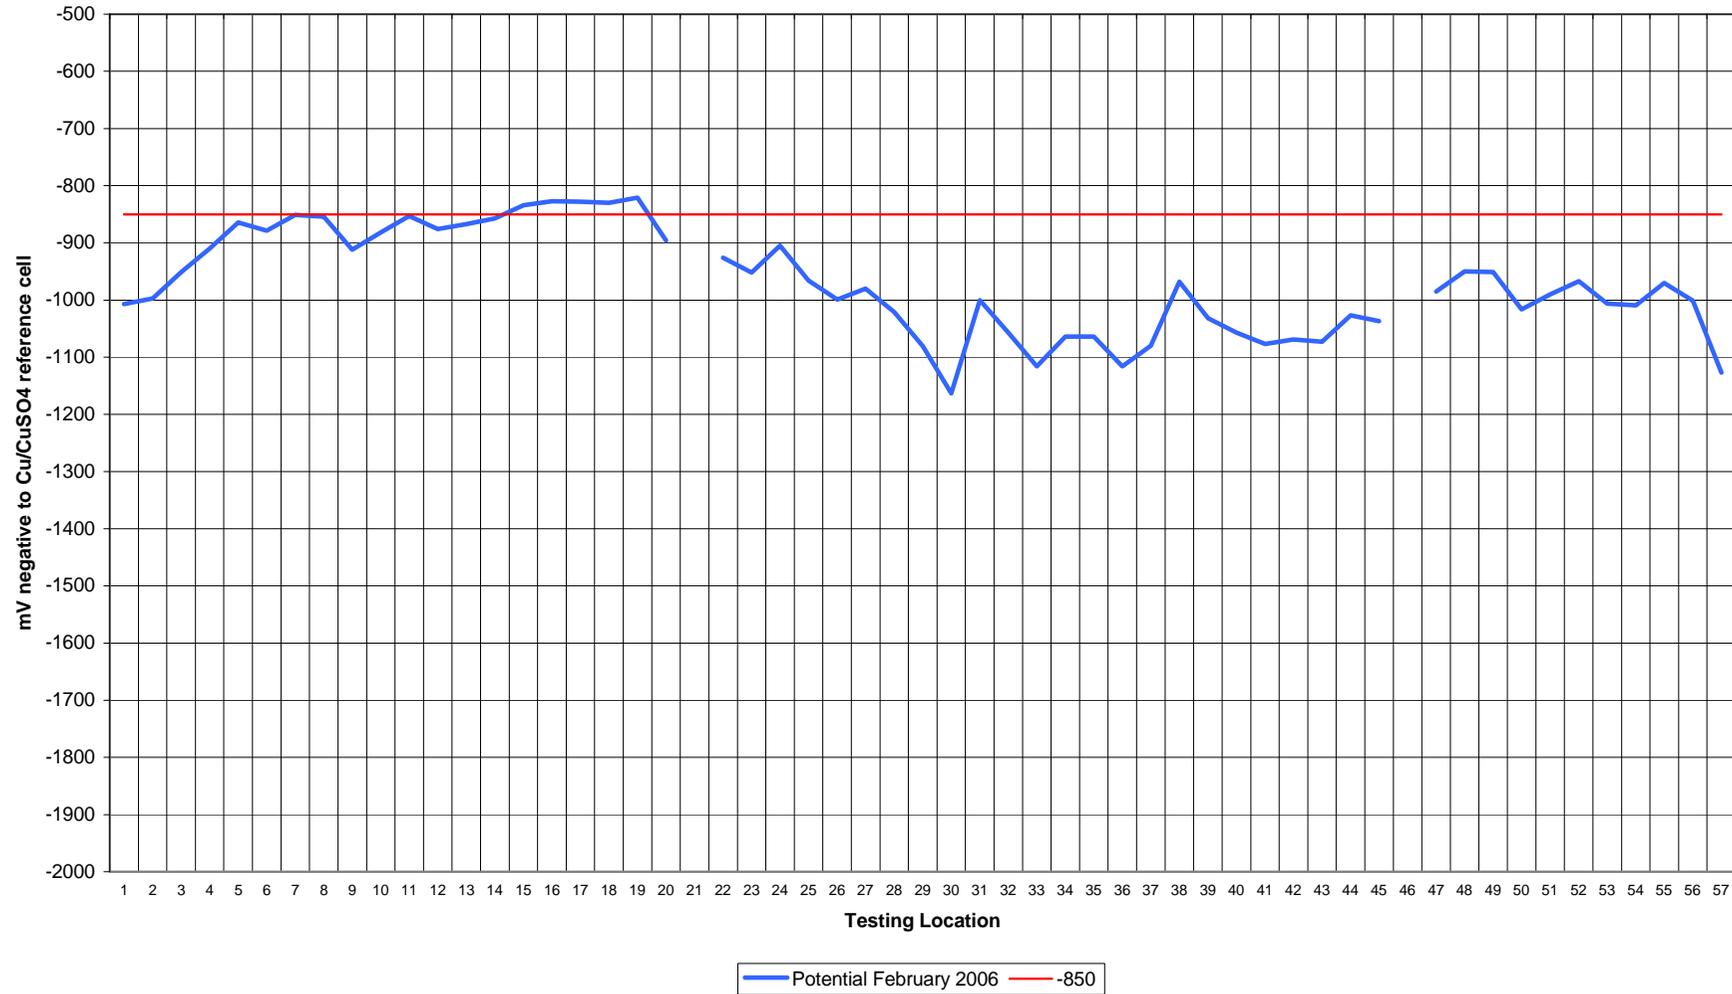
Potential Summary and Graph for Murray Bridge Lateral February 2006

Results from the survey indicate pipeline protection levels have marginally decreased between KP18.3 and KP23.3, resulting in the pipeline being not cathodically protected at these locations. Some telluric activity was noted during the survey period.

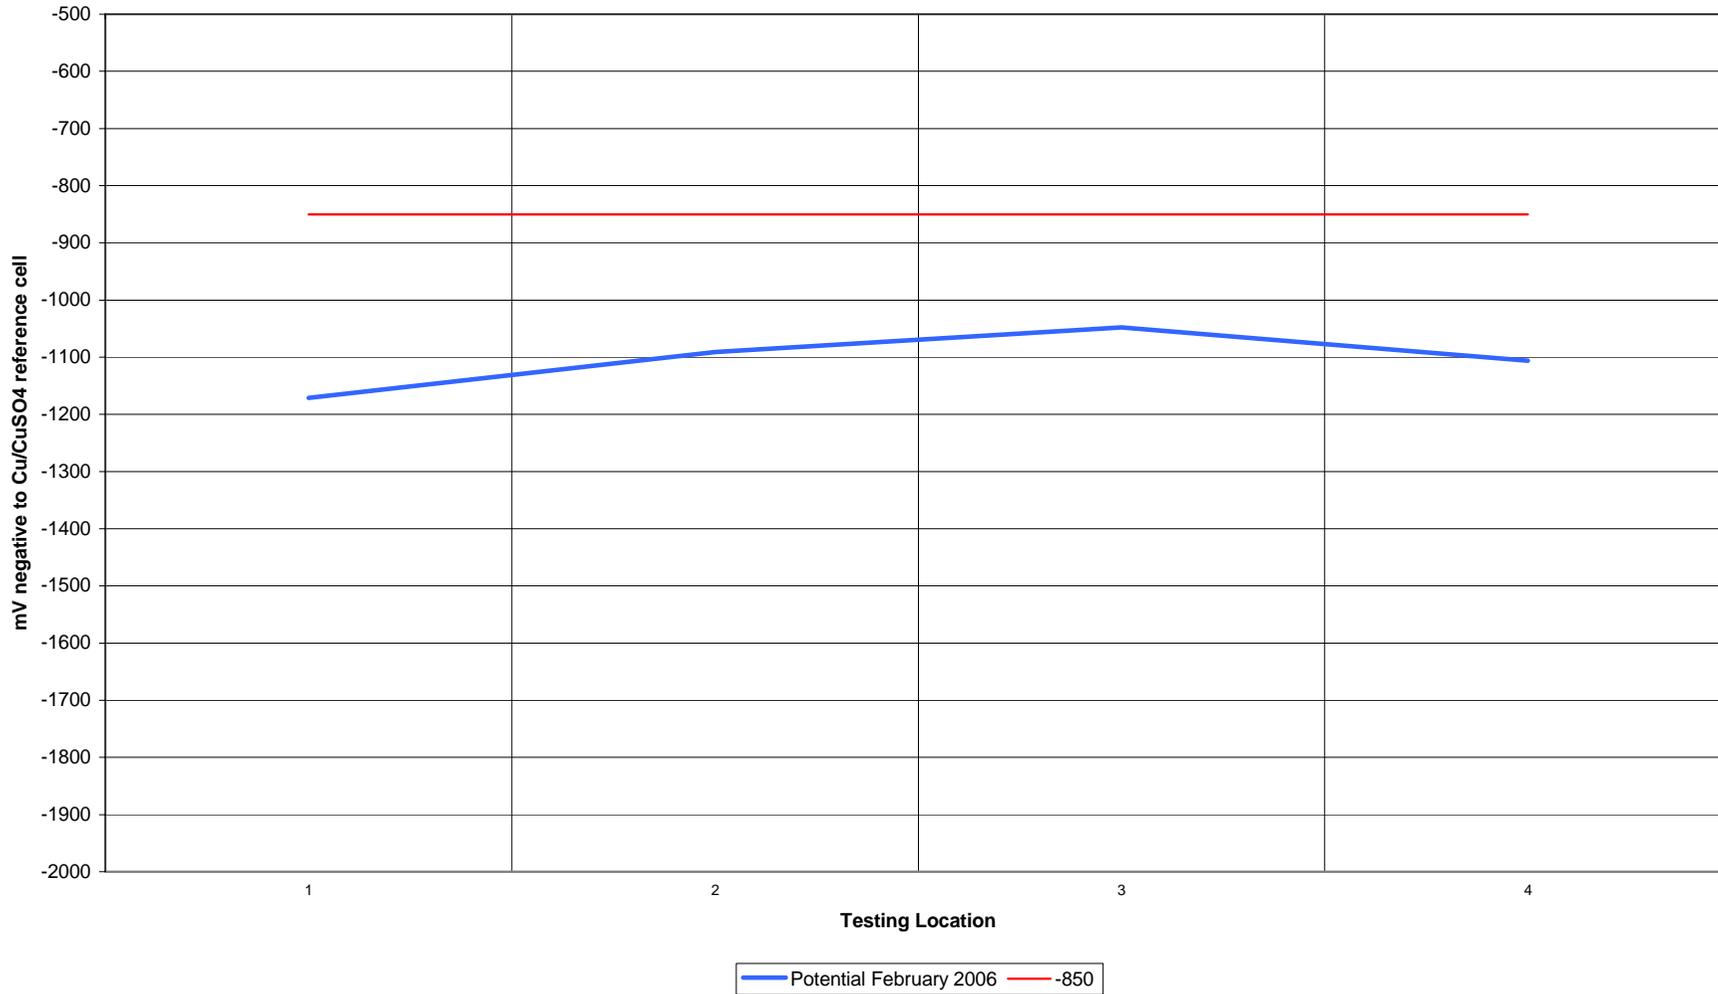
Potential Summary and Graph for Tooravale & Visy Lateral February 2006

Results from the survey indicate pipeline protection levels have increased since the August 2005 survey and the line is cathodically protected. Varistors installed inside the test points across the inlet insulating flanges at both VisyBoard and Tooravale Metering Stations were assessed and found to be satisfactory.

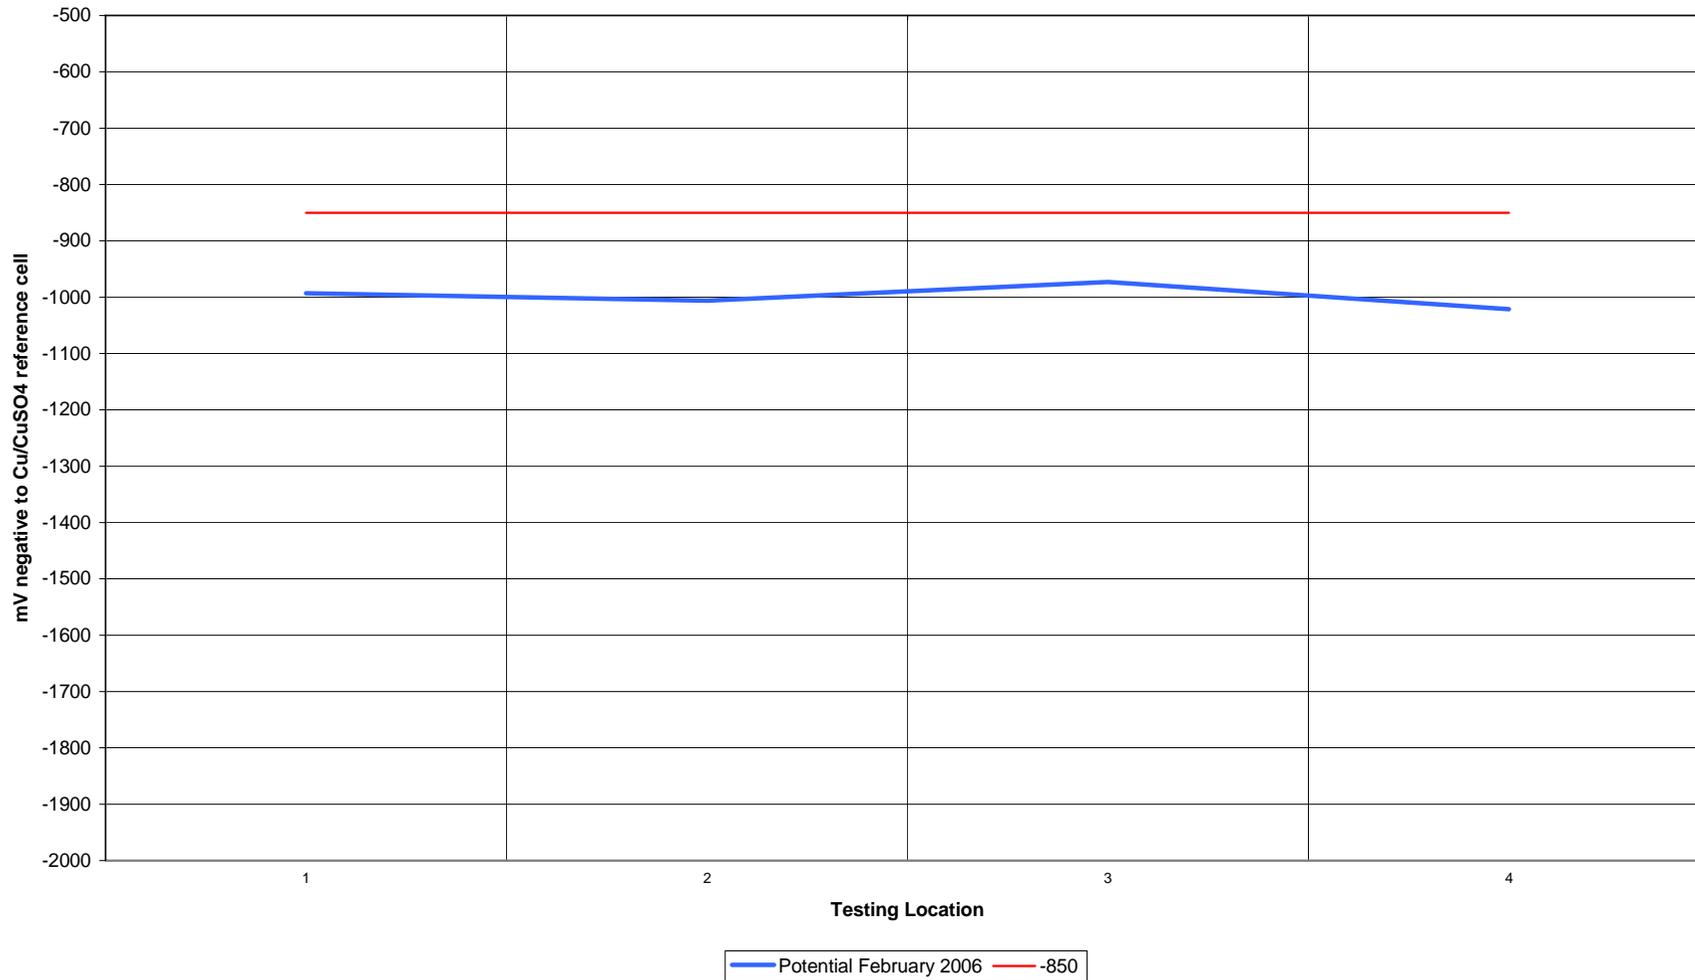
Potential Summary and Graph for National Dairies Lateral February 2006

Results from the survey indicate pipeline protection levels have increased since the August 2005 survey and the line is cathodically protected.
