2006 ANNUAL REPORT

**PRIMARY INDUSTRIES AND
RESOURCES SA**
(Petroleum and Geothermal Group)

Pipeline Licence No 11

Berri to Mildura Pipeline

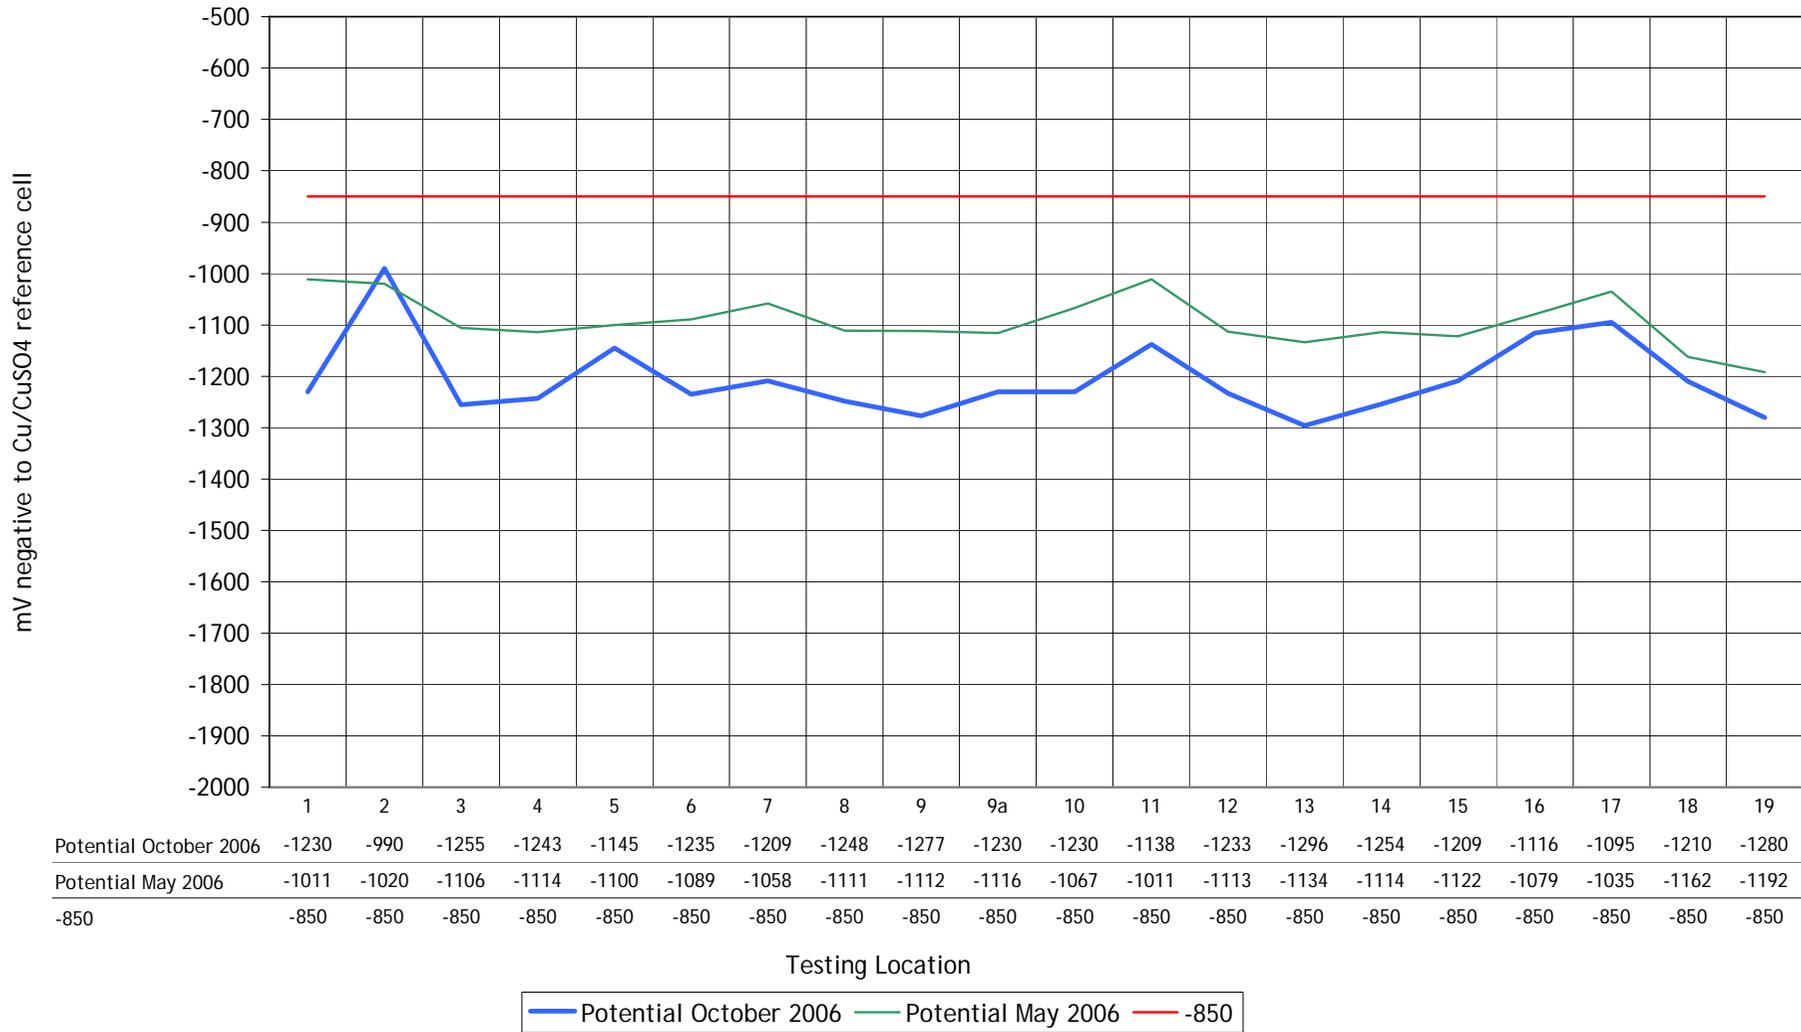
Potential Summary and Graph for Berri-Mildura Pipeline
 October 2006
 Test Point 1 - 19

A marginal reduction in the level of cathodic protection was noted in the May 2006 survey. The level of protection generally increased from Test Points 1-19 between the May 2006 and October 2006 surveys. This is possibly due to the zinc earthing anode at TP1 being disconnected during the May 2006 survey. The magnesium anode bed at TP19 has an open circuit potential of -1360mV indicating that its remaining serviceable life is limited. The magnesium anode bed at TP29 is not connected to the pipeline, so if the output of the anode bed at TP 19 drops significantly this can be reconnected.

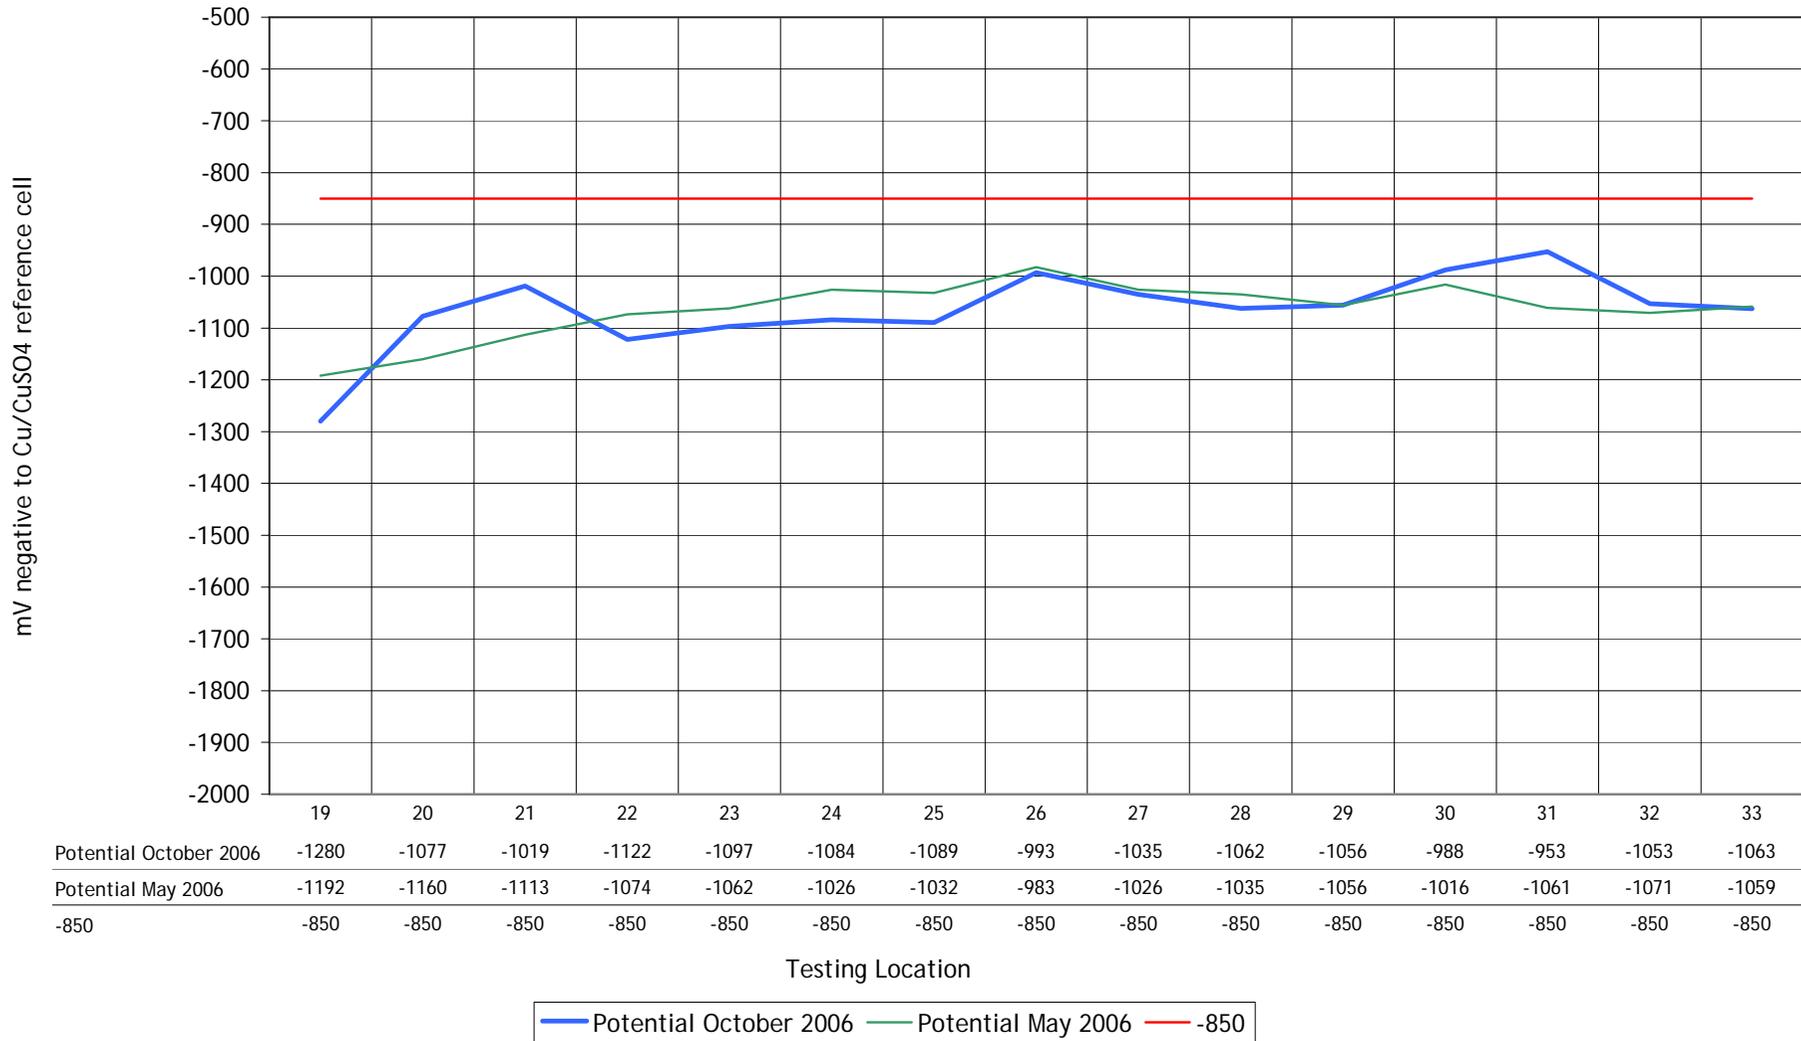
Potential Summary and Graph for Berri-Mildura Pipeline
 October 2006
 Test Point 19 - 33

The output of the anode bed at TP19 Loxton-Mildura Road will be monitored as it appears to be reaching the end of its serviceable life.

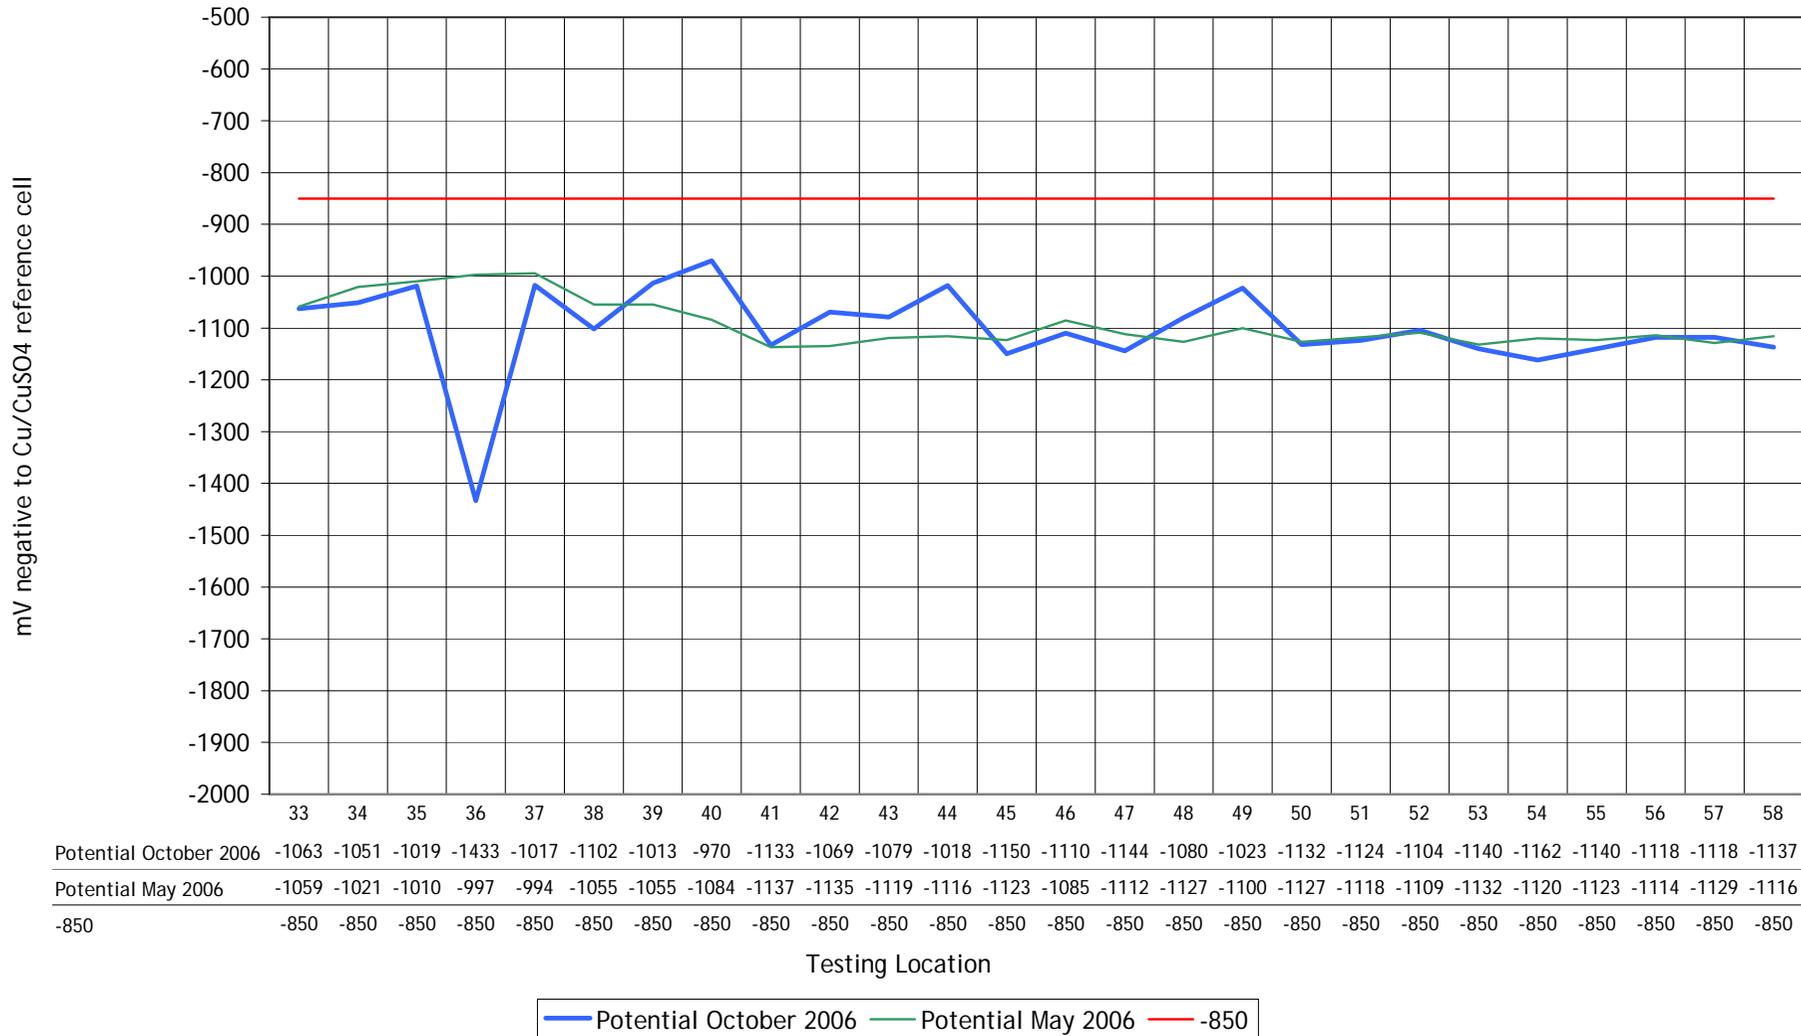
Potential Summary and Graph for Berri-Mildura Pipeline
 October 2006
 Test Point 33 - 58

At TP36 the potential readings have not been consistent during the previous surveys and further investigation is required.
