Department for Energy and Mining

Caroline-1 Tubing and Casing

Report

August 2019

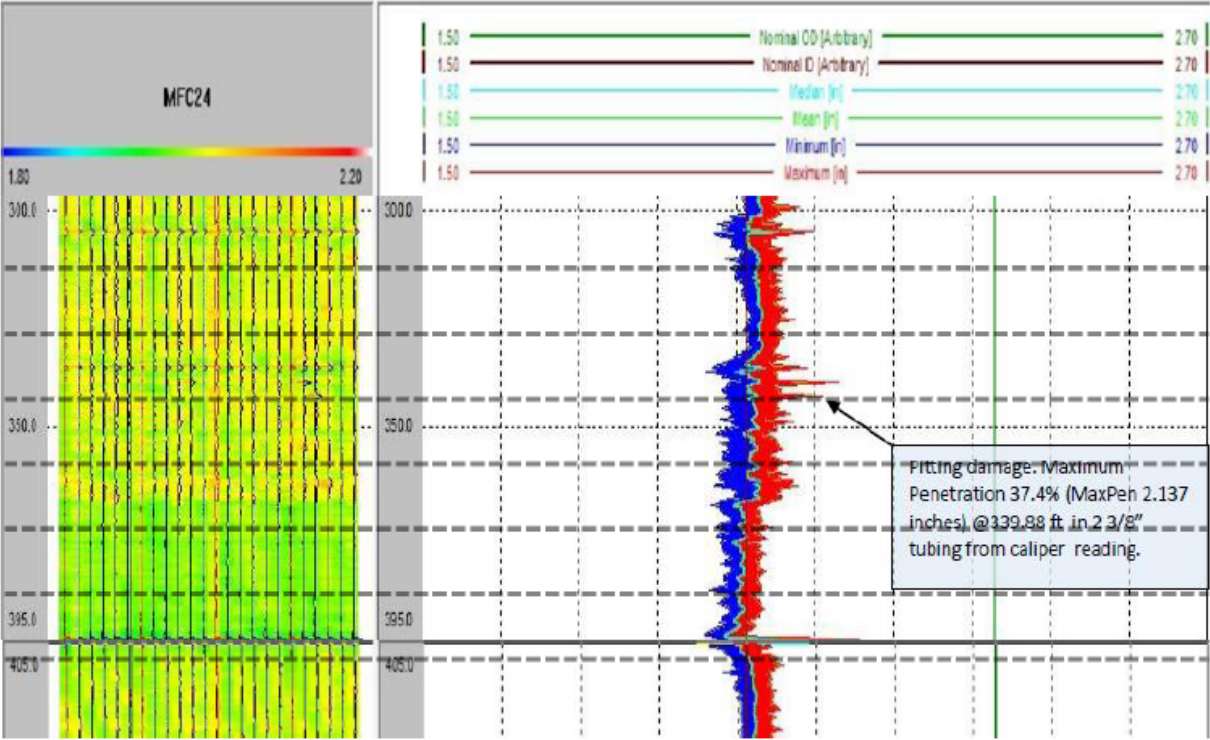
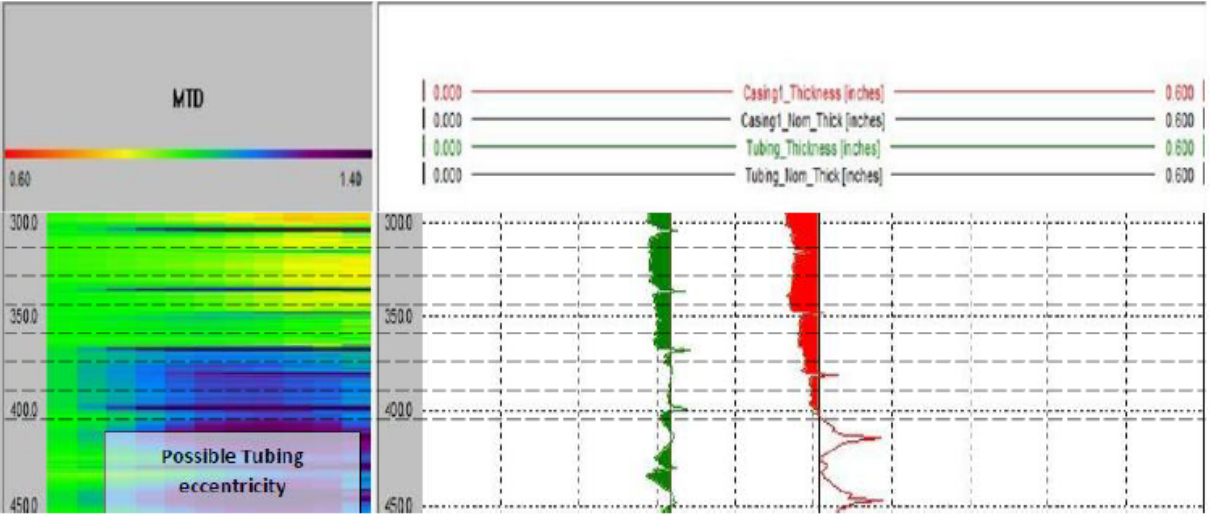
Figure 10: Joints 11-13 MFC Log

Joint Range	Est. Depth Range (m (ft))	Reason for Interest
11 - 13	95.40 – 124.02 (313 – 407)	High pitting

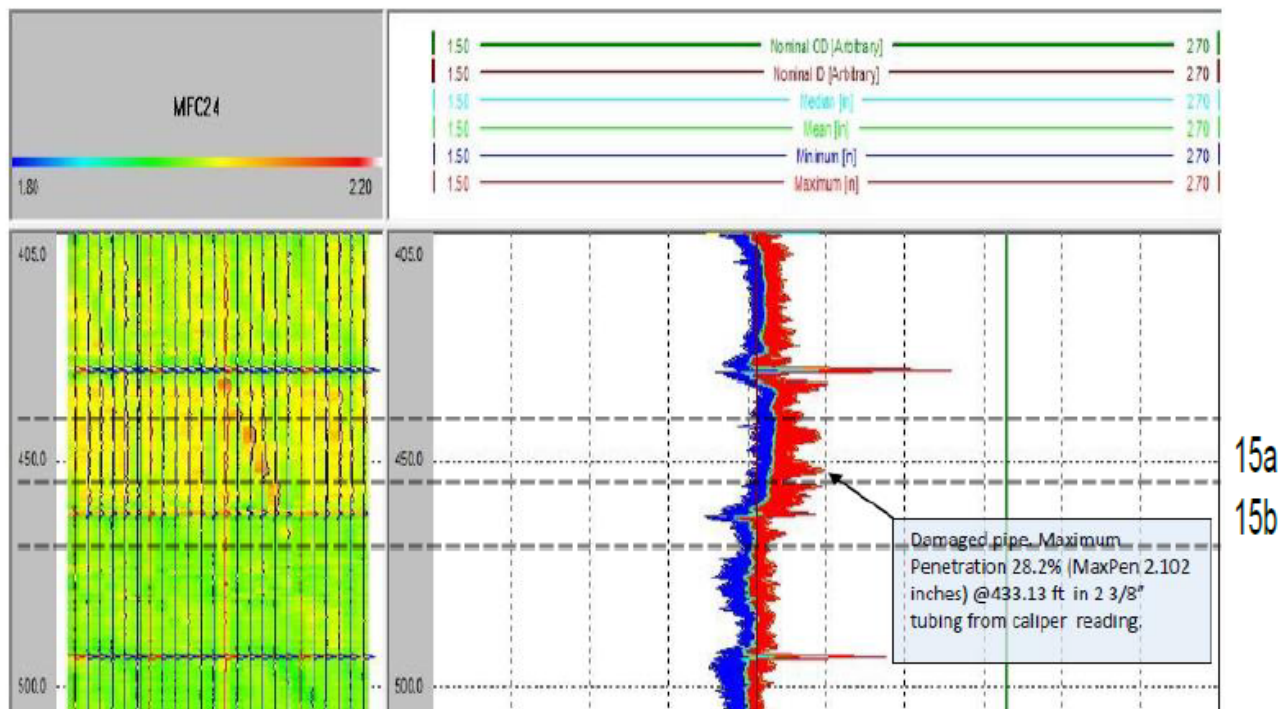
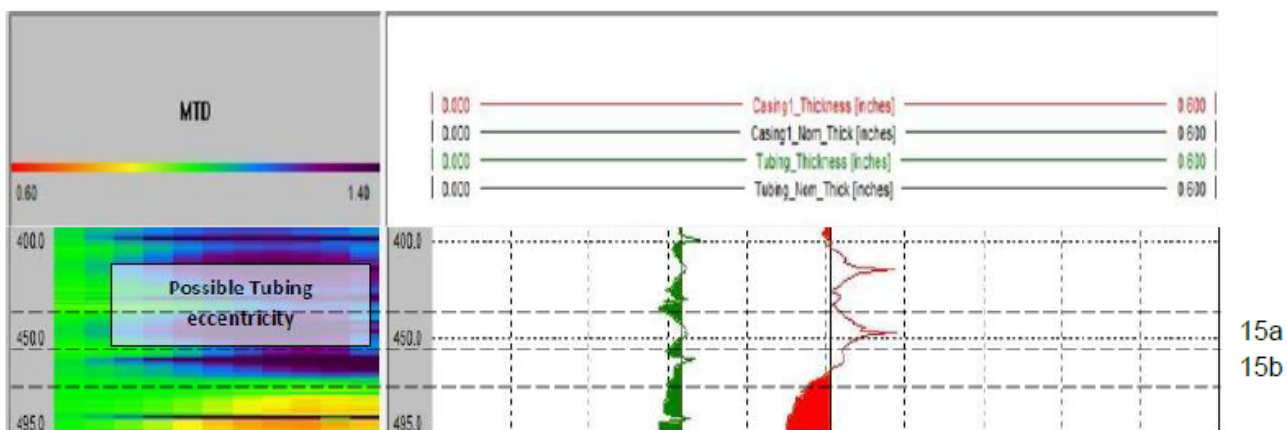
Figure 12: Joint 15 MFC log

Joint Range	Est. Depth Range (m (ft))	Reason for Interest
15	133.56 – 143.10 (438 – 469)	Damaged pipe

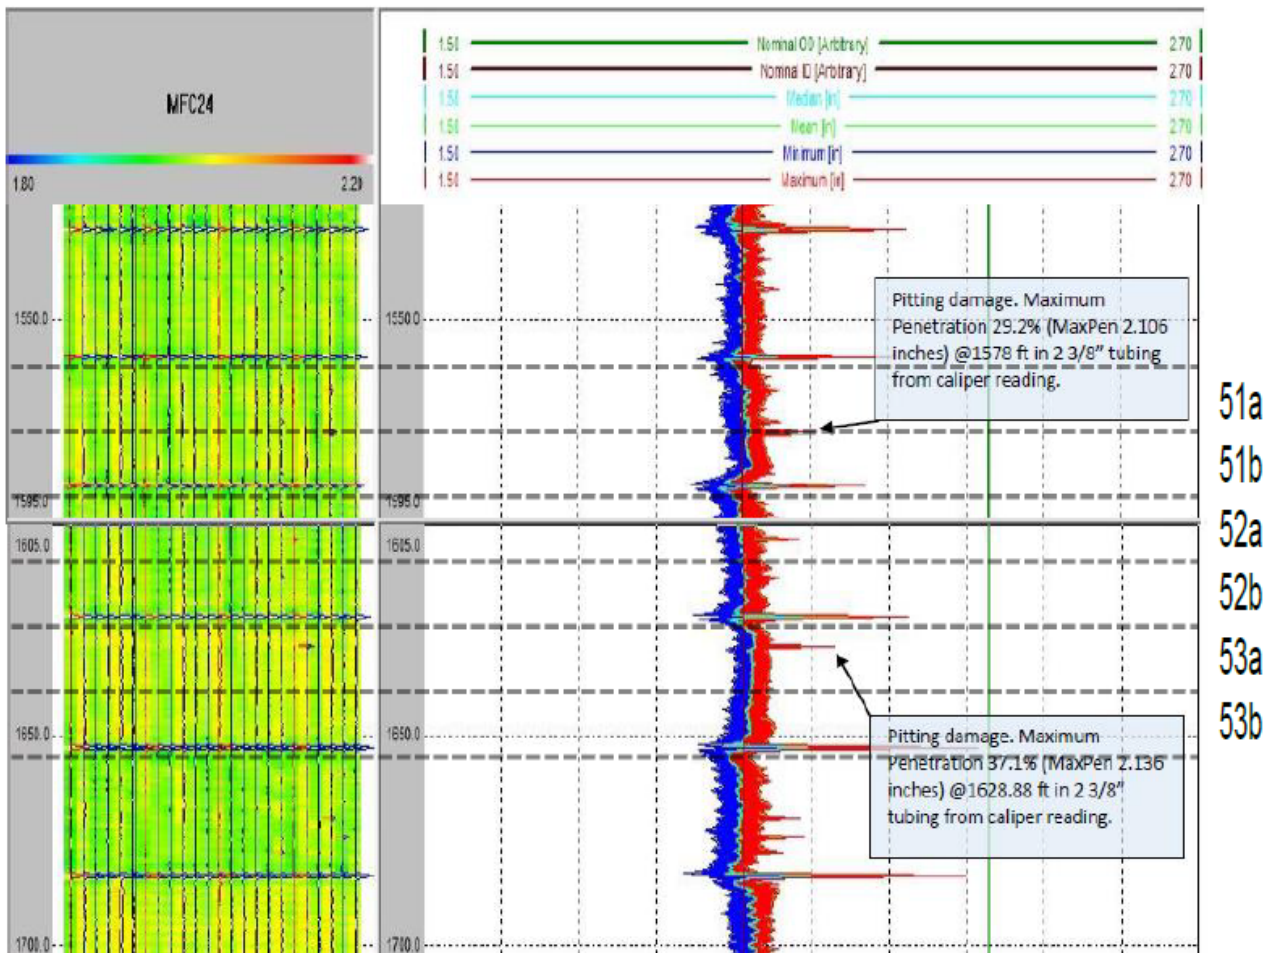
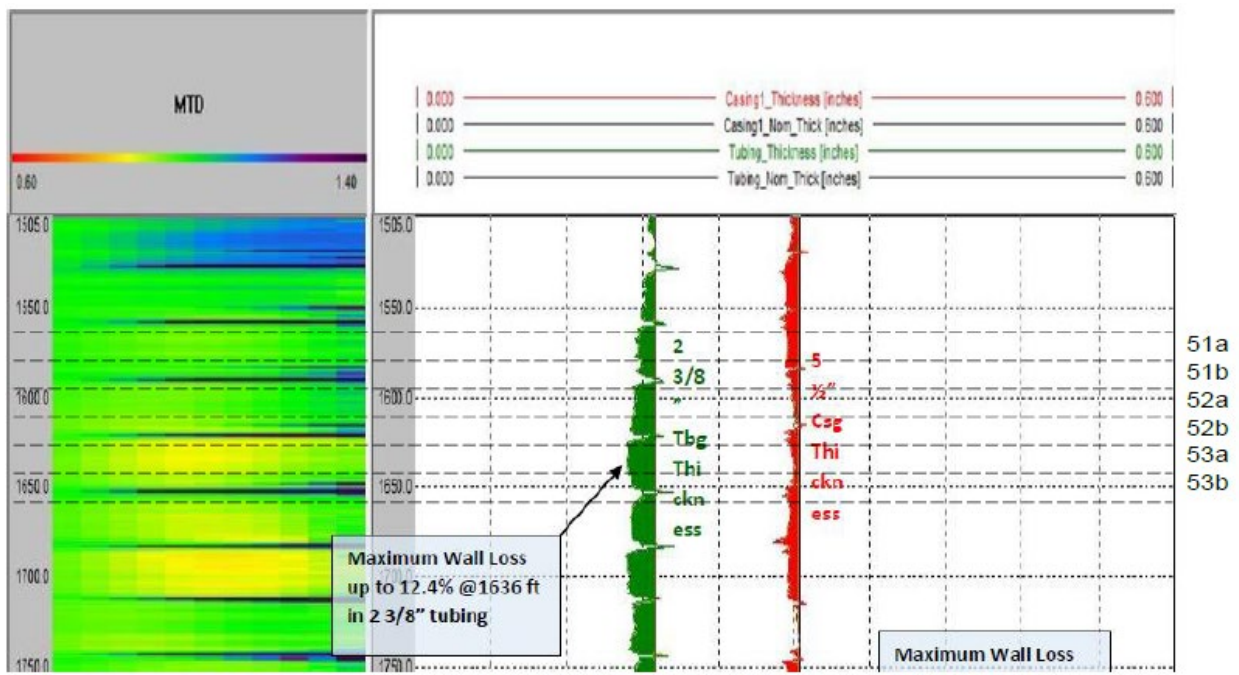
Figure 16: Joints 51-53 MFC log

Joint Range	Est. Depth Range (m (ft))	Reason for Interest
51 - 53	477.0 – 505.62 (1565 – 1659)	High pitting

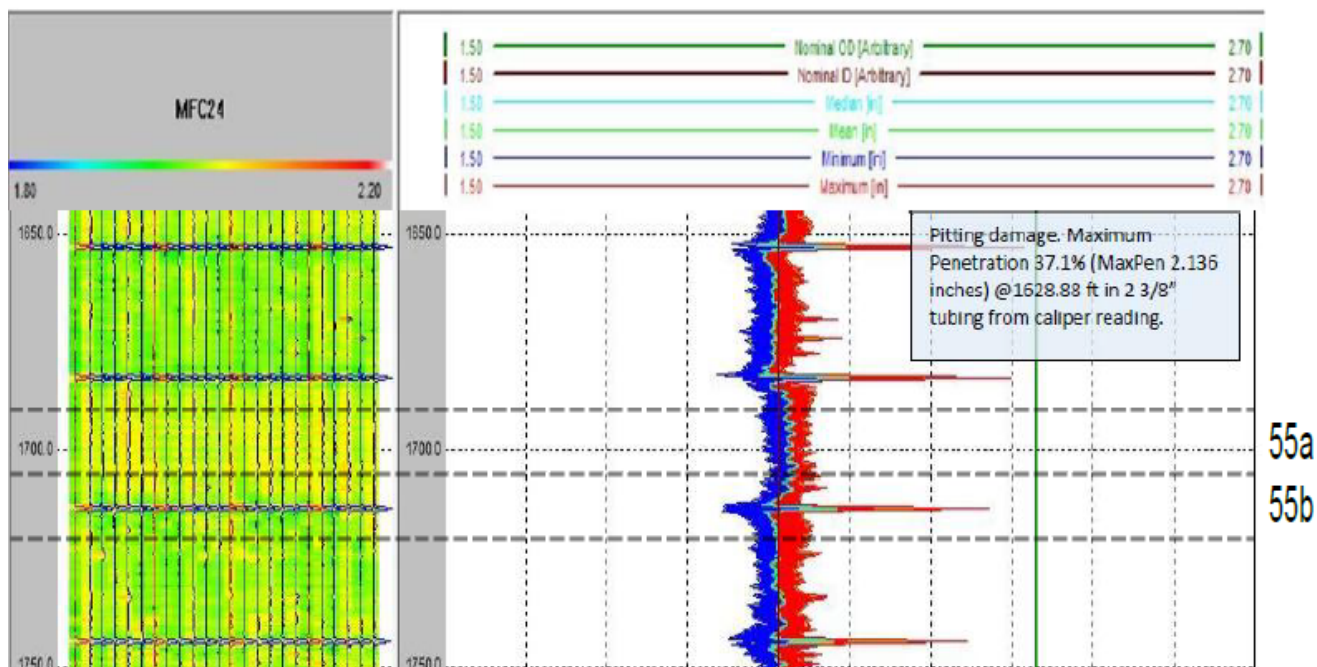
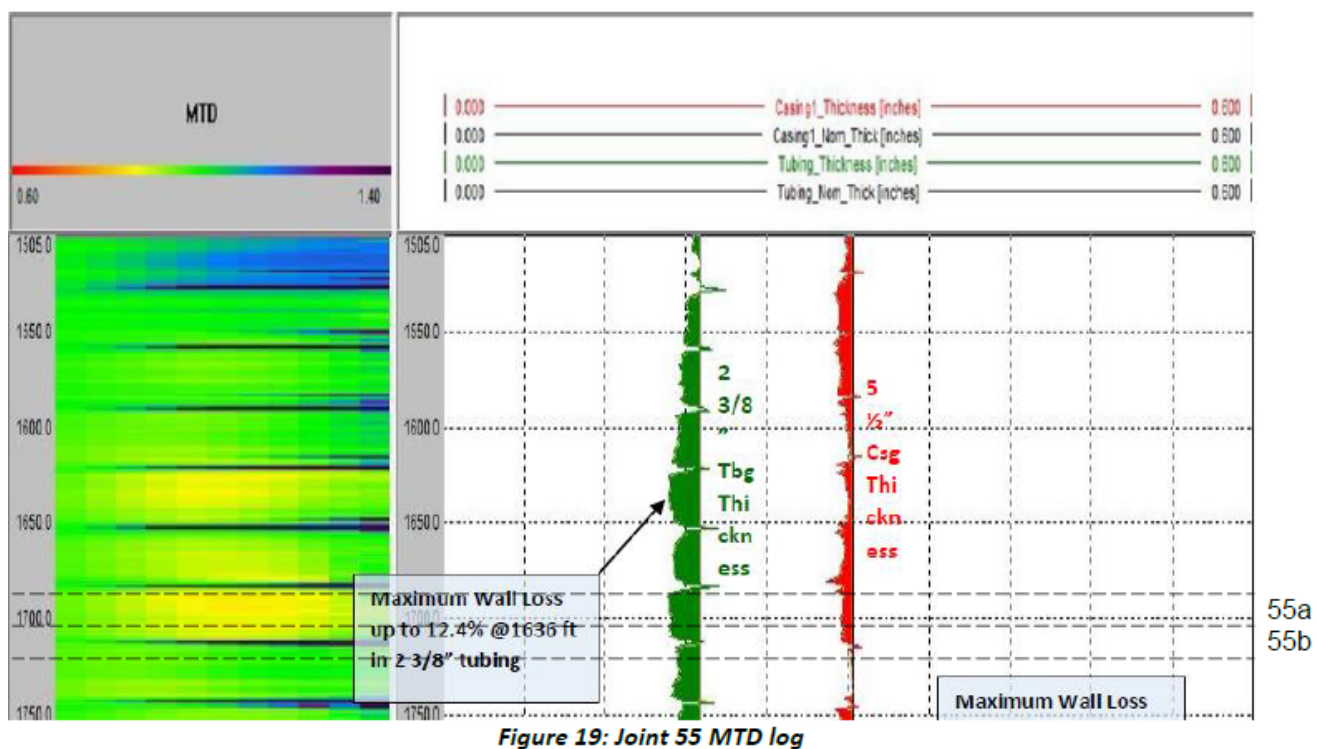
Joint Range	Est. Depth Range (m (ft))	Reason for Interest
55	515.16 – 524.70 (1690 – 1721)	Odd calliper response

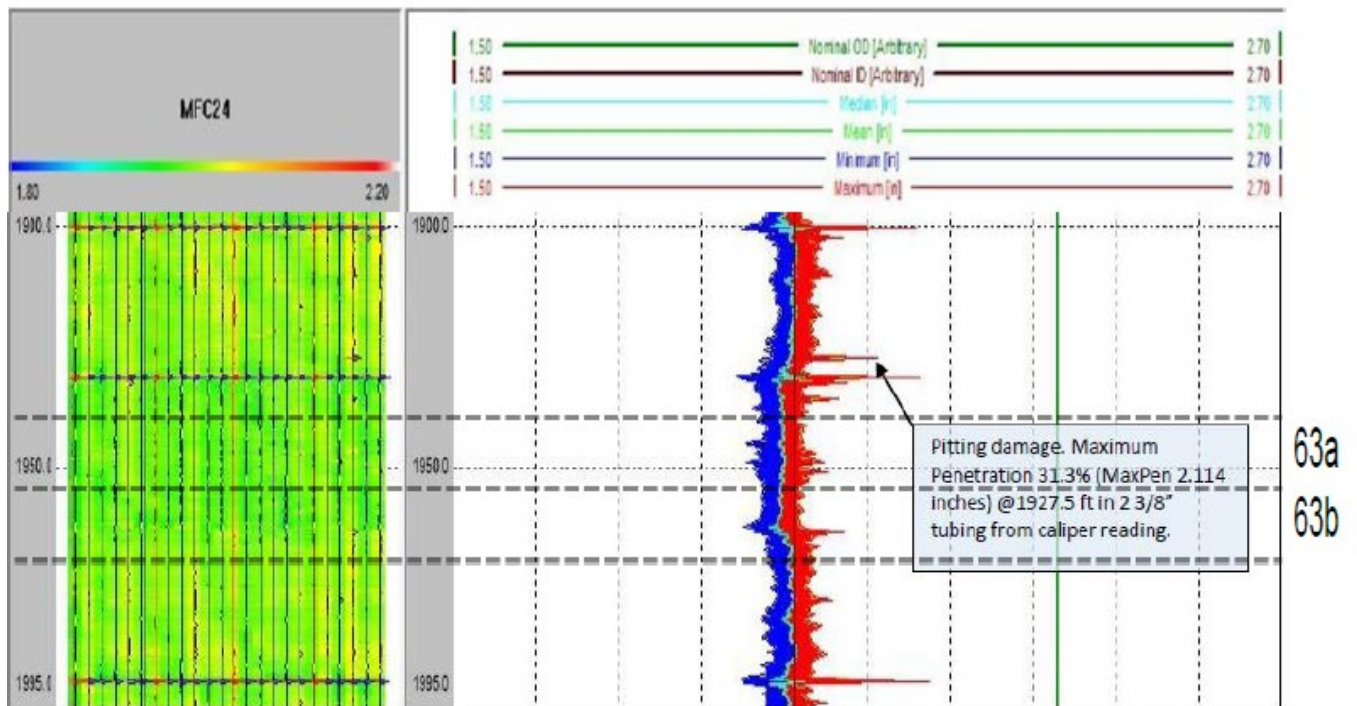
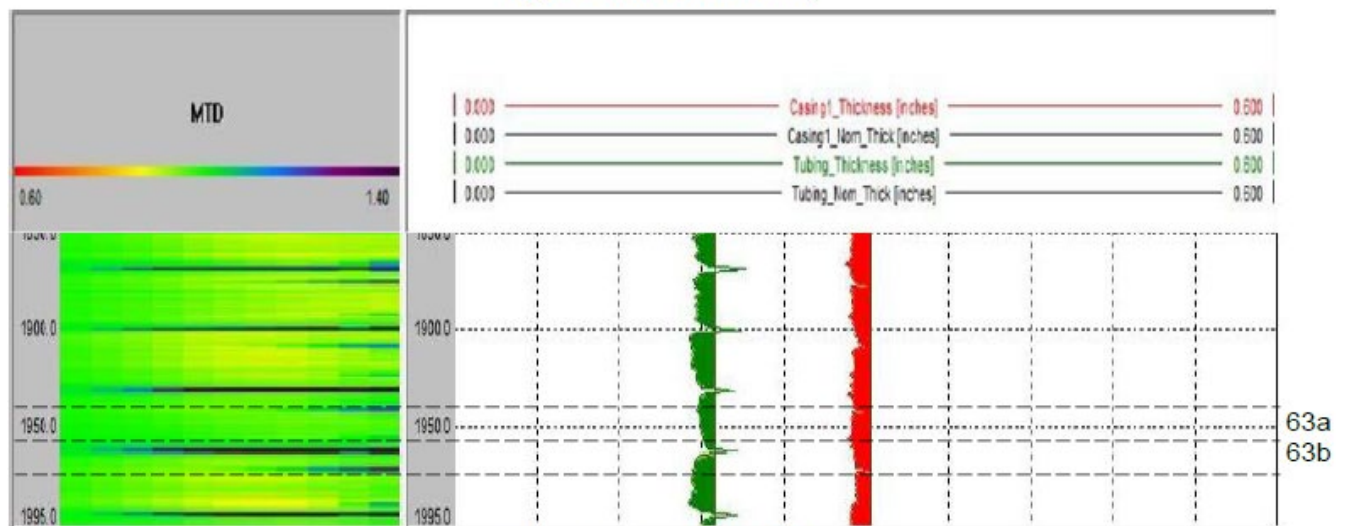
Joint Range	Est. Depth Range (m)	Reason for Interest
63	591.48 – 601.02 (1941 – 1972)	Scale build-up

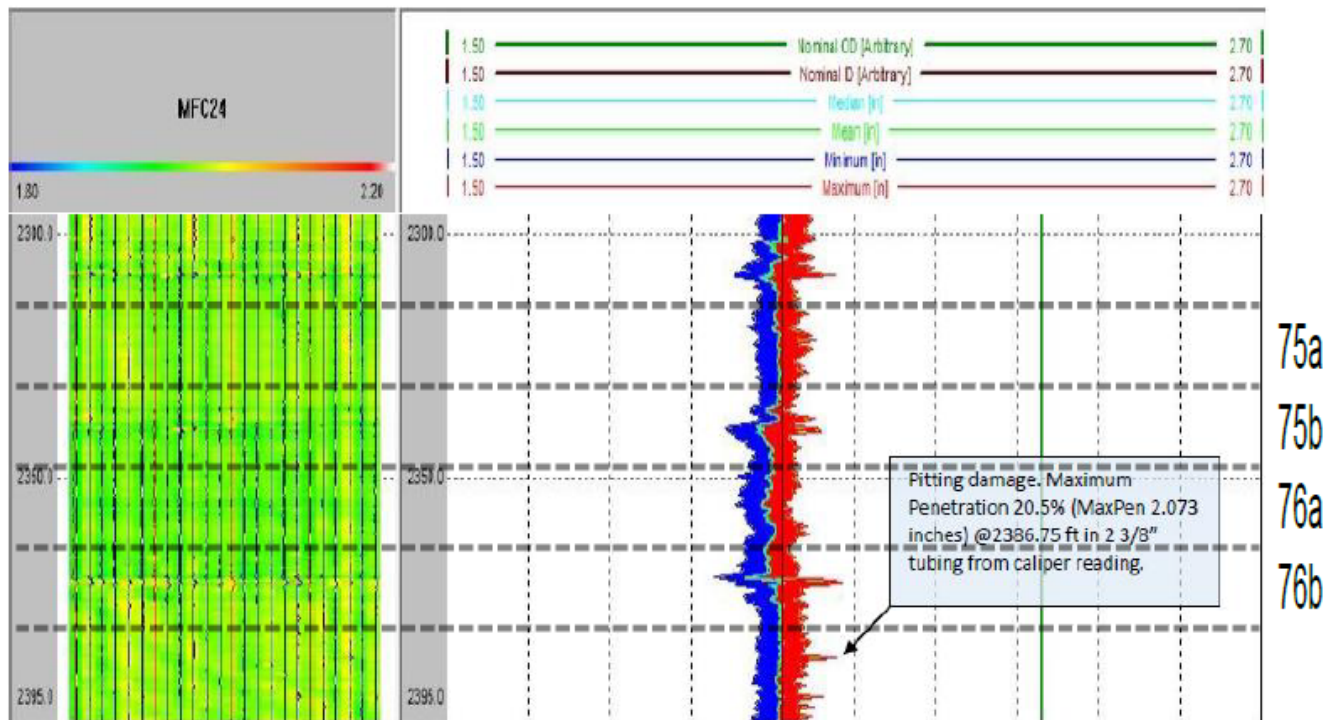
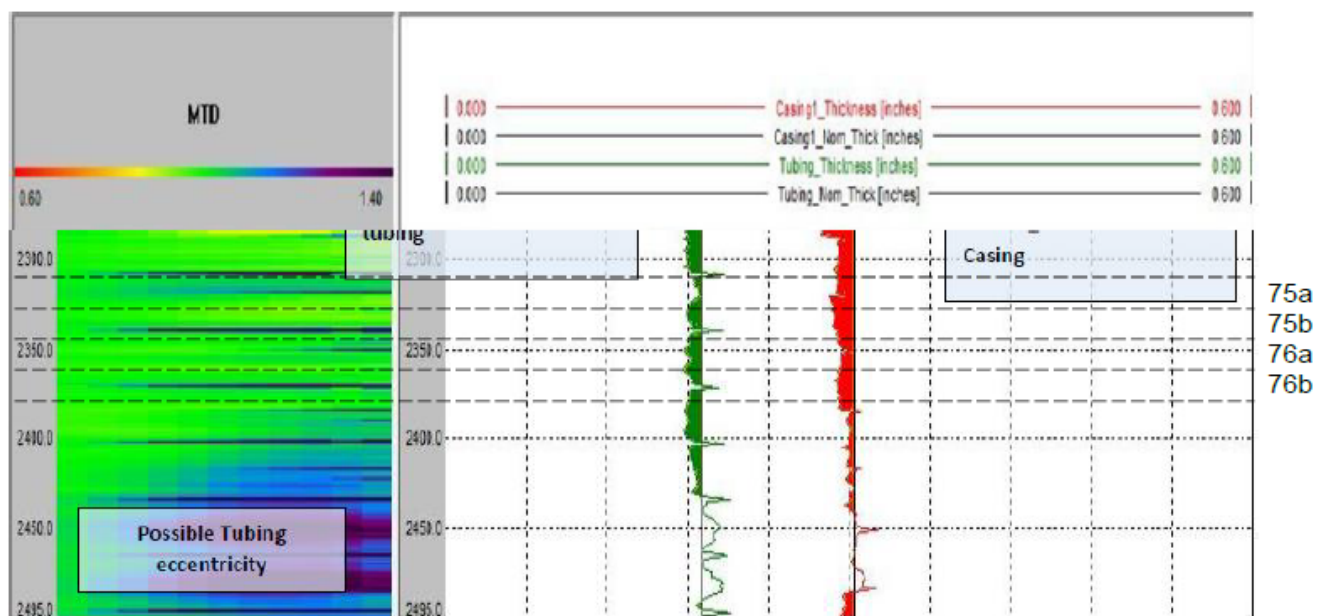
Figure 22: Joints 75-76 MFC log

Joint Range	Est. Depth Range (m)	Reason for Interest
75 -76	705.96 – 725.04 (2316 – 2379)	Scale build-up

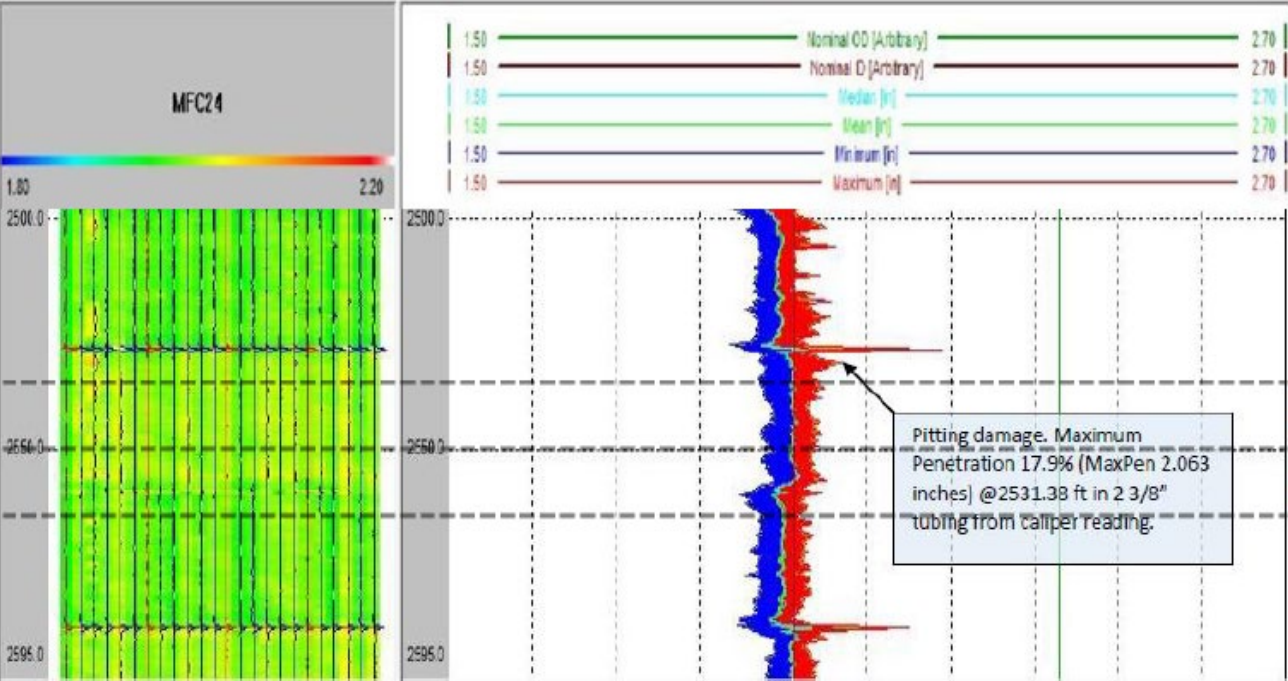
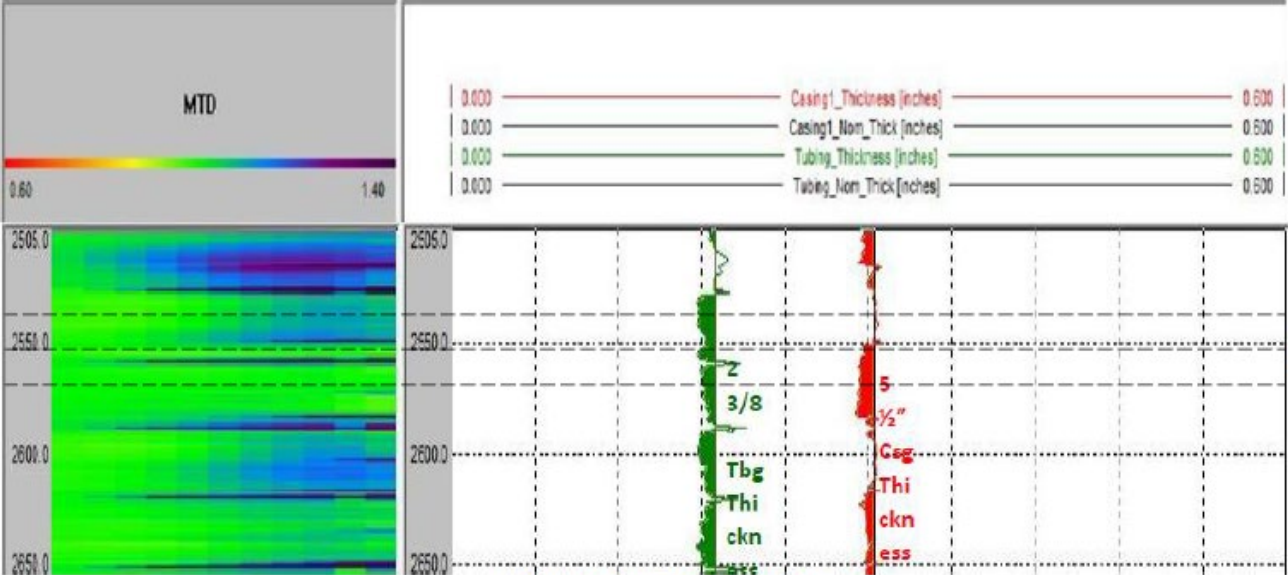
Figure 24: Joint 82 MFC log

Joint Range	Est. Depth Range (m)	Reason for Interest
82	772.74 – 782.28 (2535 – 2567)	Scale build-up

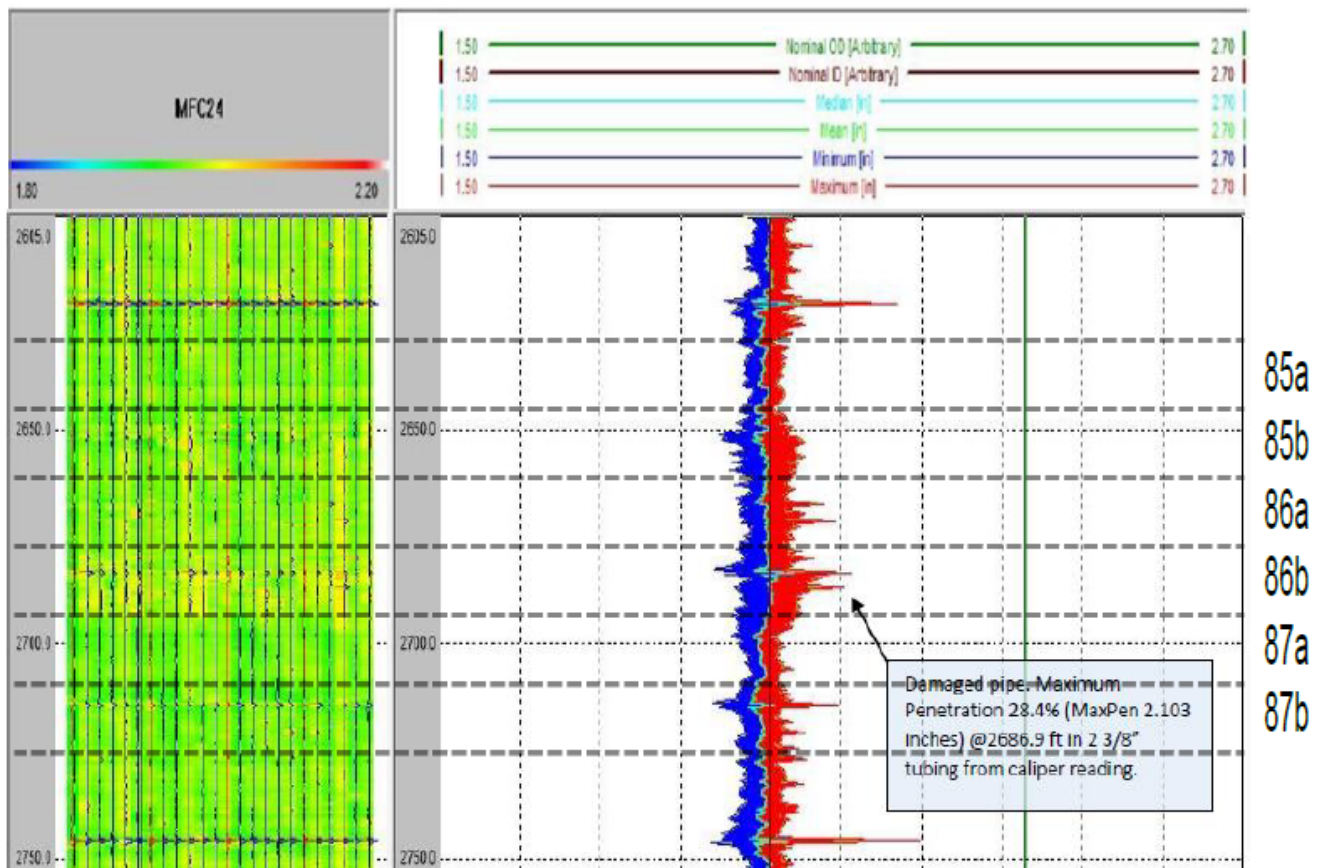
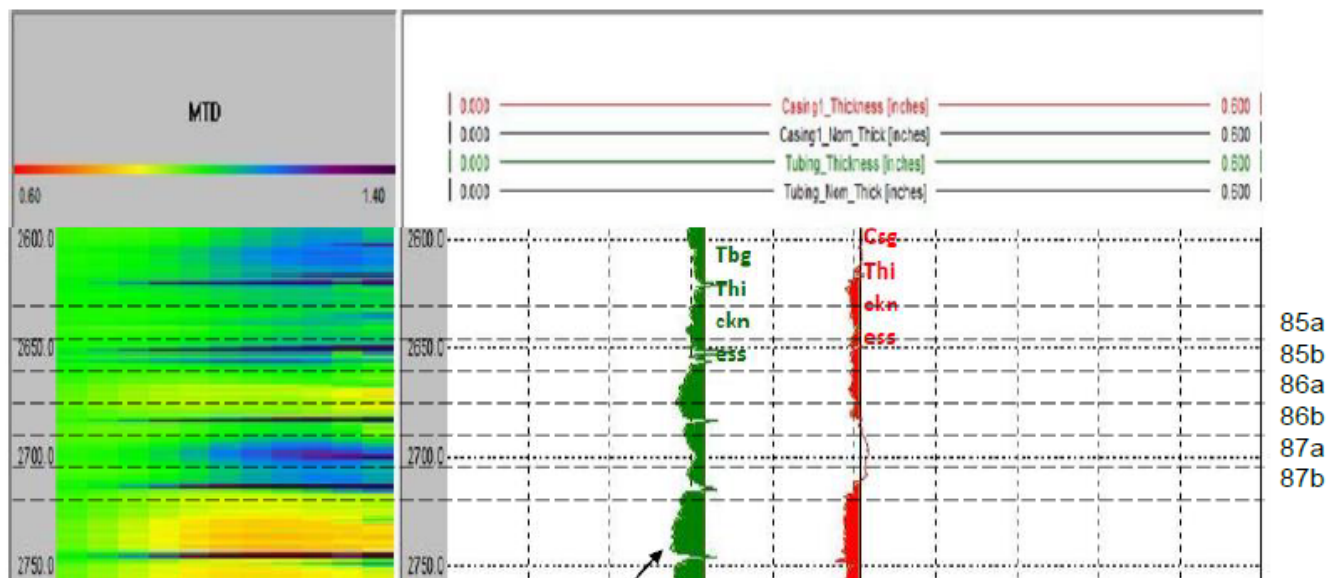
Figure 26: Joints 85-87 MFC log

Joint Range	Est. Depth Range (m)	Reason for Interest
85 - 87	801.36 – 829.98 (2629 – 2723)	Low wall thickness / high pitting

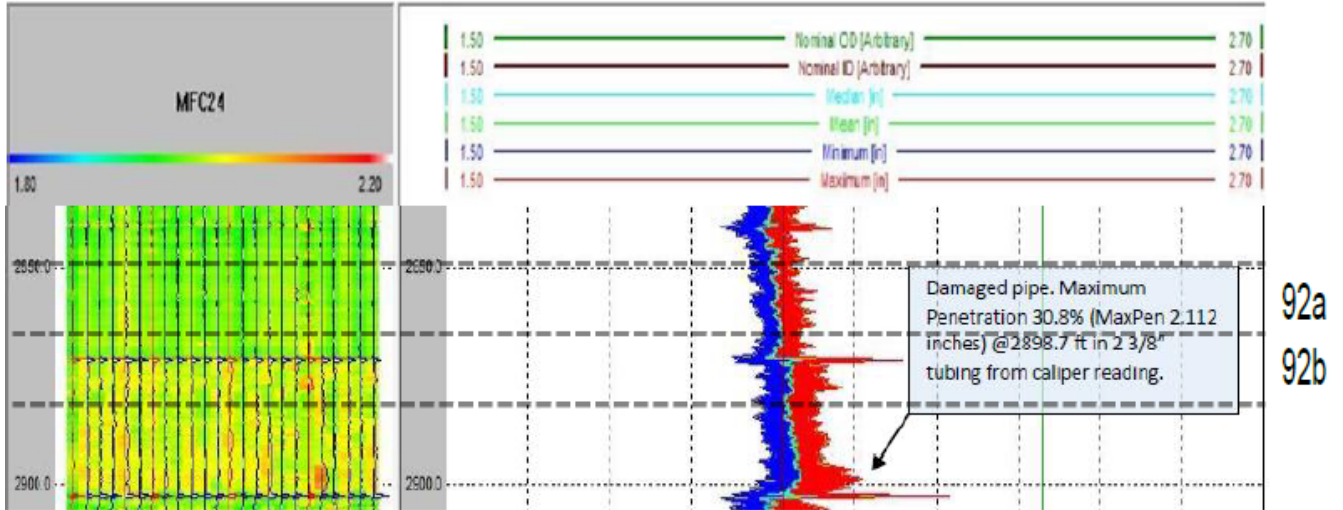
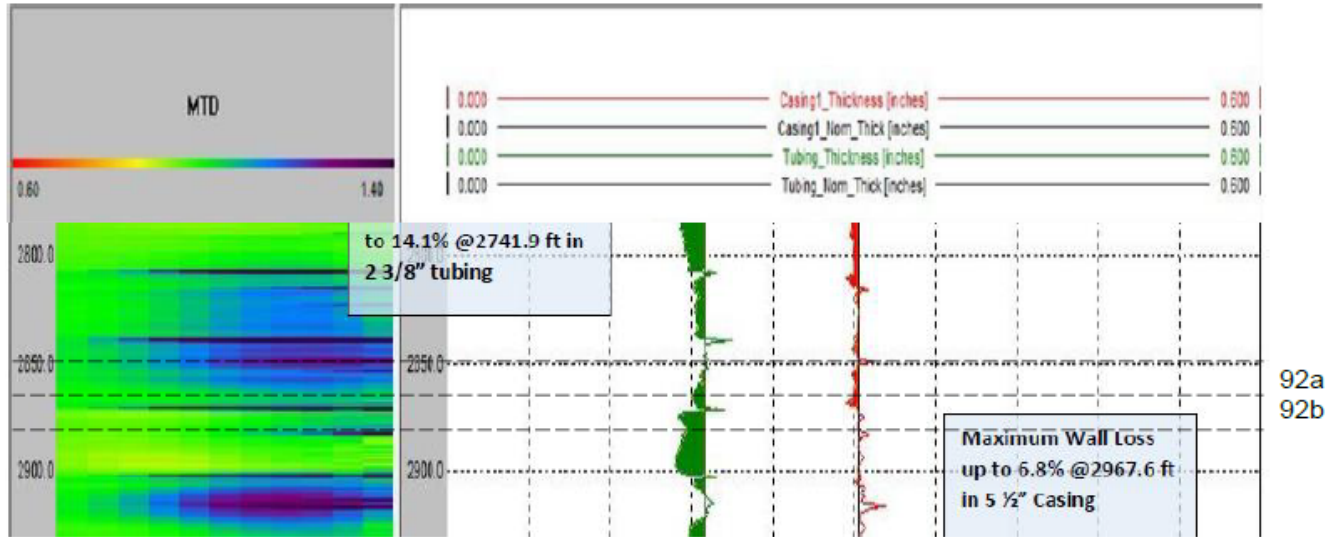
Figure 28: Joint 92 MFC log

Joint Range	Est. Depth Range (m (ft))	Reason for Interest
92	868.14 – 877.68 (2848 - 2880)	Damaged pipe

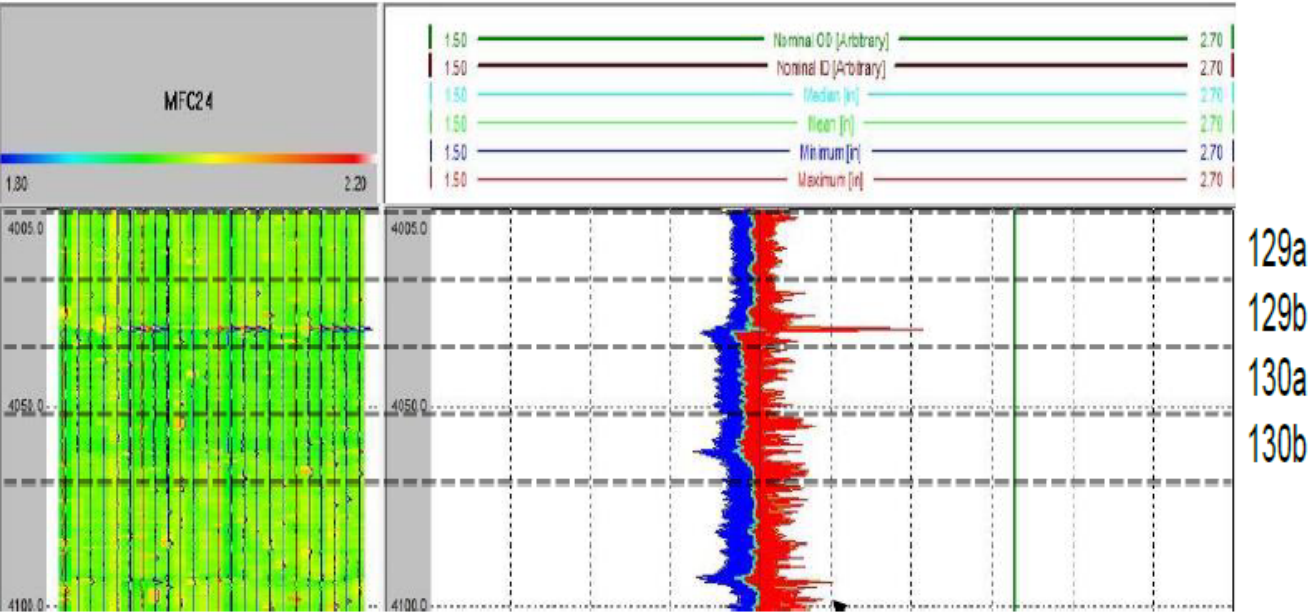
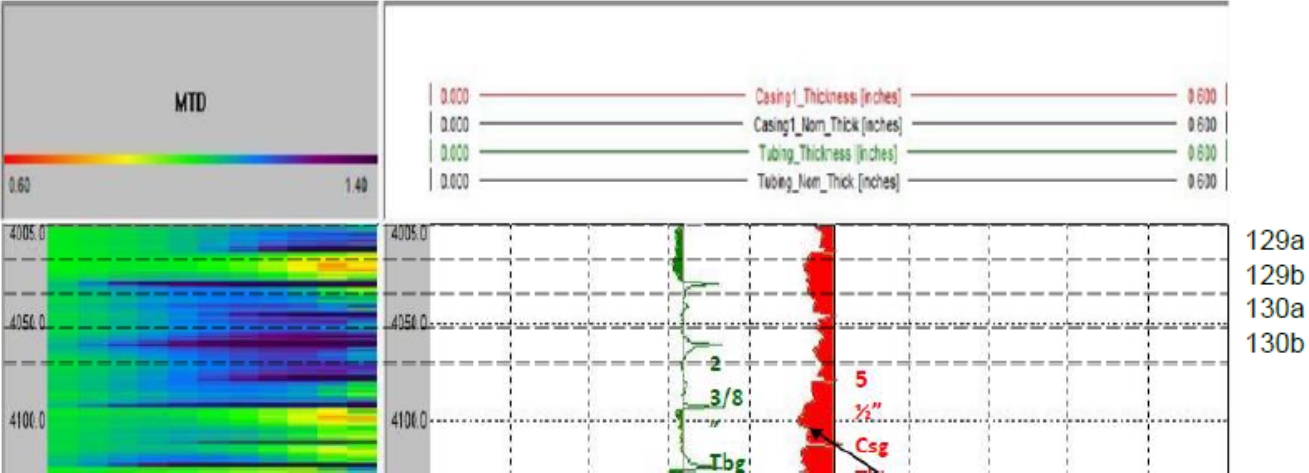
Figure 34: Joints 129-130 MFC log

Joint Range	Est. Depth Range (m (ft))	Reason for Interest
129 - 130	1221.12 – 1240.20 (4006 – 4069)	High pitting

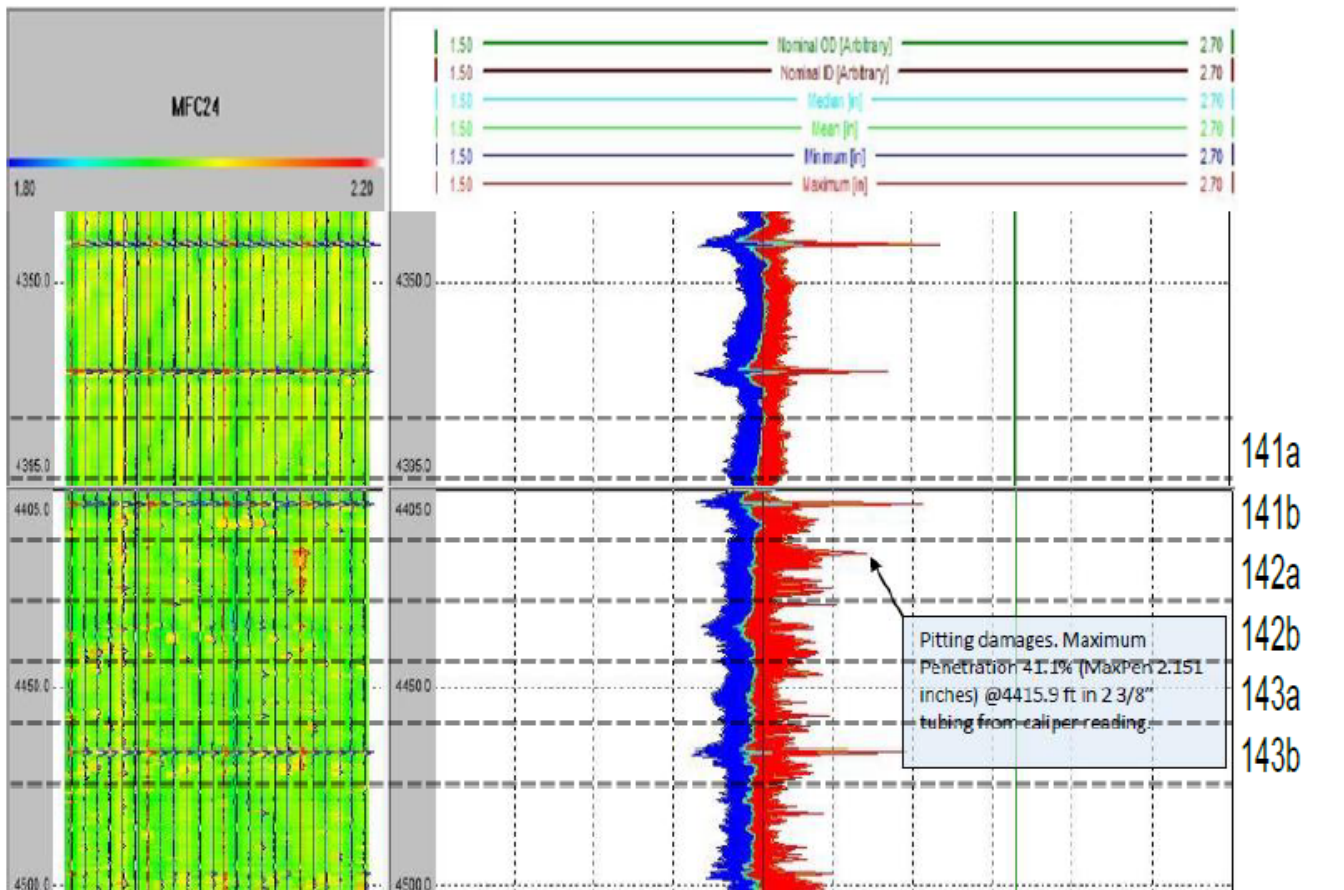
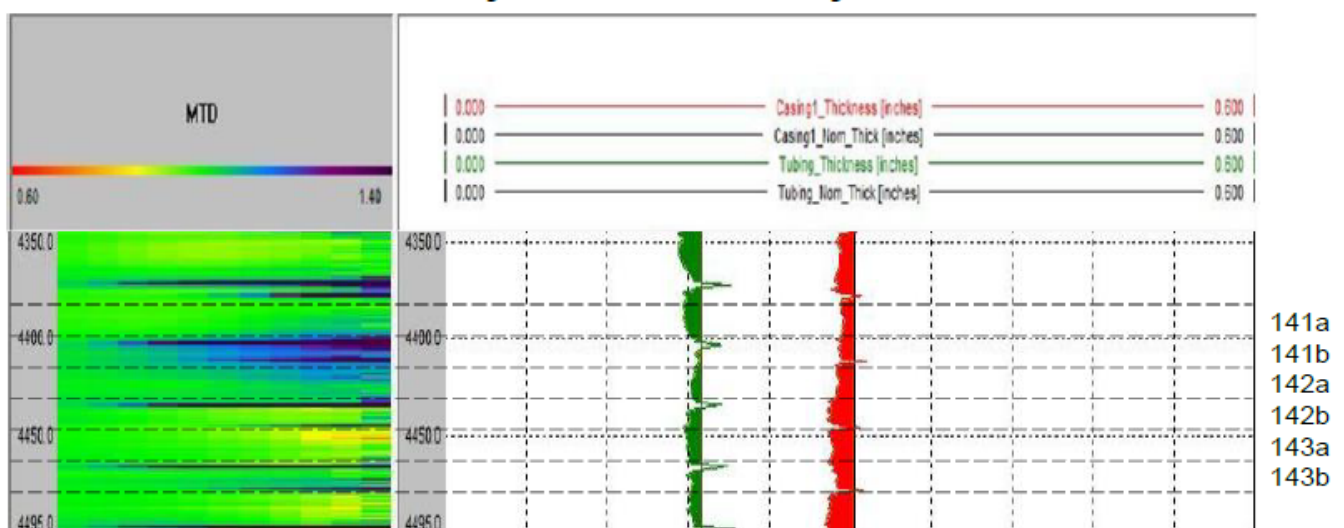
Figure 36: Joints 141-143 MFC log

Joint Range	Est. Depth Range (m (ft))	Reason for Interest
141 - 143	1335.60 – 1364.22 (4382 – 4476)	High pitting

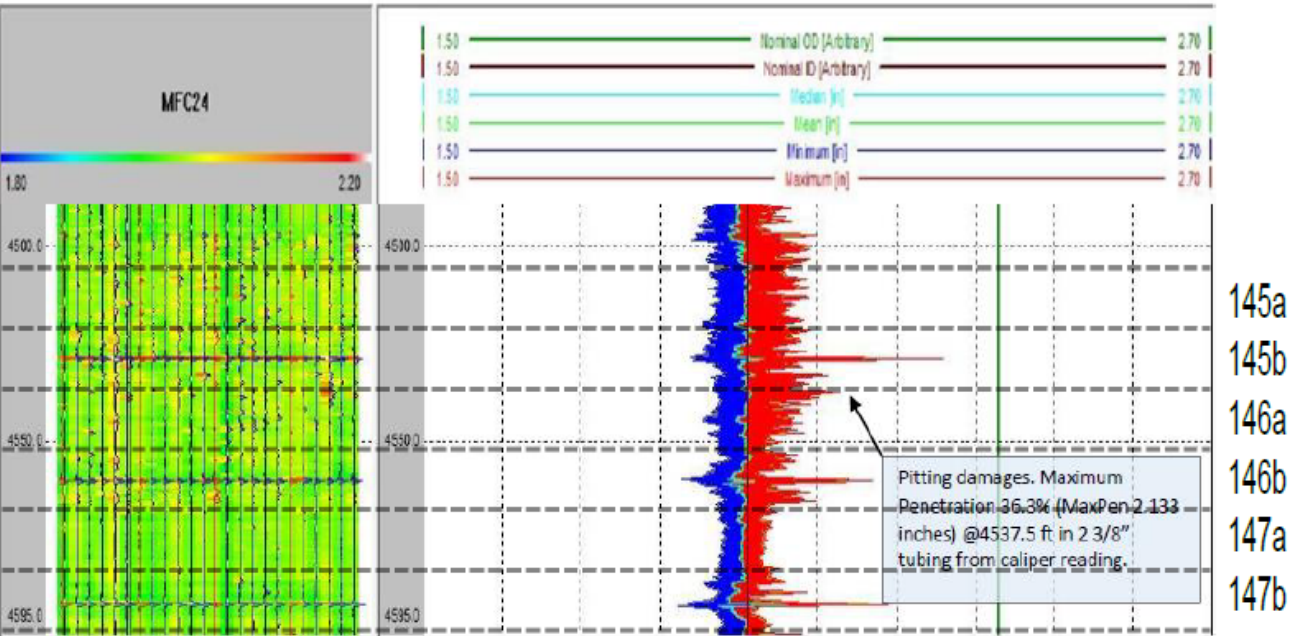
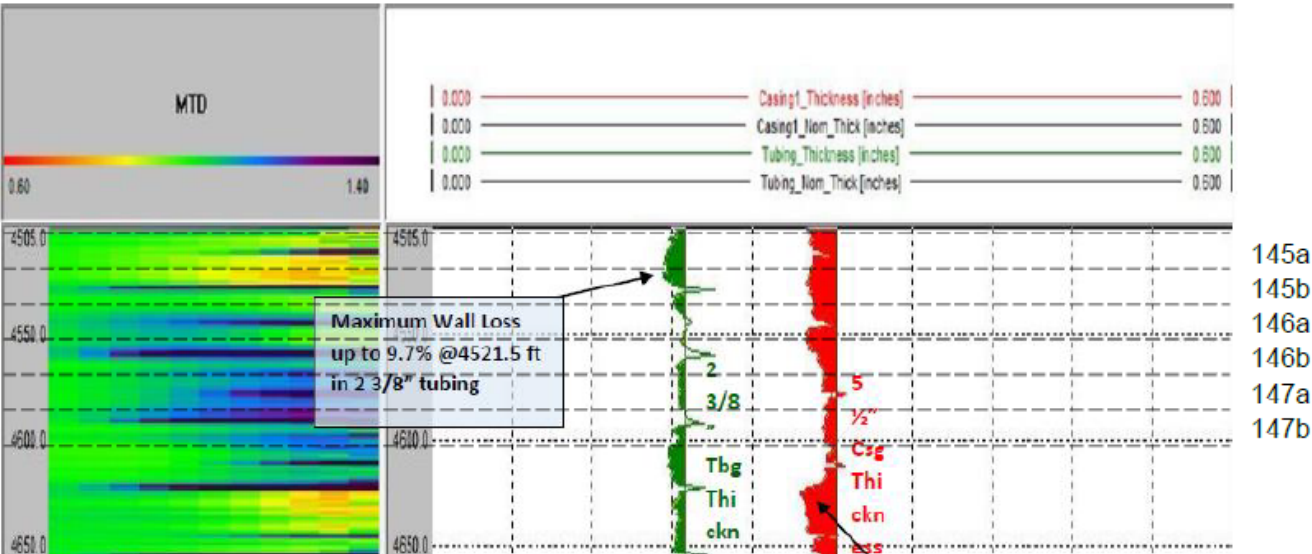
Figure 38: Joints 145-147 MFC log

Joint Range	Est. Depth Range (m (ft))	Reason for Interest
145 - 147	1373.76 – 1402.38 (4507 – 4601)	High pipe damage / Good pipe jt. 147?

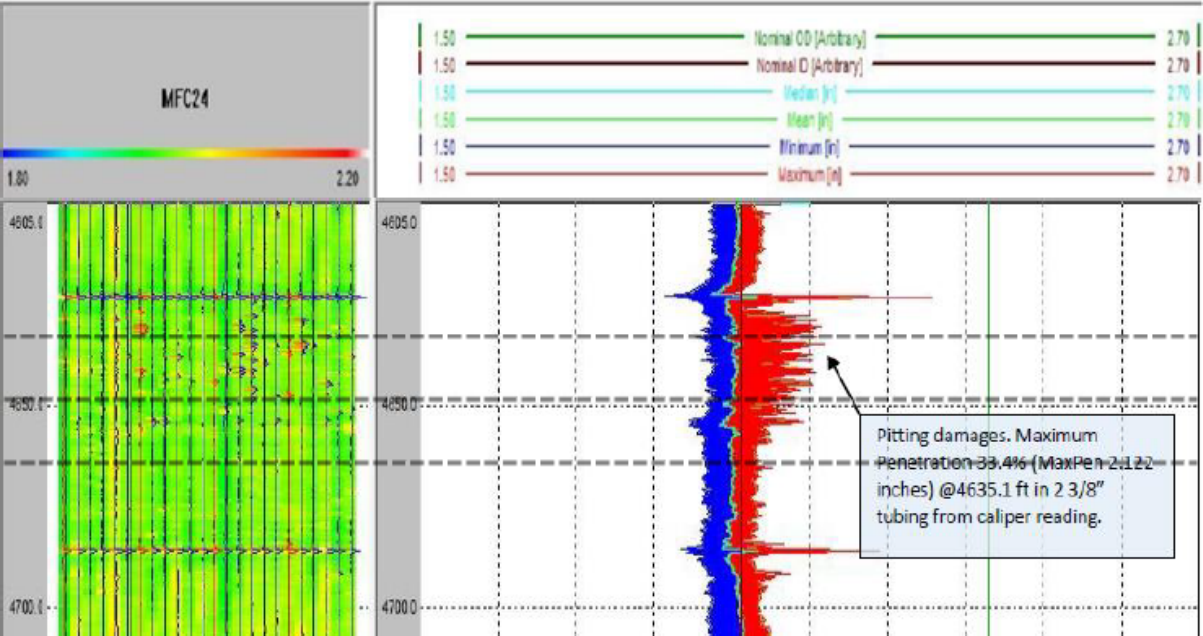
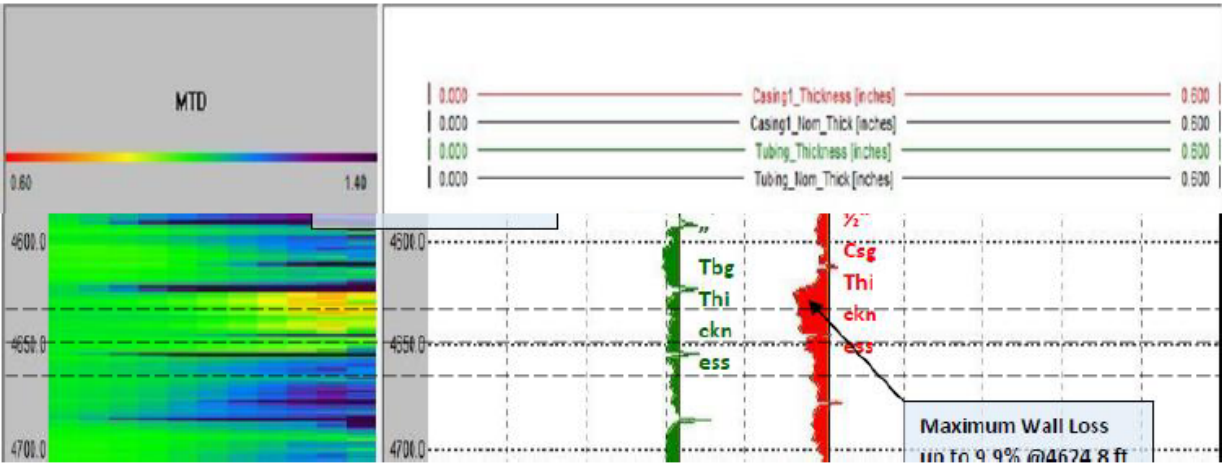
Figure 40: Joint 149 MFC log

Joint Range	Est. Depth Range (m (ft))	Reason for Interest
149	1411.92 – 1421.46 (4632 – 4665)	High pitting
