Department for Energy and Mining

Caroline-1 Tubing and Casing

Report

August 2019

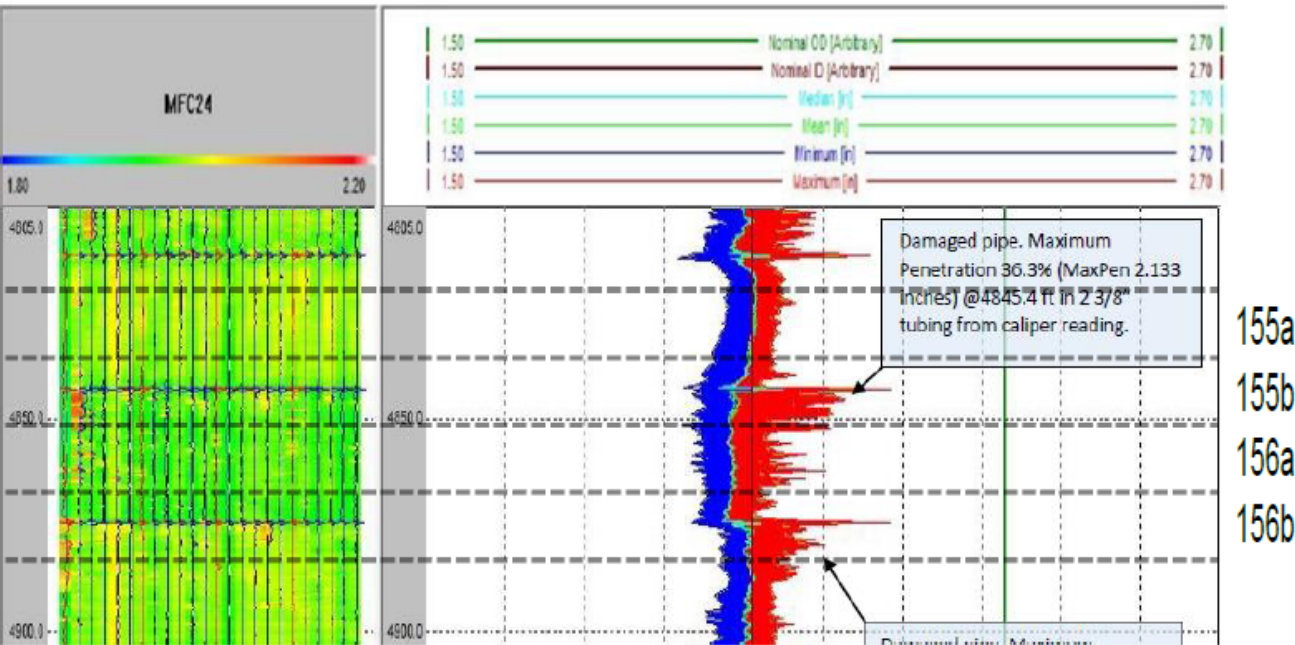
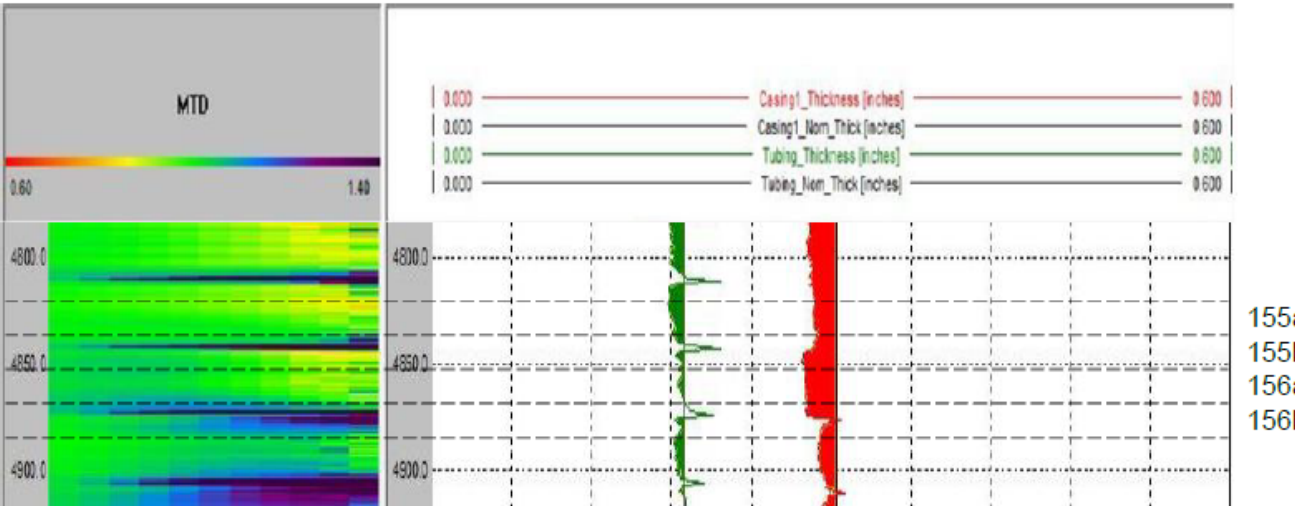
Joint Range	Est. Depth Range (m (ft))	Reason for Interest
155 - 156	1469.16 – 1488.24 (4820 – 4883)	Damaged pipe

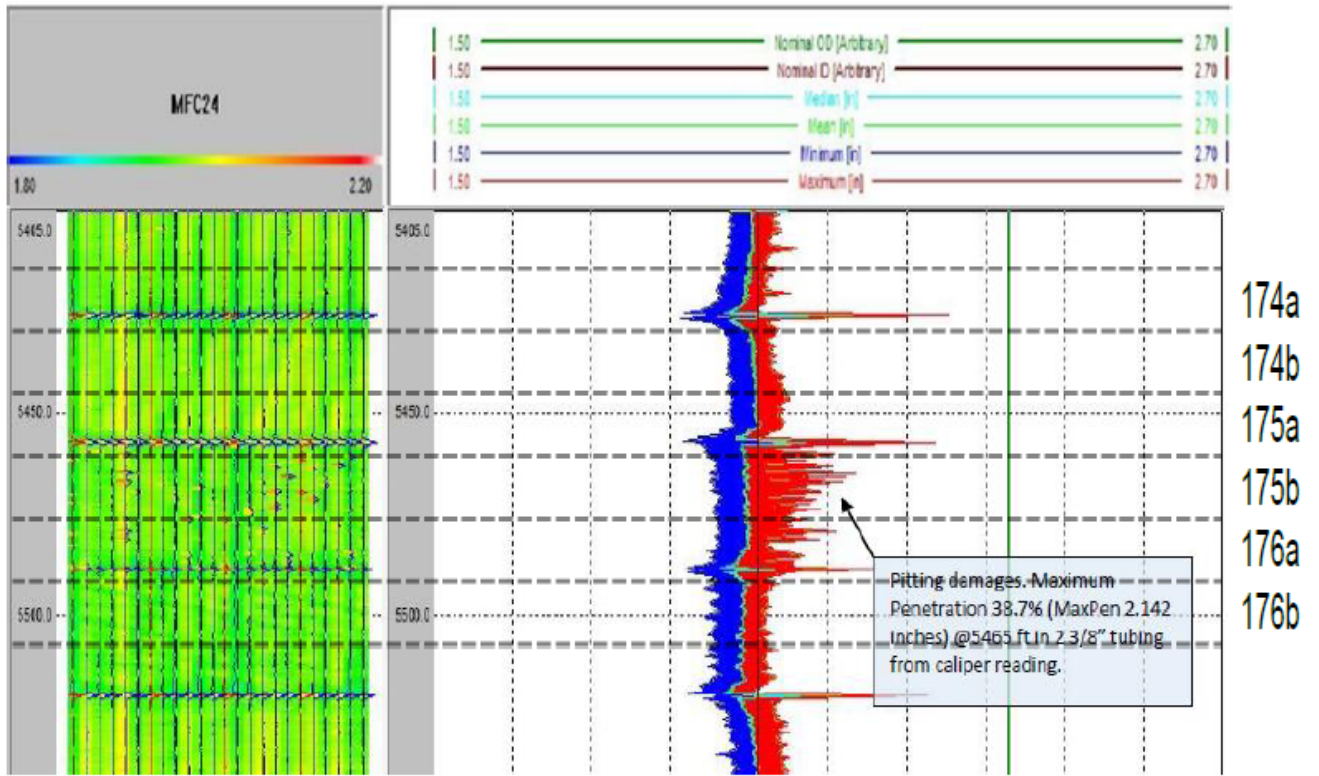
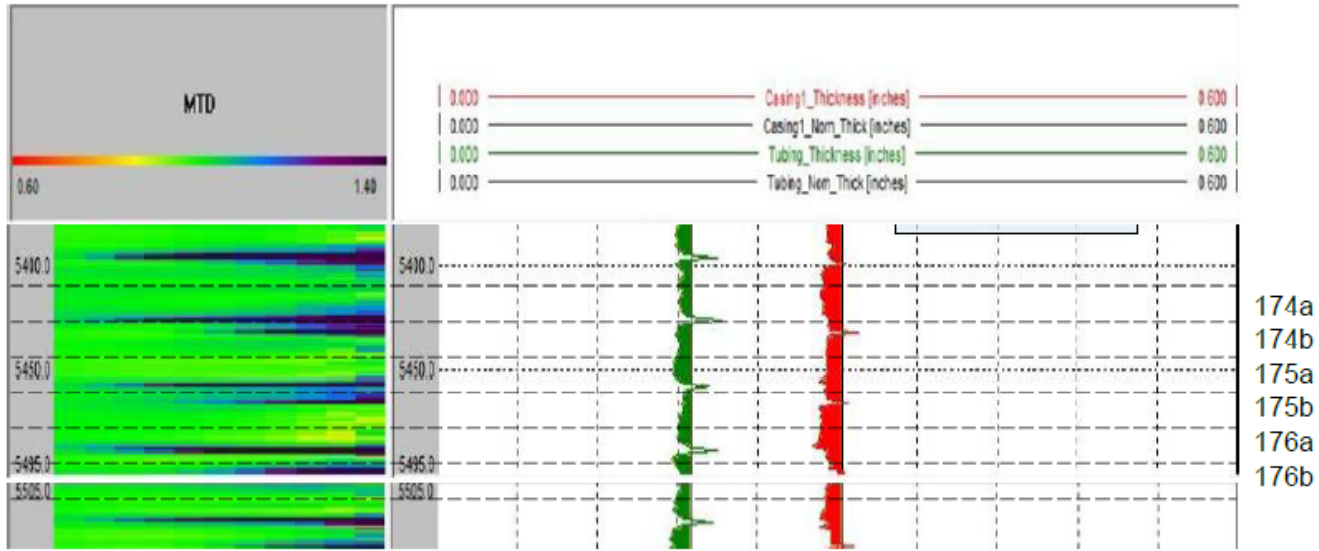
Figure 44: Joints 174-176 MFC log

Joint Range	Est. Depth Range (m (ft))	Reason for Interest
174 - 176	1650.42 – 1679.04 (5414 – 5509)	High pitting

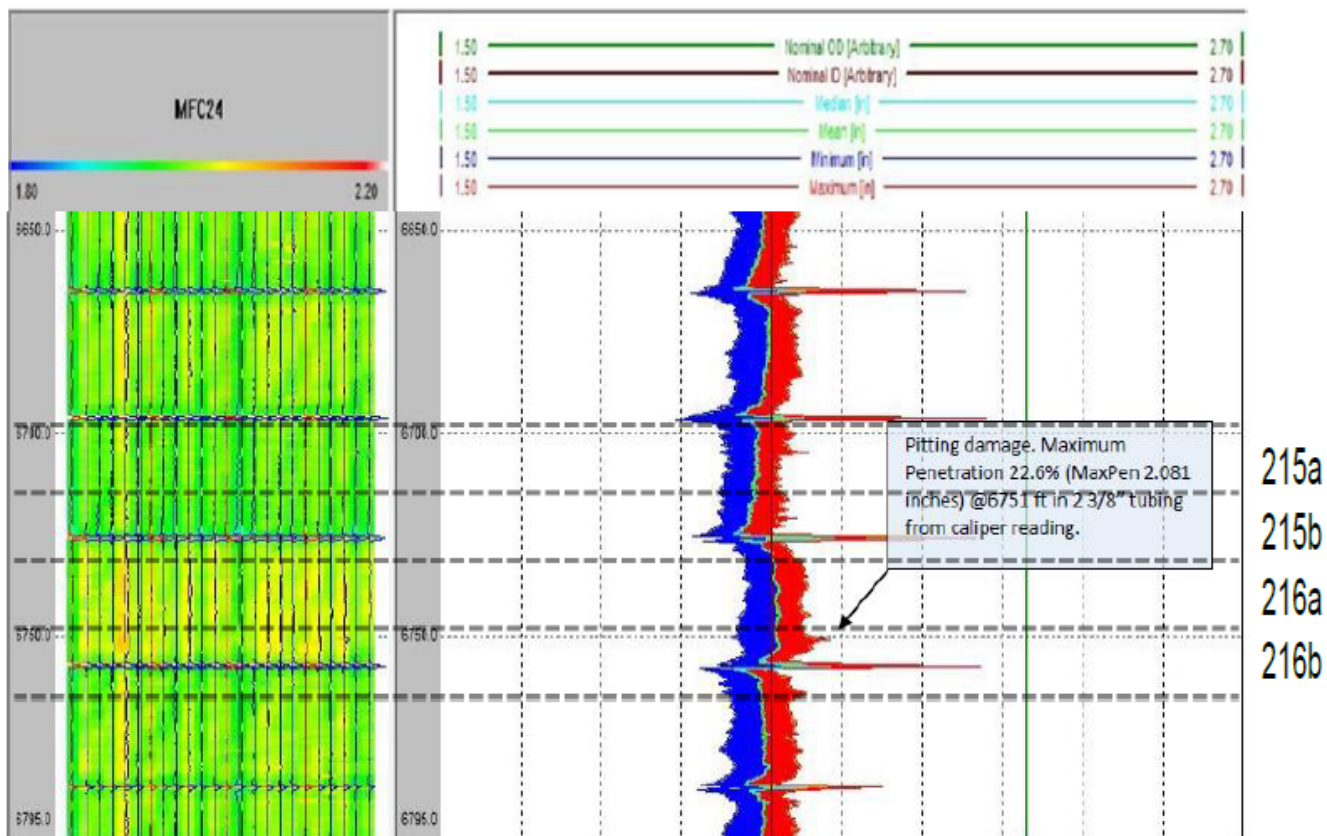
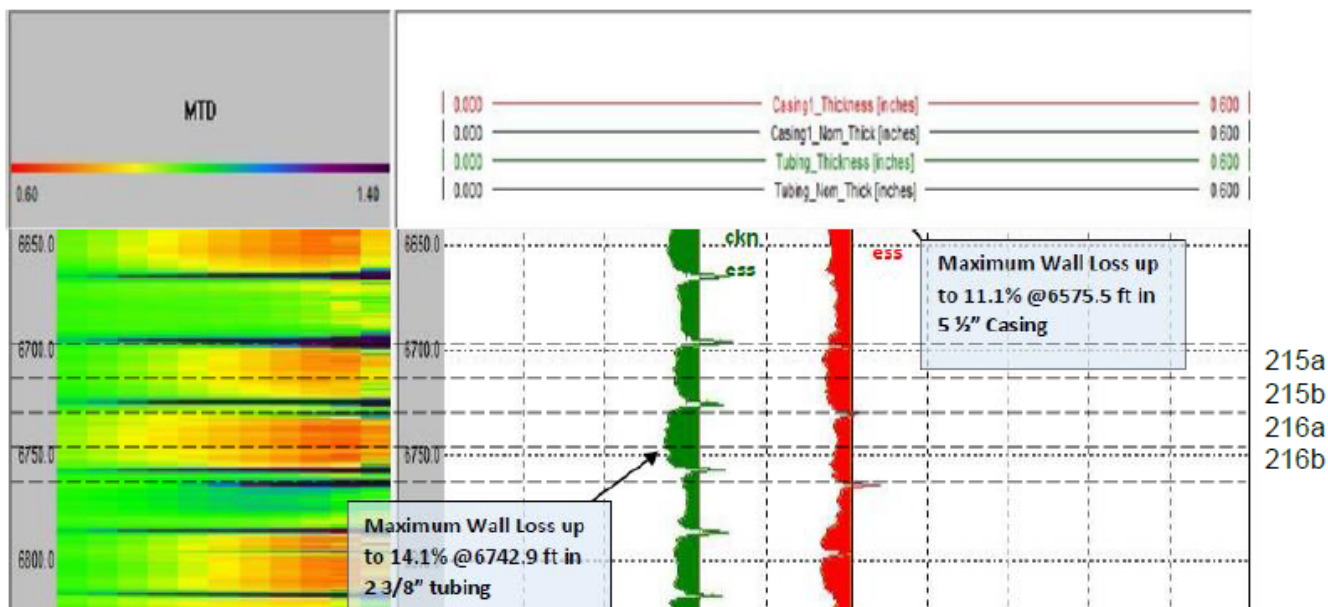
Figure 48: Joints 215-216 MFC log

Joint Range	Est. Depth Range (m (ft))	Reason for Interest
215 - 216	2041.56 – 2060.64 (6698 – 6761)	Scale build-up

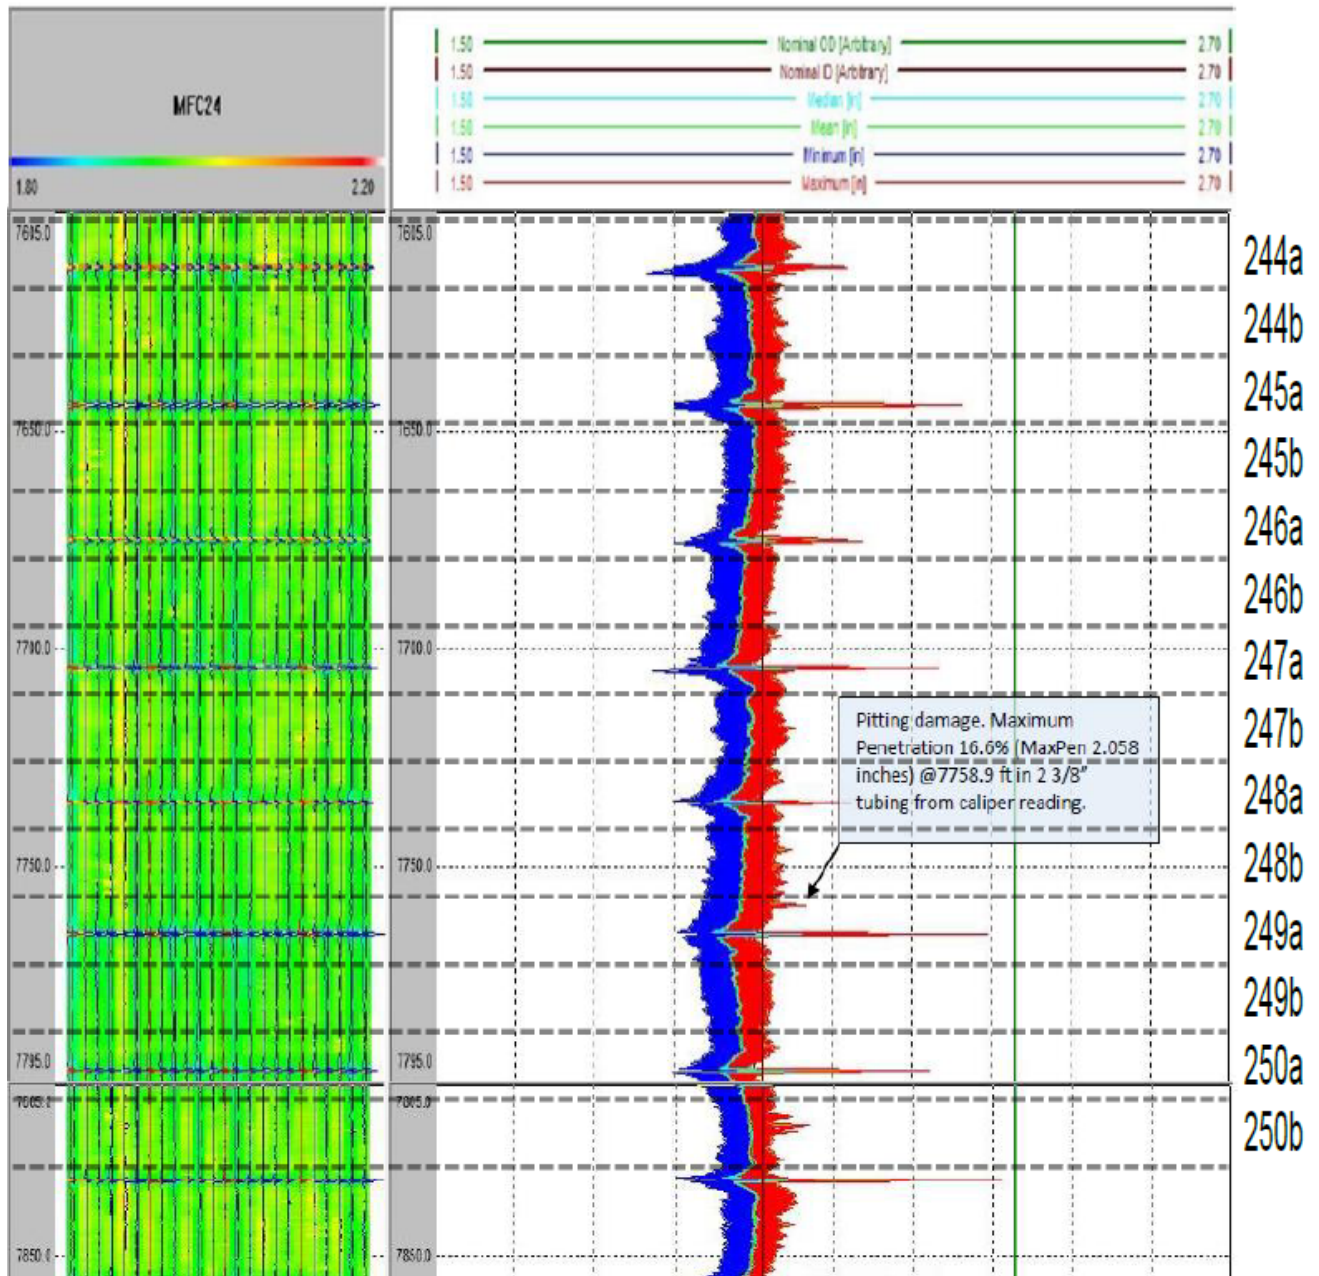
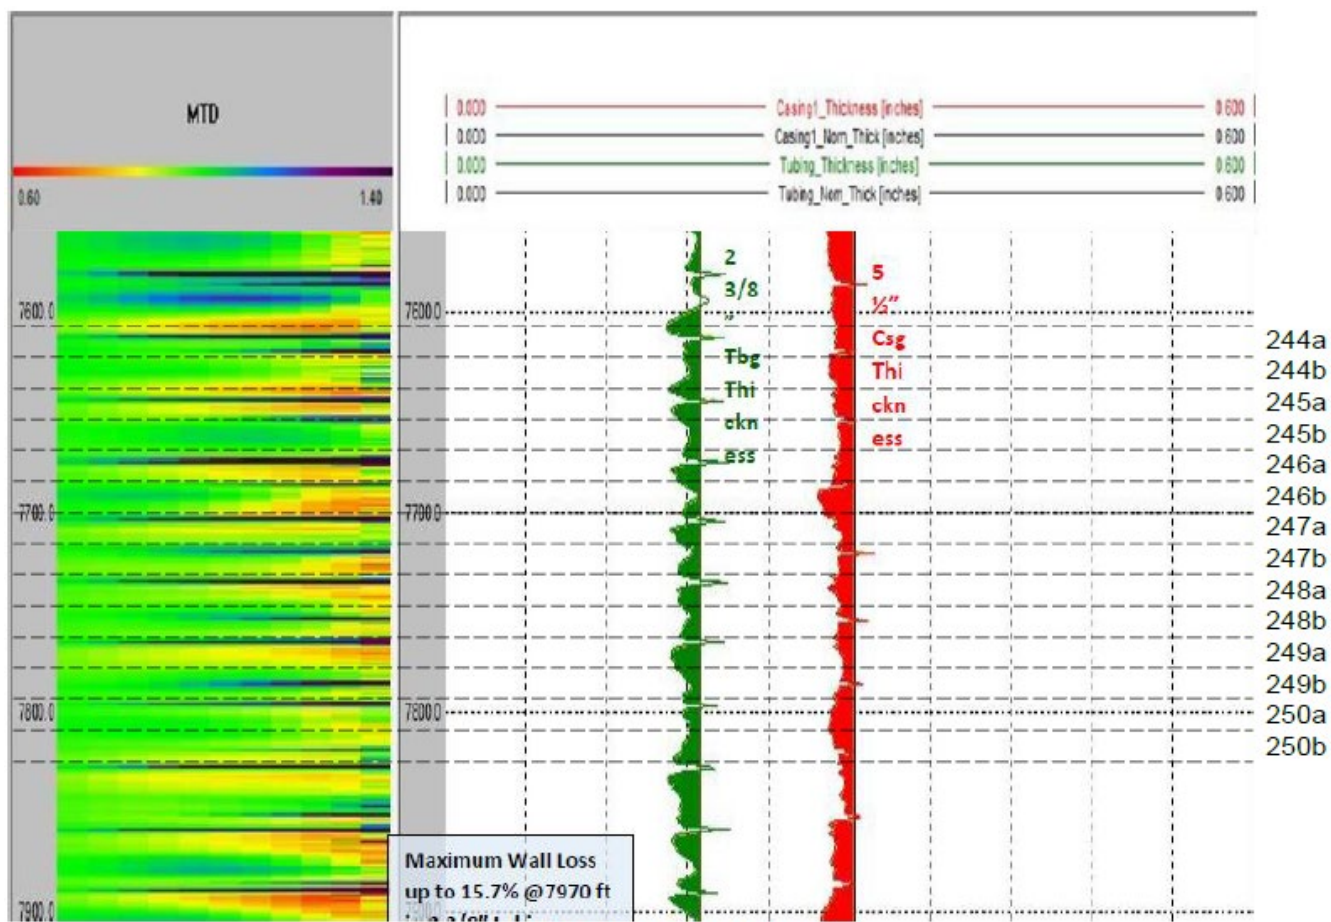
Figure 50: Joints 244-250 MFC log

Joint Range	Est. Depth Range (m (ft))	Reason for Interest
244 - 245	2318.22 – 2337.30 (7606 – 7668)	?
246 - 248	2337.30 – 2365.92 (7668 – 7762)	Scale build-up
249 - 250	2365.92 – 2385.00 (7762 – 7825)	Damaged pipe / Last joints

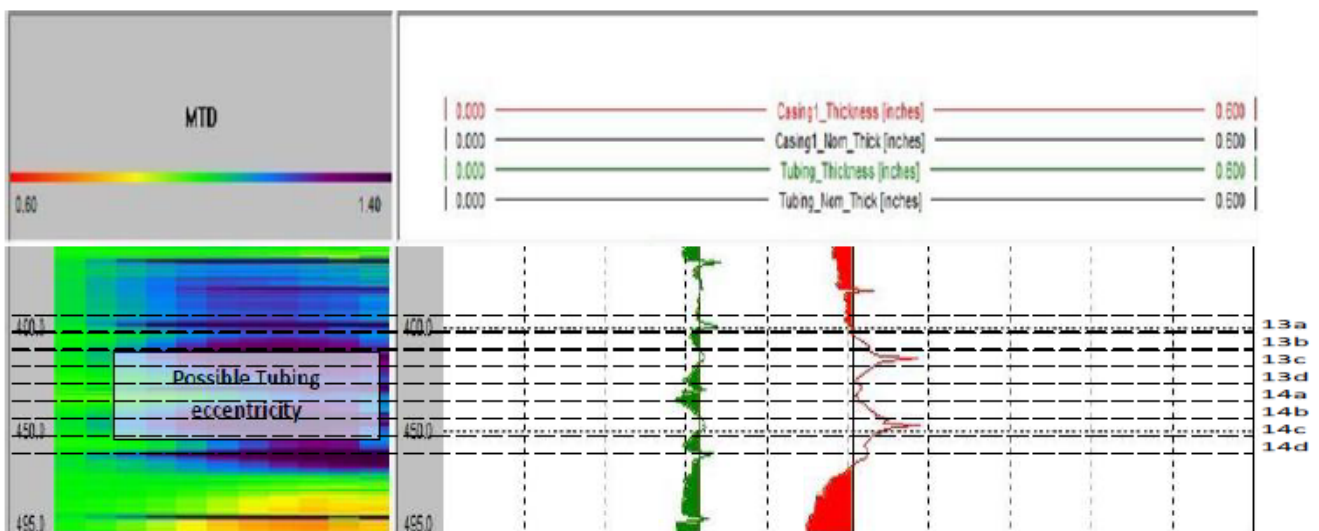
Figure 53: Joints 13-14 MTD log

Joint Range	Est. Depth Range (m (ft))	Reason for Interest
13 - 14	120.0 – 140.0 (394 – 459)	Scale / eccentricity

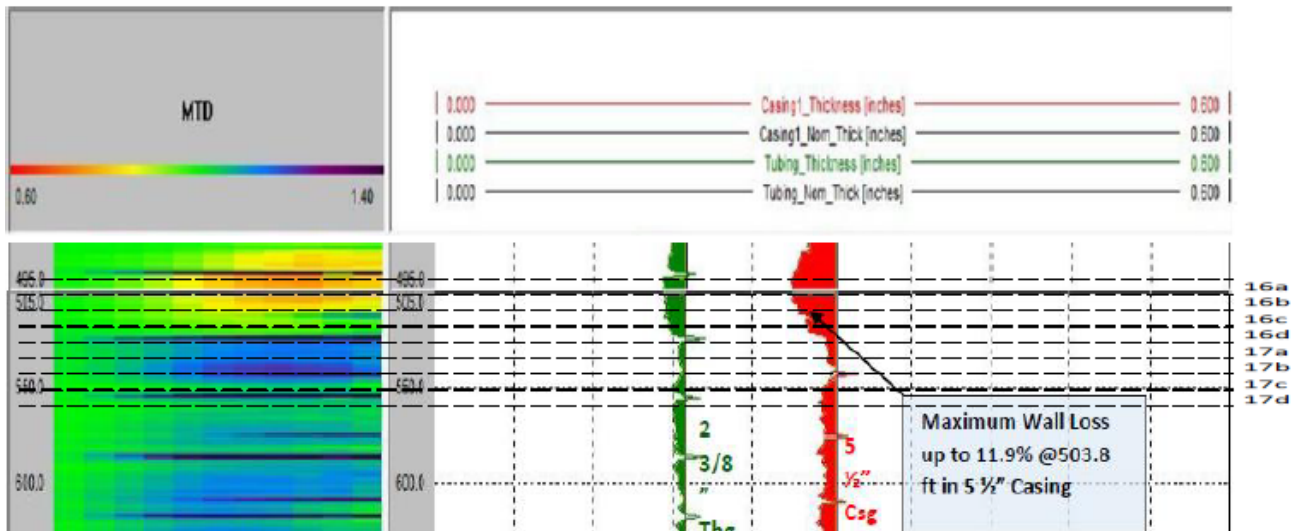
Figure 54: Joints 16-17 MTD log

Joint Range	Est. Depth Range (m (ft))	Reason for Interest
16 - 17	150.0 – 170.0 (492 – 558)	Maximum wall loss

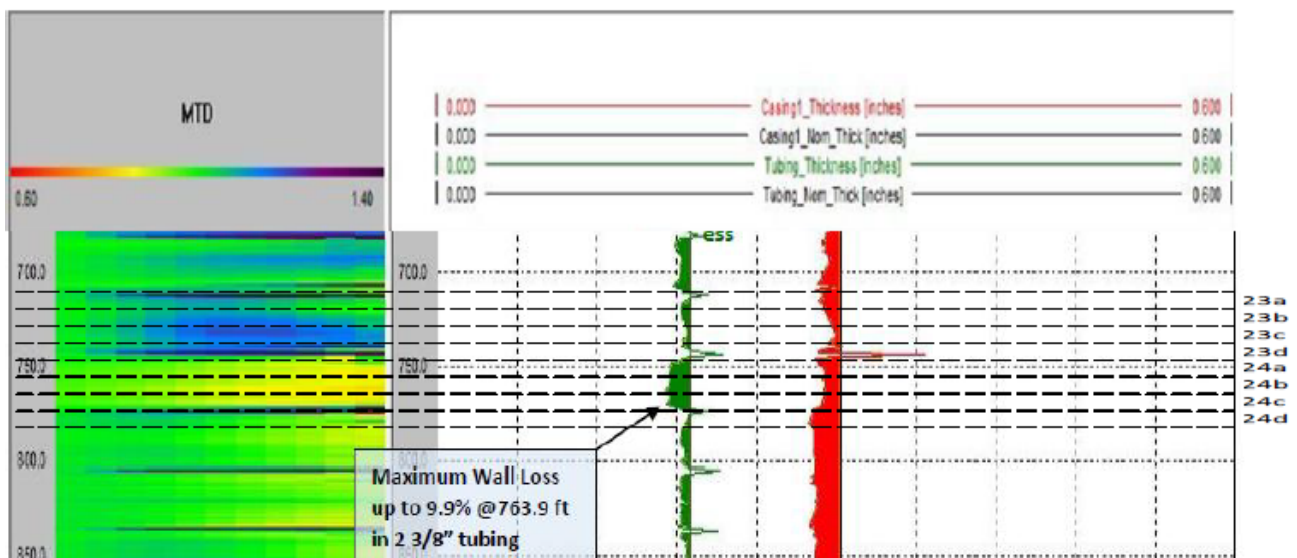
Figure 55: Joints 23-24 MTD log

Joint Range	Est. Depth Range (m (ft))	Reason for Interest
23 - 24	220.0 – 240.0 (722 – 787)	Anomaly in MTD 2015

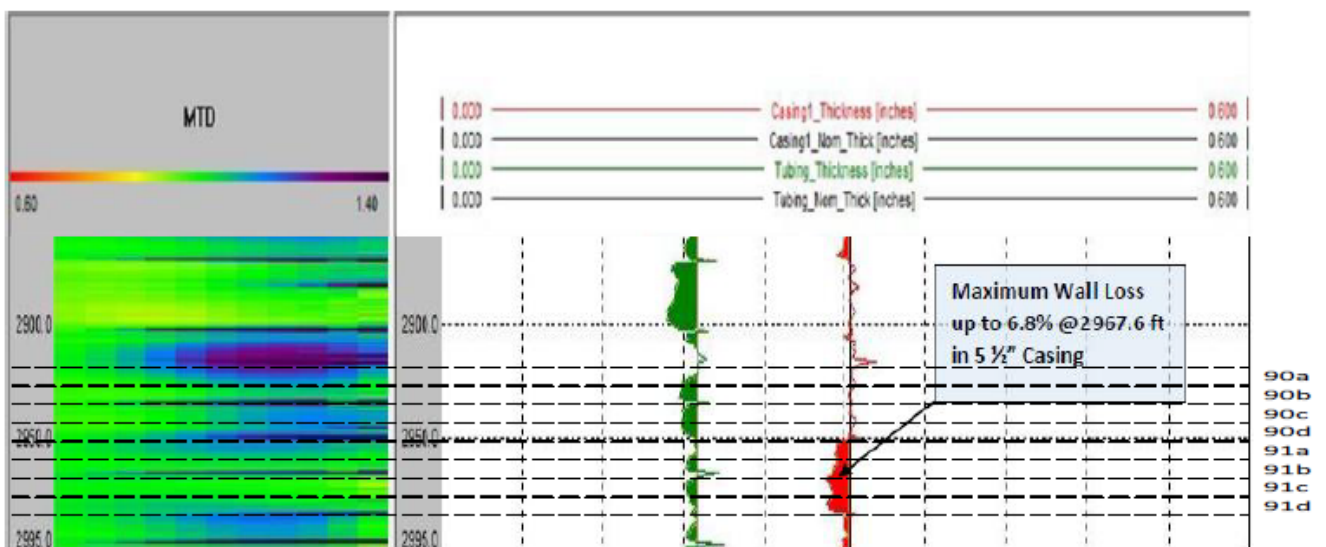
Figure 57: Joints 90-91 MTD log

Joint Range	Est. Depth Range (m (ft))	Reason for Interest
90 - 91	890.0 – 910.0 (2920 – 2986)	Scaling to wall loss
