ENVIRONMENTAL DIRECTION

Issued under Section 70E(1) of *the Mining Act 1971*

RE: Mineral Lease (ML) 234, 235, 237, 357, 358, 359, 360, 361, 389, 390, 391, 392, 404, 405, 406, 416, 417, 418, 421, 429, 439, 440, 441, 442, 443, 444, 445, 446, 447, 448, 587, 600, 605, 606, 607, 608, 617, 618, 702, 5205, 5206, 5207, 5208, 5209, 5210, 5908, 6514, Private Mine 199 and 248, known as the "**Dry Creek Salt Fields**".

RE: Program for Environment Protection and Rehabilitation (**PEPR**) 2017/001

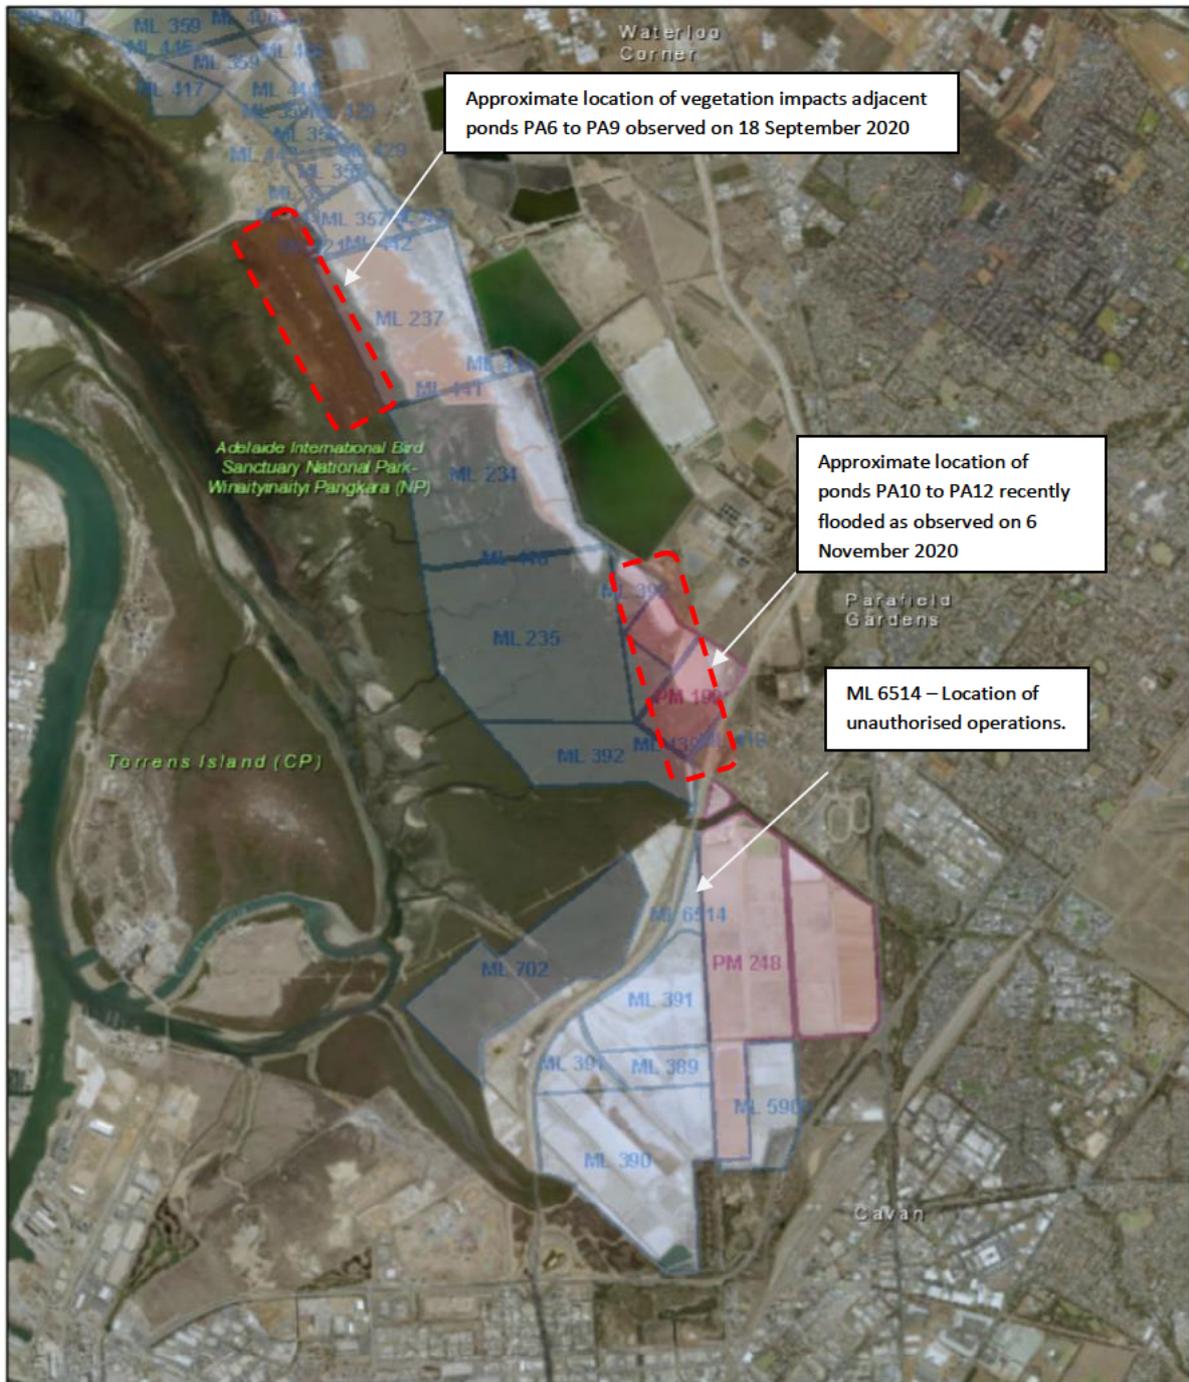
ATTACHMENT 1 – Maps and Plans of the Dry Creek Salt Fields

Approximate location of vegetation impacts adjacent ponds PA6 to PA9 observed on 18 September 2020

Approximate location of ponds PA10 to PA12 recently flooded as observed on 6 November 2020

ML 6514 – Location of unauthorised operations.

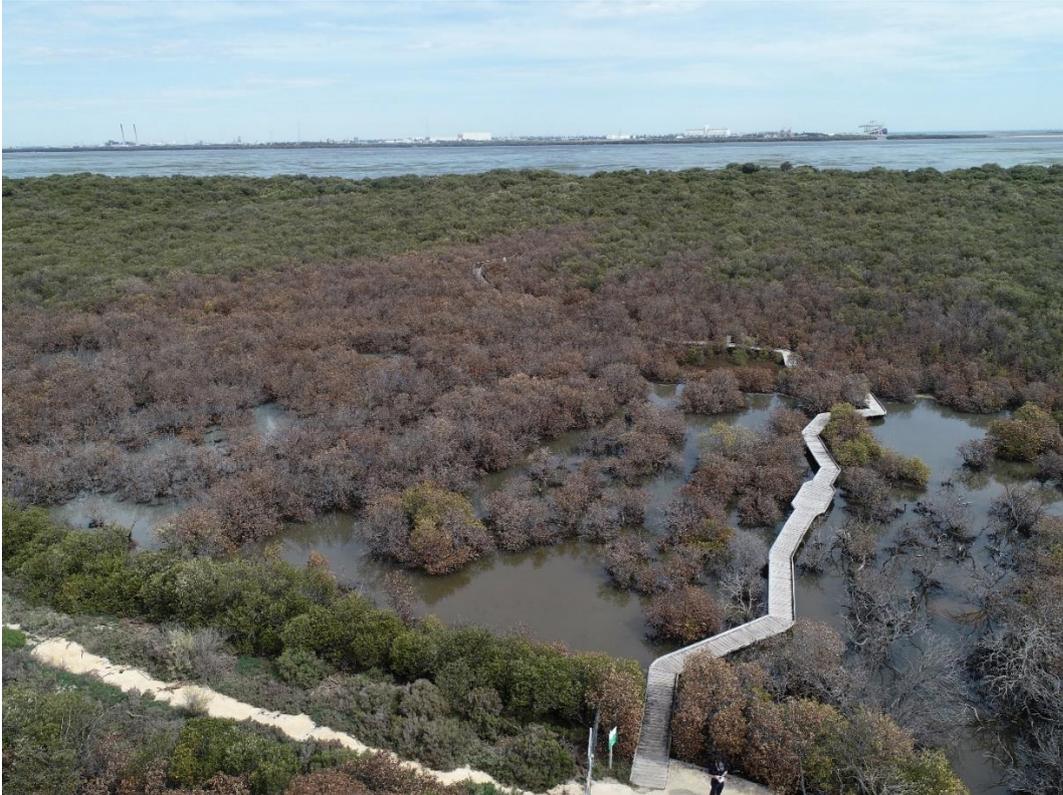
Lat: 34°44'43.9546 Long: 138°32'18.8153

Photo 1: Northern section of mangrove dieback, start of old boardwalk, 18 September 2020.

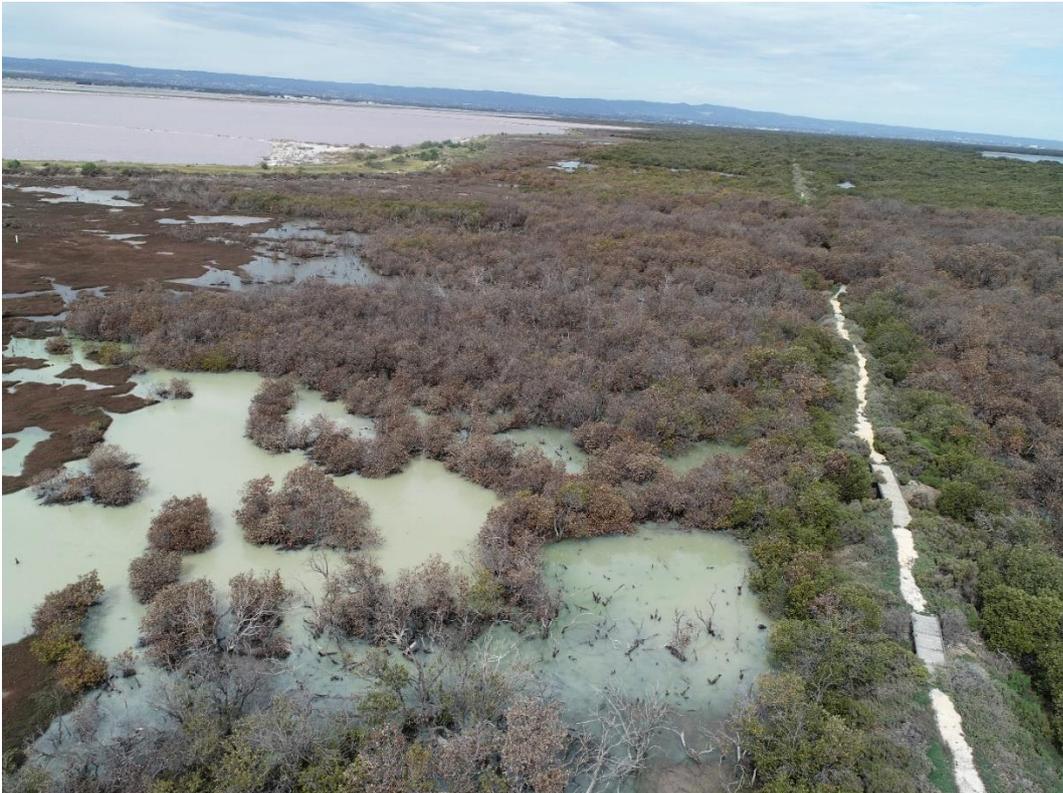
Lat: 34°44'45.0394 Long: 138°32'19.1523

Photo 2: Southern section of mangrove dieback (pond PA 7 to left), east of old boardwalk, 18 September 2020.

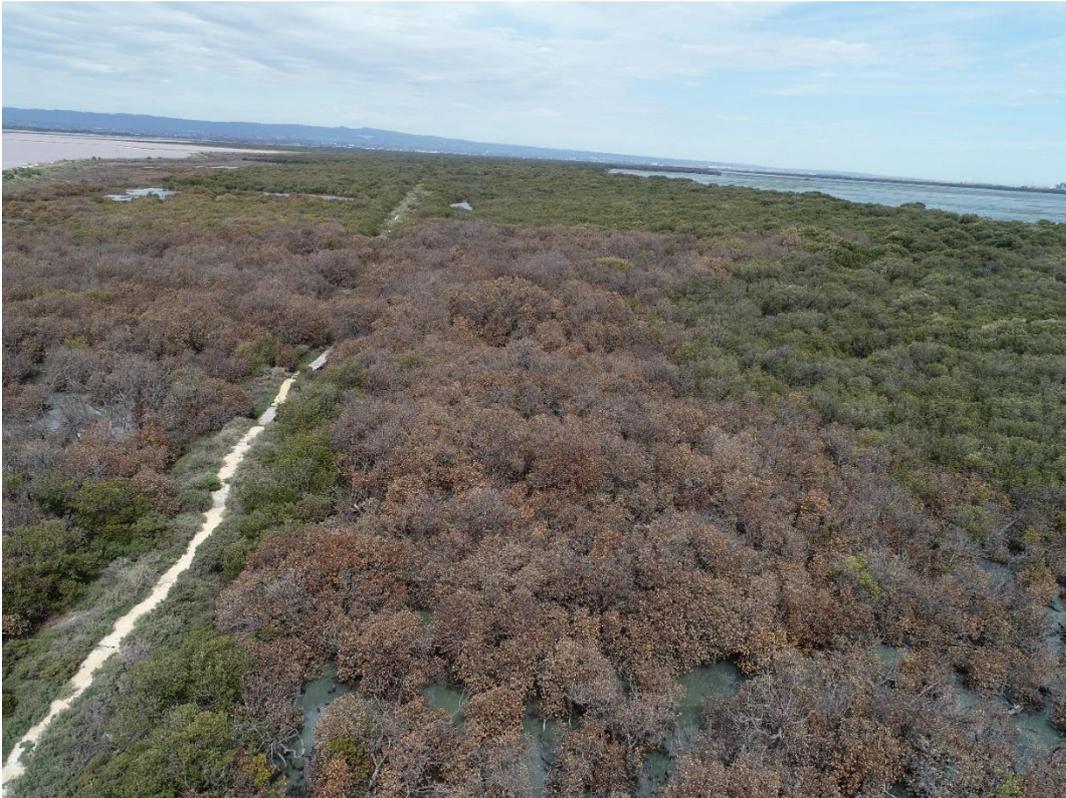
Lat: 34°44'46.3077 Long: 138°32'19.0918

Photo 3: Southern section of mangrove dieback (pond PA 7 to left), west of old boardwalk, 18 September 2020.

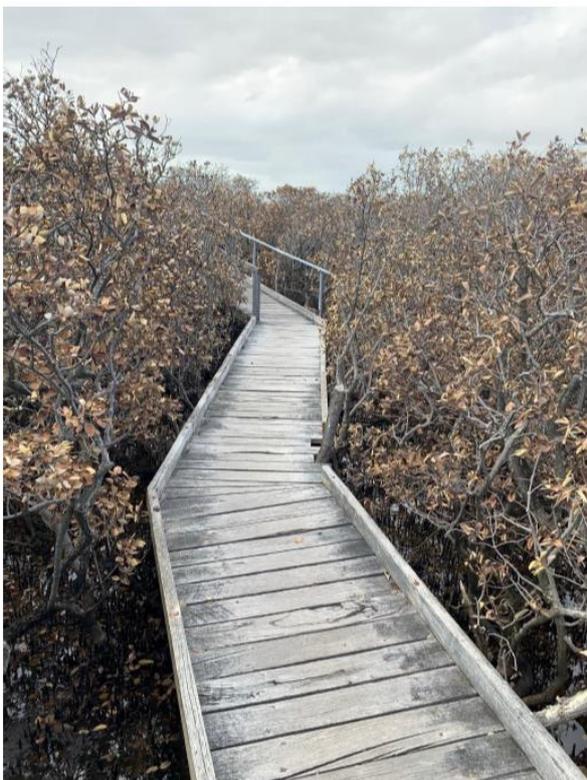
Lat: 34°44'46.1497 Long: 138°32'16.5944

Photo 4: Mangrove boardwalk showing dead mangroves, 18 September 2020.

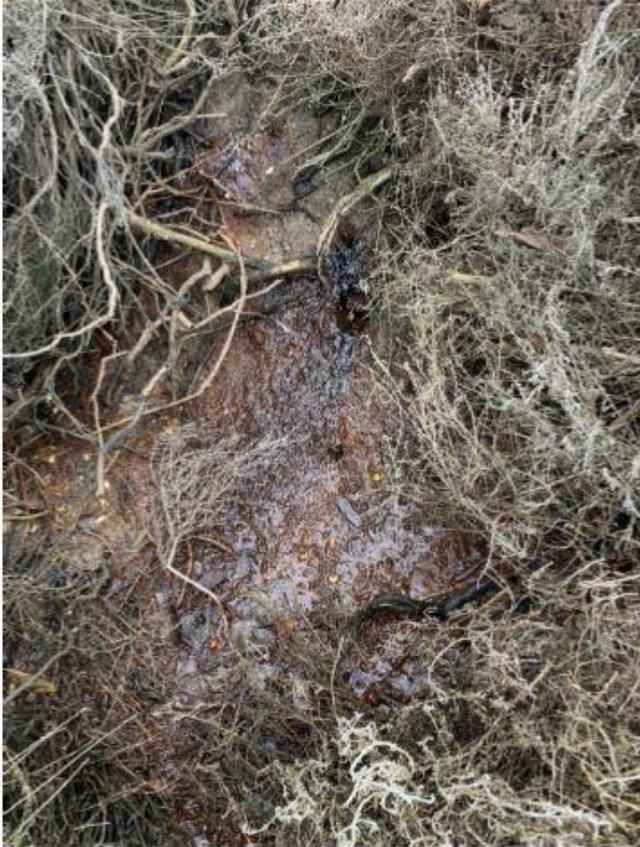
Photo 5: Seepage from bund wall (taken of western side of ML 421), salinity recorded at approximately 172 psu, 21 September 2020.

During the inspections Government officers identified hypersaline water approximately 4 to 5 times the salinity of seawater (see Attachment D) in the impacted mangrove area and in adjacent salt marsh areas towards the salt field bund wall (the western bund of Pond PA7). Seepage was observed from the bund wall in various locations.

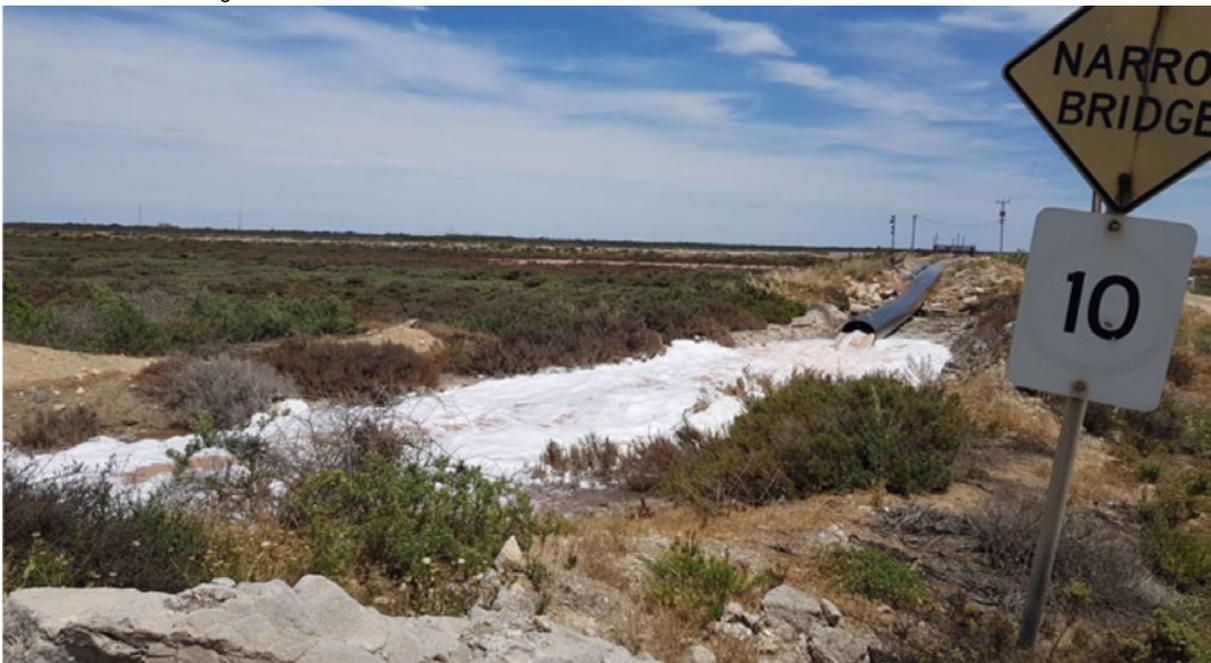
Photo 6: Brine flowing into Pond PA10 on route to ML 6514, 6 November 2020.
Lat: 34°46'20.6144 Long: 138°34'16.0928

You, BDC, are directed to immediately cease all unauthorised mining operations including but not limited to the pumping of Brine into ML 6514.

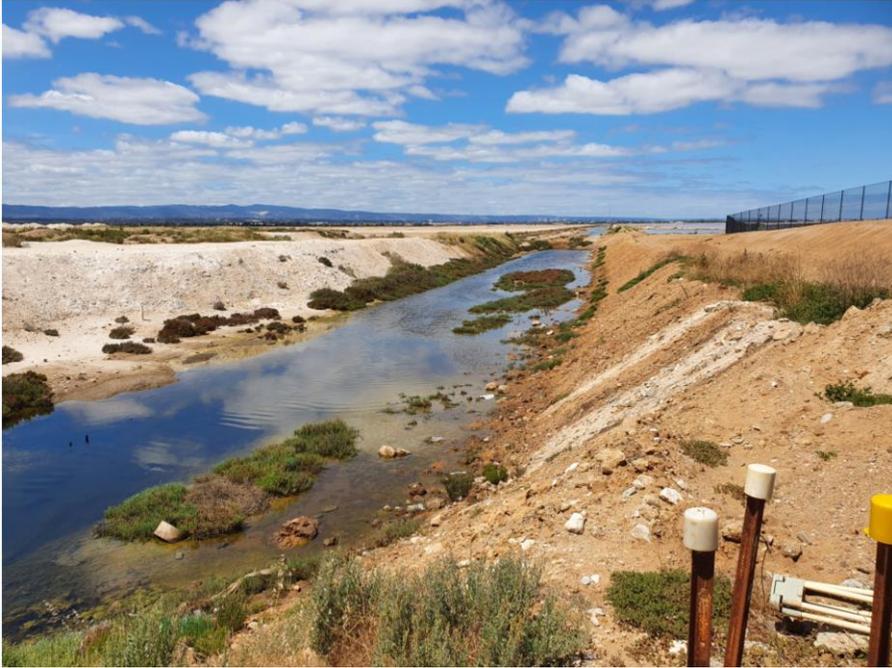
Photo 7: Brine flowing through ML 6514, 6 November 2020.

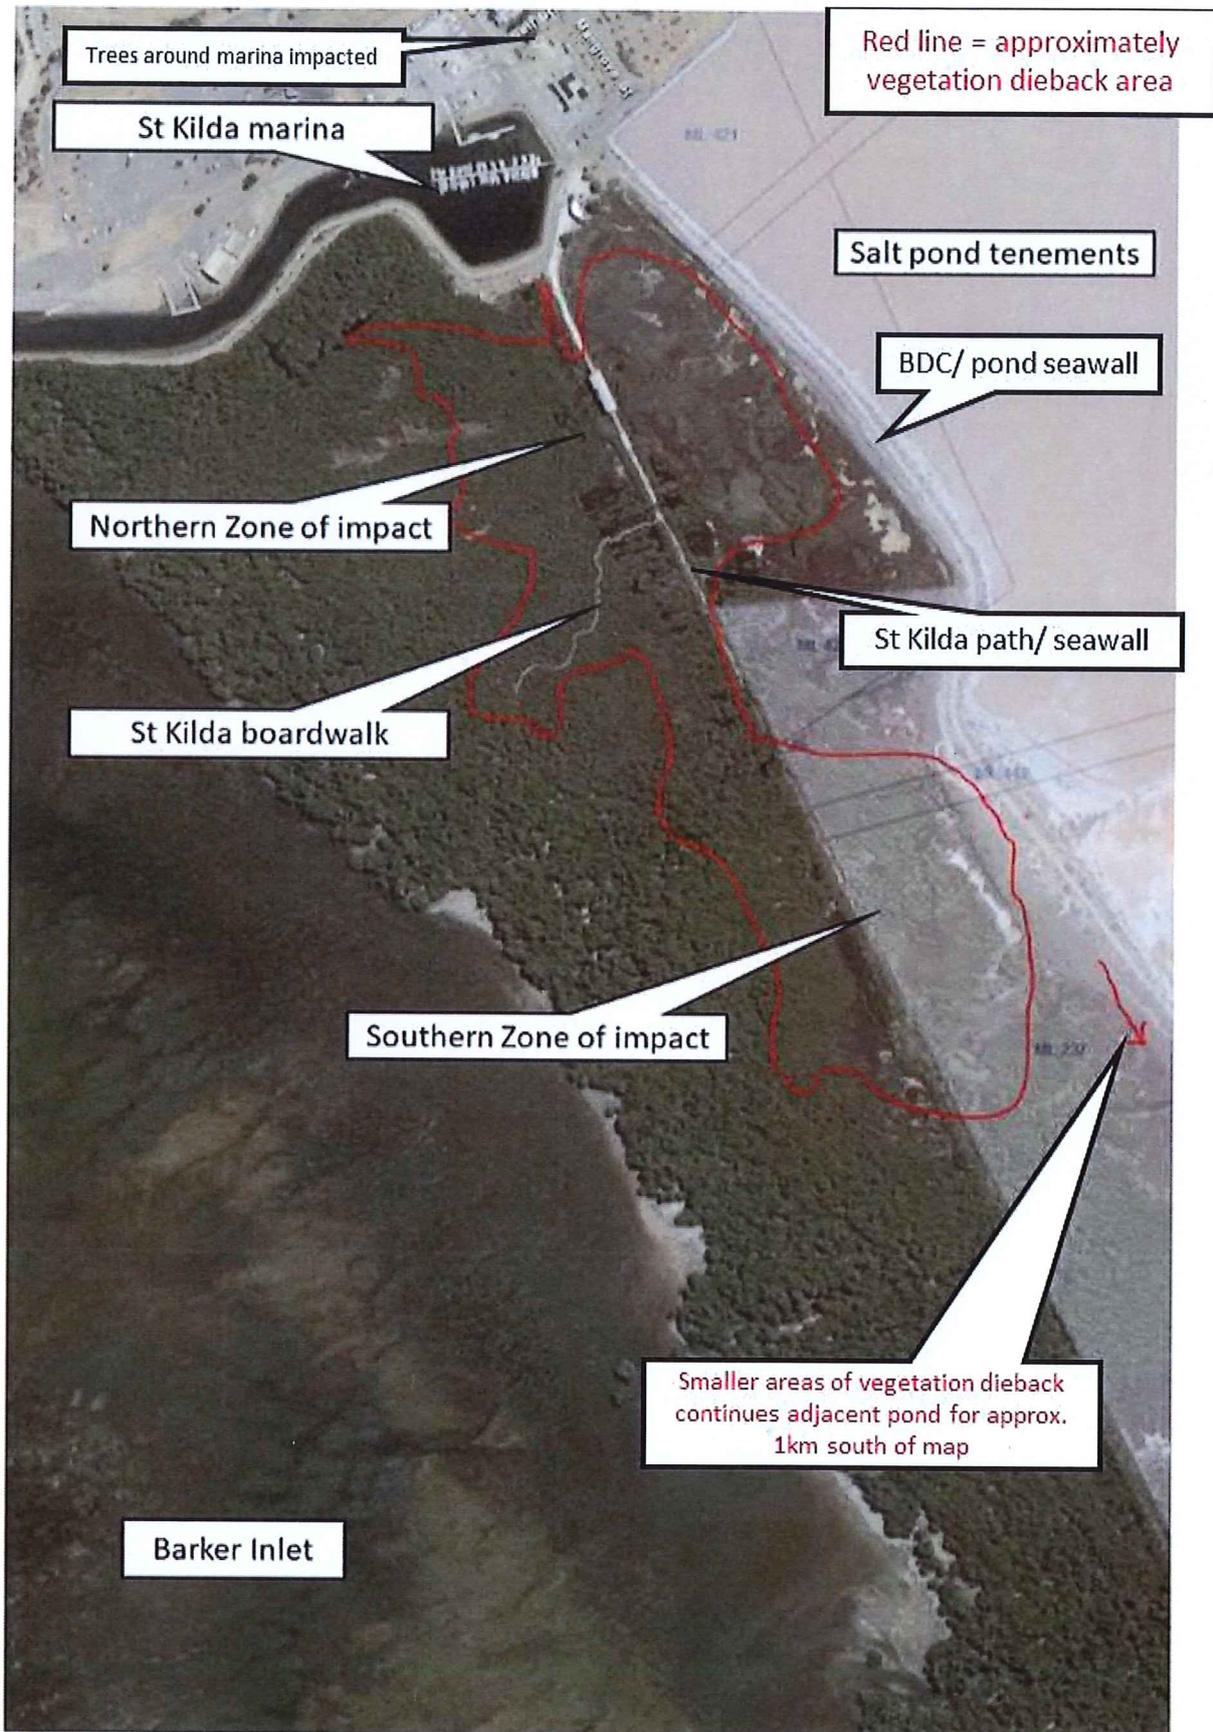
Attachment A: Approximate area of impact (red line) and Mineral leases (black lines)

Substantial dieback of mangroves was observed at the start of the St Kilda boardwalk on both sides, and along the old seawall approximately 300 meters to the south. It is estimated that approximately 10 hectares of mangroves and other vegetation have been impacted (see Attachments A and B). Review of satellite imagery indicates most of these impacts have occurred between May and September 2020 (see Attachment C).

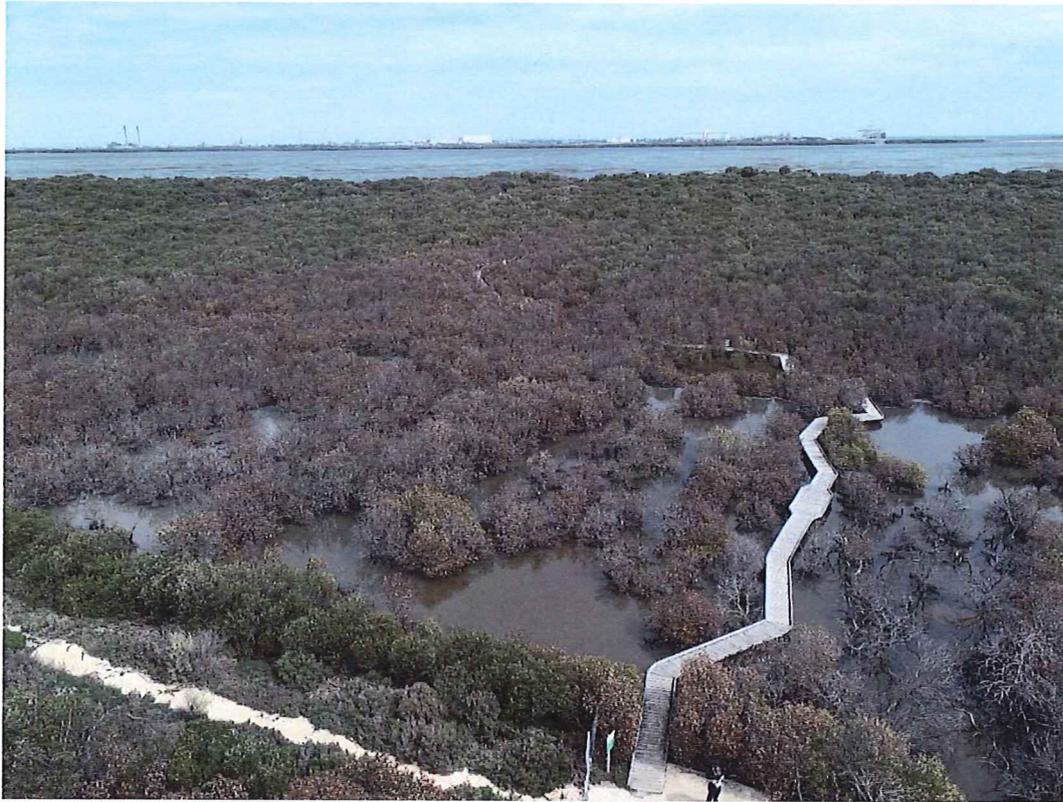
Photo 1: Northern section of mangrove dieback, start of old boardwalk

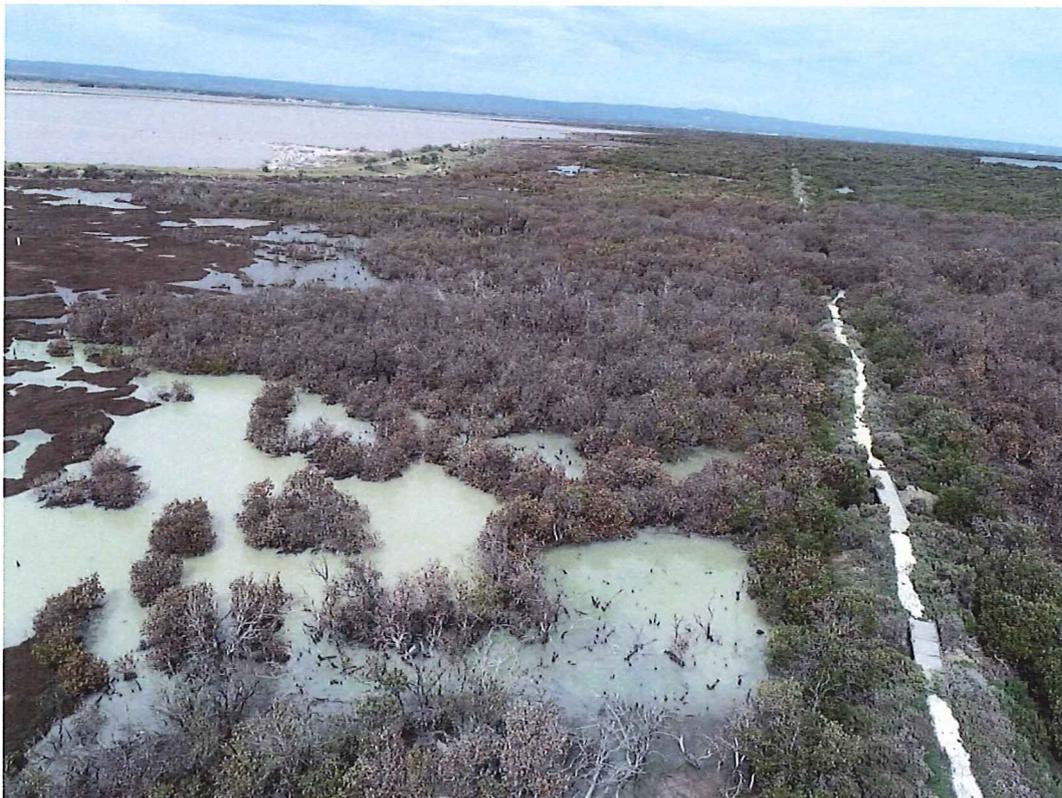
Photo 2: Southern section of mangrove dieback (pond PA 7 to left), east of old boardwalk

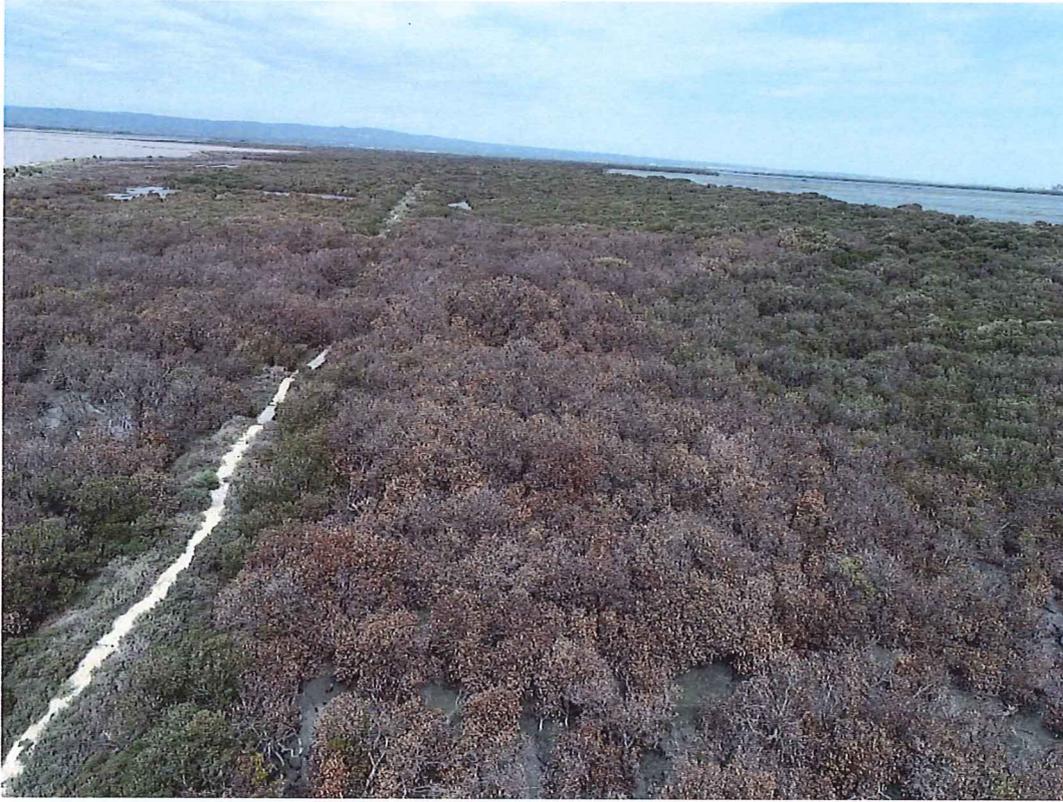
Photo 3: Southern section of mangrove dieback (pond PA 7 to left), west of old boardwalk

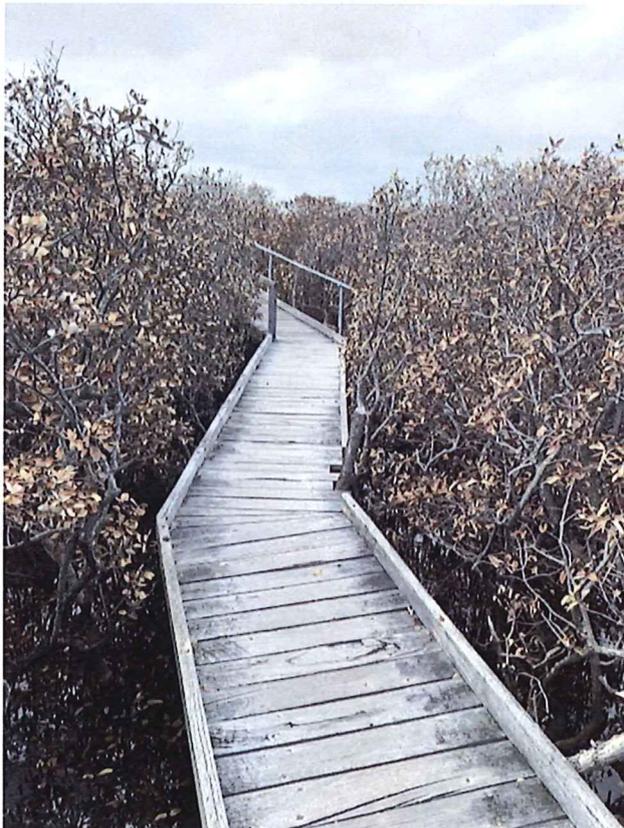
Photo 4: Mangrove boardwalk showing dead mangroves

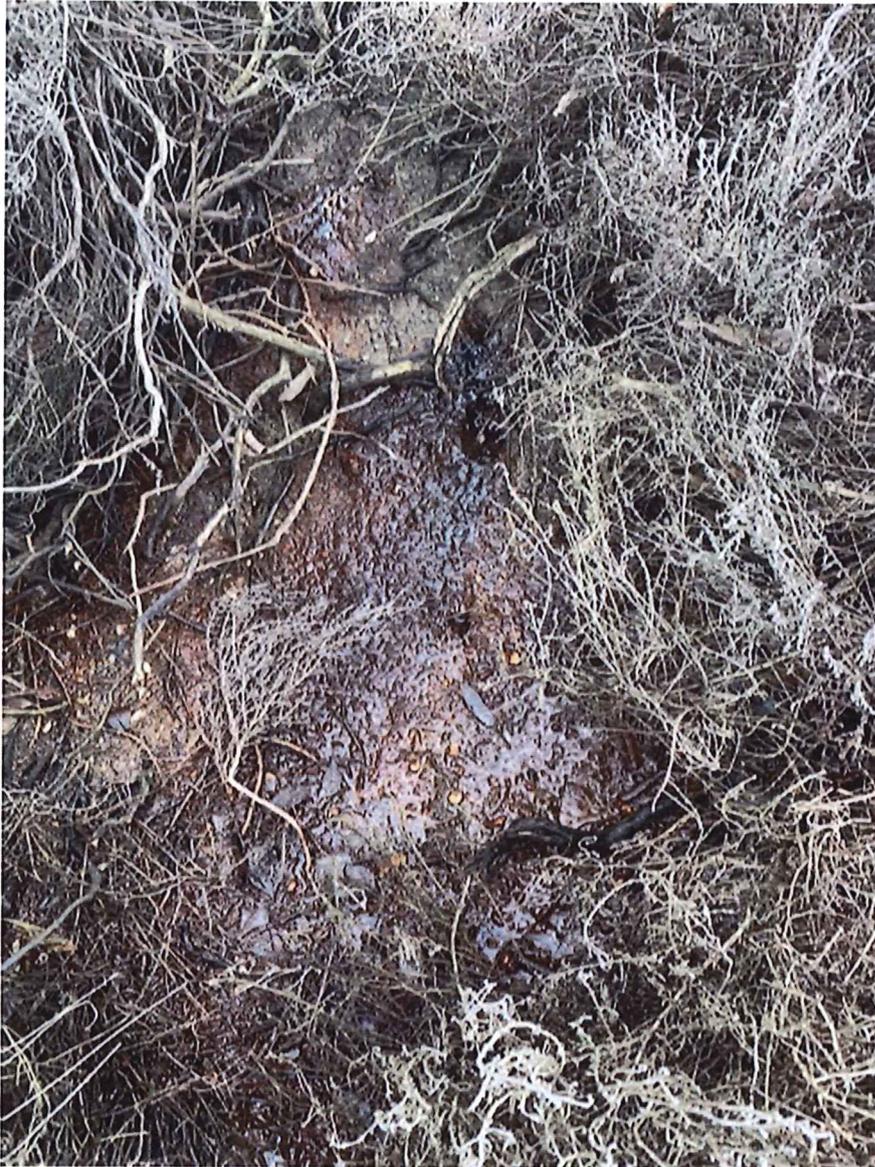
Photo 5: Seepage from bund wall (taken of western side of ML 421), salinity recorded at approximately 172 psu.

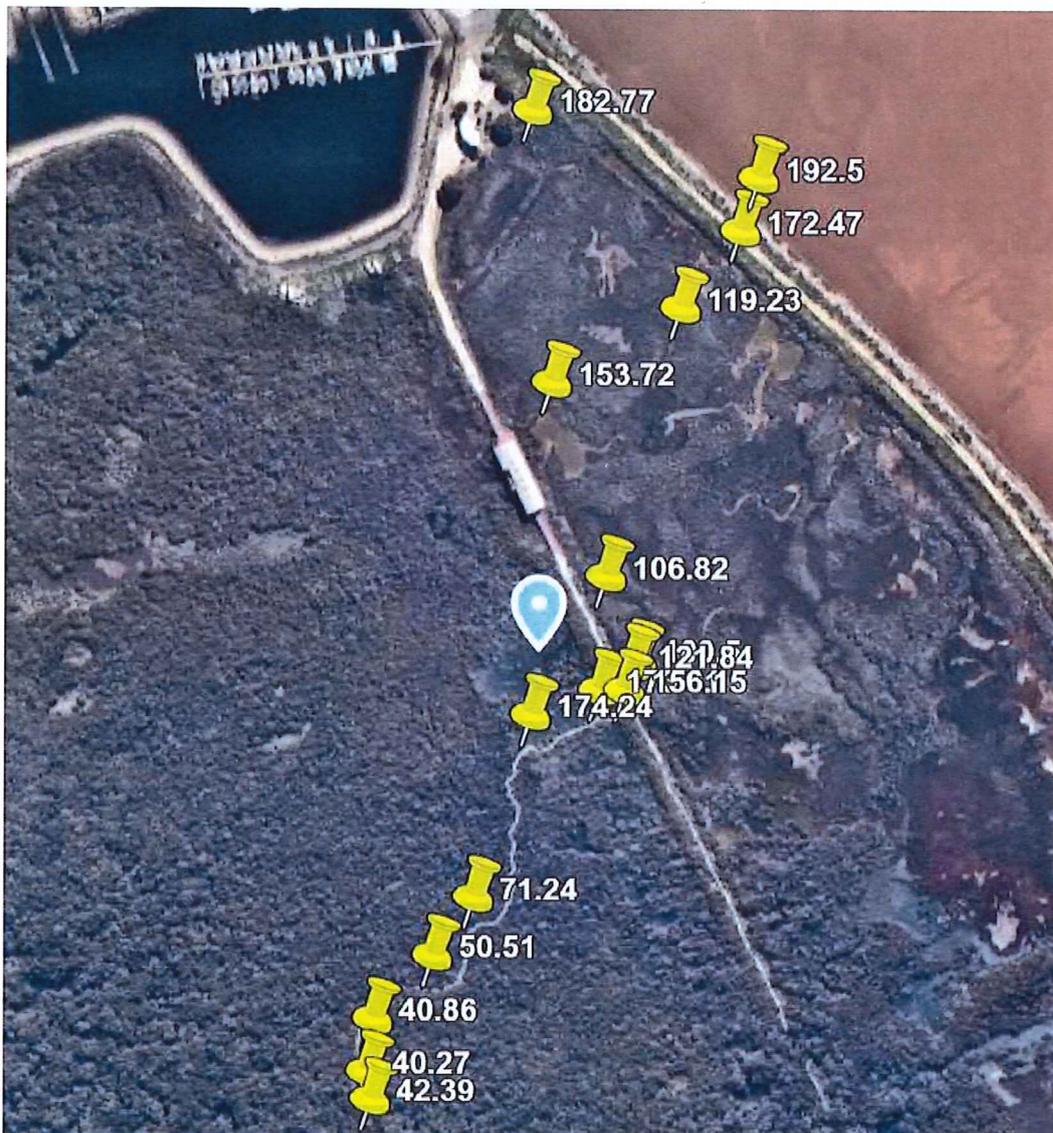
Measurement 1 :DEW 21 September 2020 (low tide)

Extremely hypersaline water (approx. 4 to 5 times seawater salinity) was observed in the dead mangrove area, and adjacent salt marsh area towards the salt pond bund. Salinity returned to typical seawater values (approx. 40 psu) towards the seaward side of the mangrove board walk, after the dead mangrove area had ended.
