**2007 ANNUAL REPORT**

**PRIMARY INDUSTRIES AND  
RESOURCES SA  
(Petroleum and Geothermal Group)**

**Pipeline Licence No 11  
Berri to Mildura Pipeline**

**March 2008**

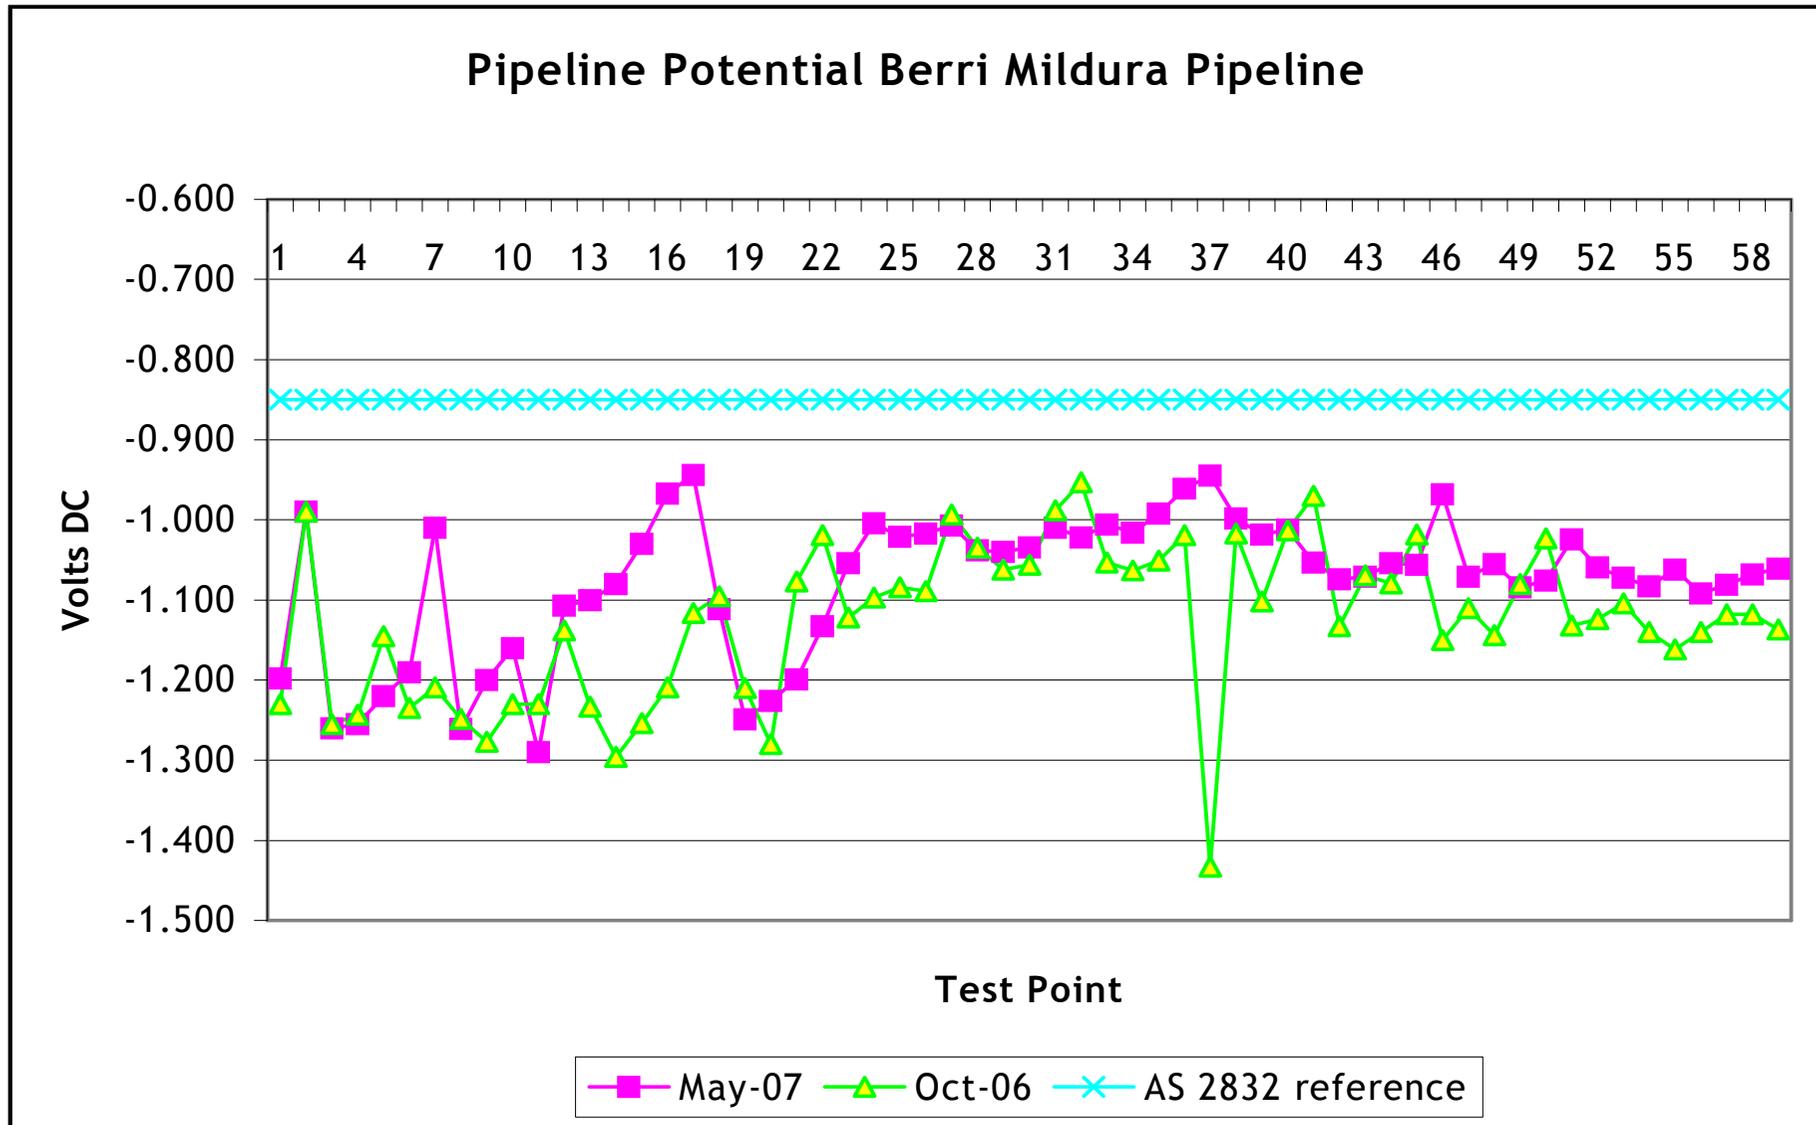
APPENDIX 3 - GRAPHICAL RESULTS FROM CATHODIC PROTECTION SURVEY MAY 2007

The effectiveness of the cathodic protection is monitored by carrying out a full line potential survey and recording potentials over 24 hour periods at selected locations on a six monthly basis as per APT O&M Work Instructions 6606, 6608 and 6614. Routine checks of test points along the pipeline showed that all sections of the pipeline are protected and there are no areas of concern for the CP system on this pipeline. The May 2007 potential survey results have been tabulated in Appendix 2 with the associated graphical summary in Appendix 3. All pipeline potentials were measured with respect to a saturated copper/copper sulphate reference electrode.
