## **2004 ANNUAL REPORT**

**Pipeline Licence 3 & 4**

## **SOUTH EAST PIPELINE SYSTEM**

**Document Number S-31-107-AR-G-001**

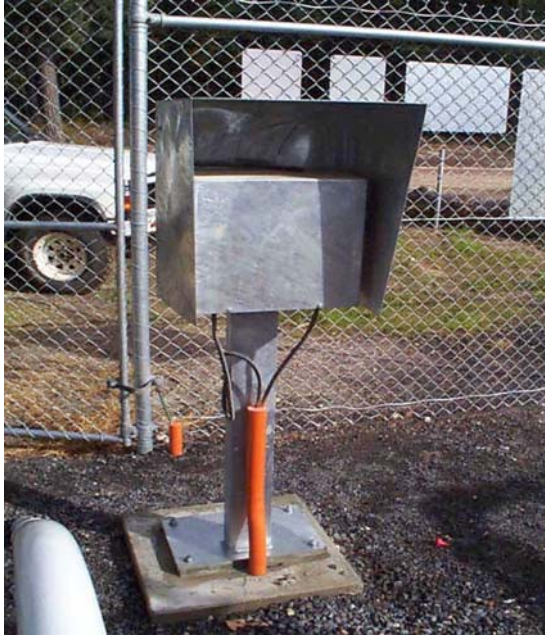
Lightening Protection Nangwarry

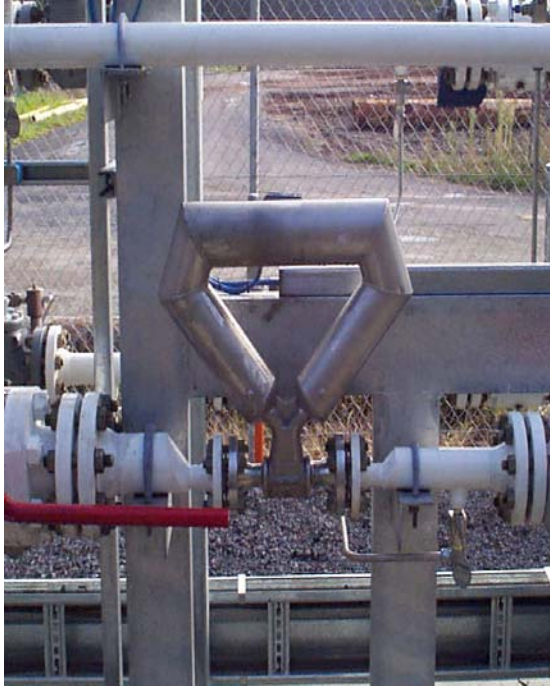
Coriolis Meter

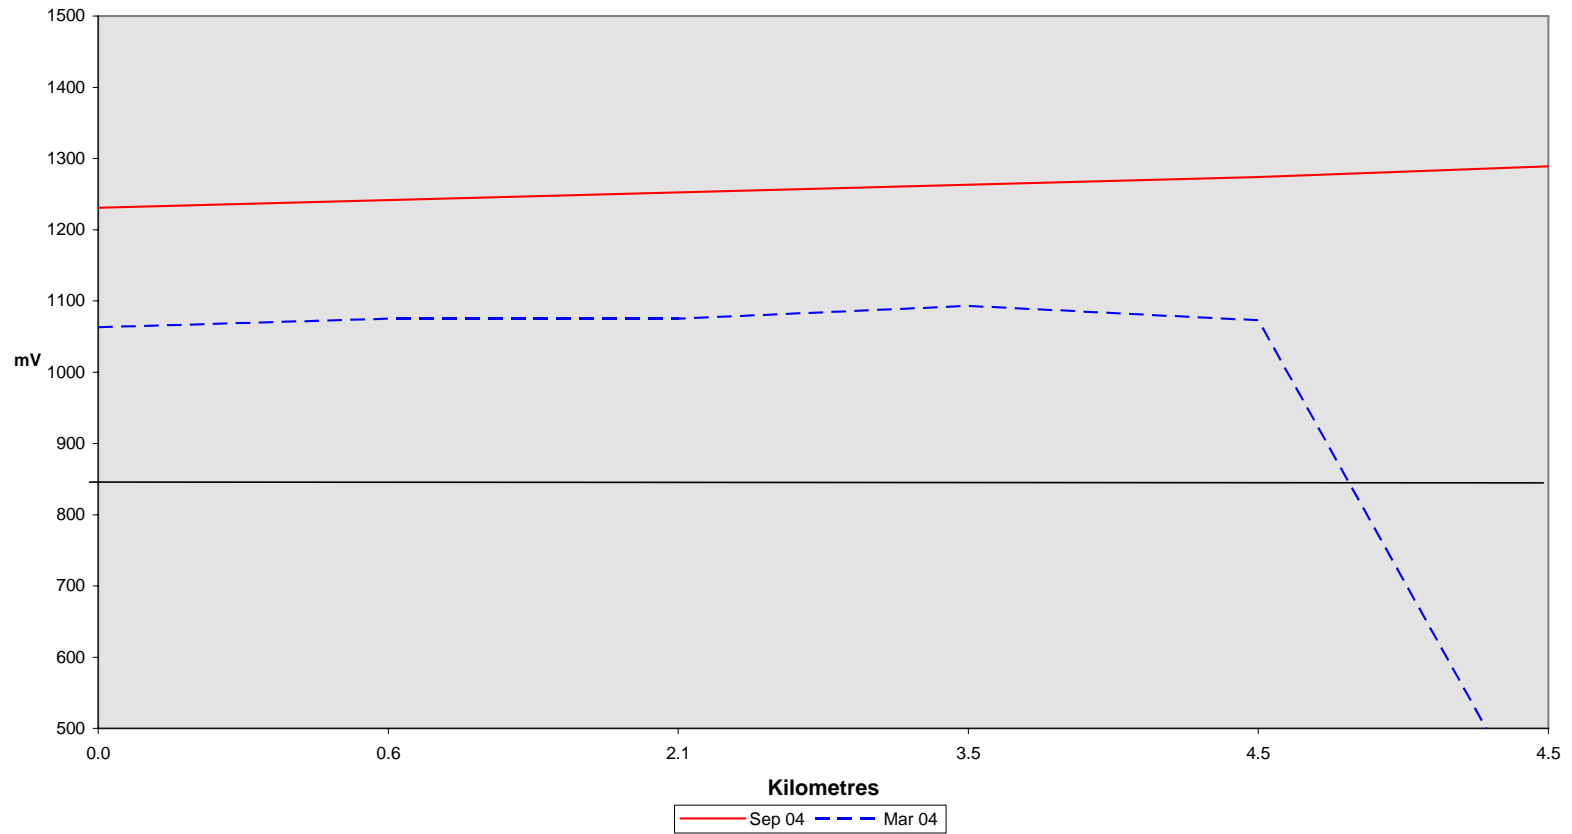
Safries Lateral Full Line Surveys

The potential profiles of this lateral indicate that the pipeline is fully protected and polarised to the cathodic protection criteria on its entire length. The protective current demand for the lateral was 28.0mA, which is equivalent to 33.0 micro A/M2. The last survey reports indicated a high current demand that was probably due to a short to the copper pipes down stream of the metering station.

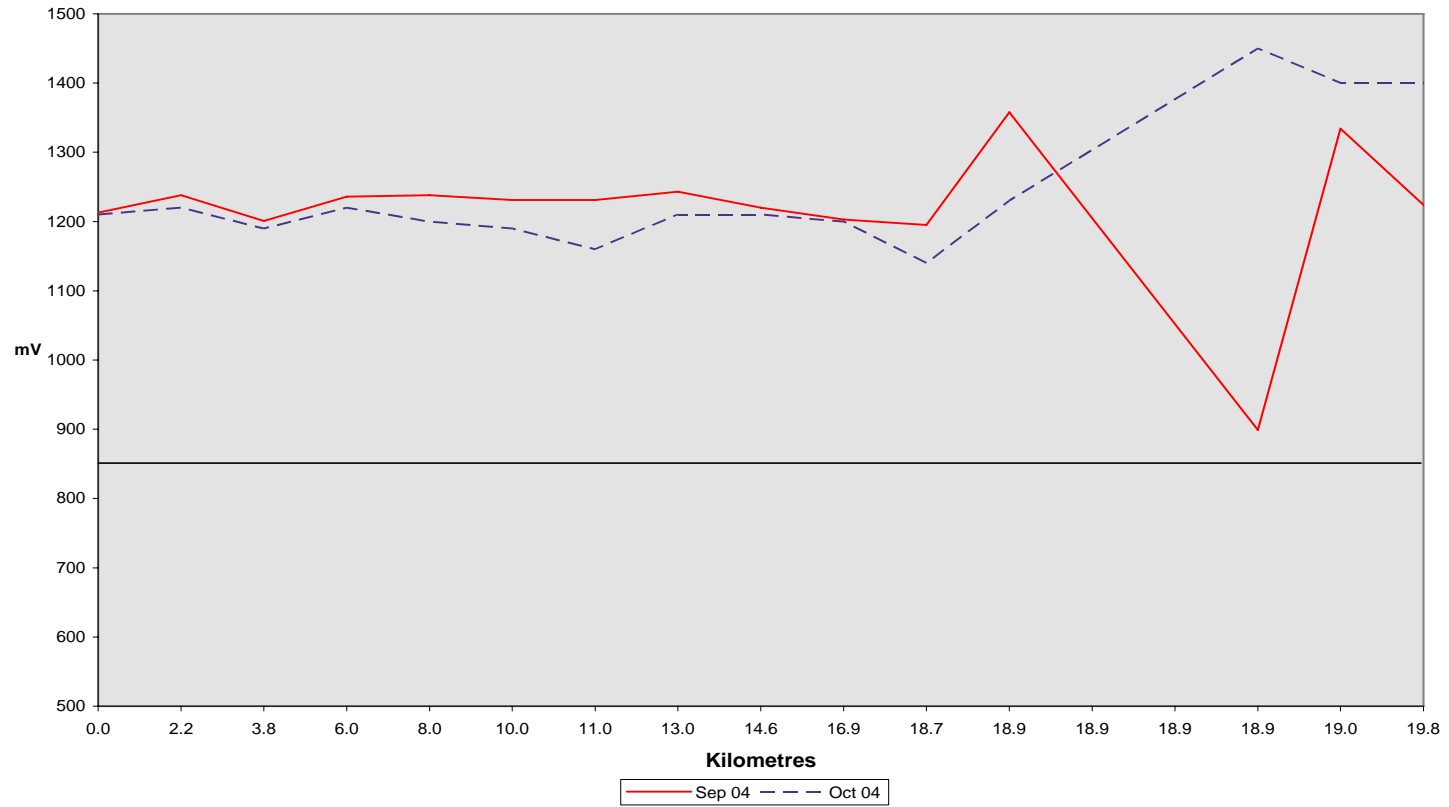
Mt. Gambier Lateral Full Line Surveys

The potential profiles of this lateral indicate that the pipeline was fully protected and polarised to the cathodic protection criteria on its entire length. The protective current demand for the lateral was 20mA, which is equivalent to 1.9 micro A/M2. This indicates that the pipeline coating is in good condition.
