2003 ANNUAL REPORT

**PRIMARY INDUSTRIES AND
RESOURCES SA
(Petroleum)**

Pipeline Licence No 11

Berri to Mildura Pipeline

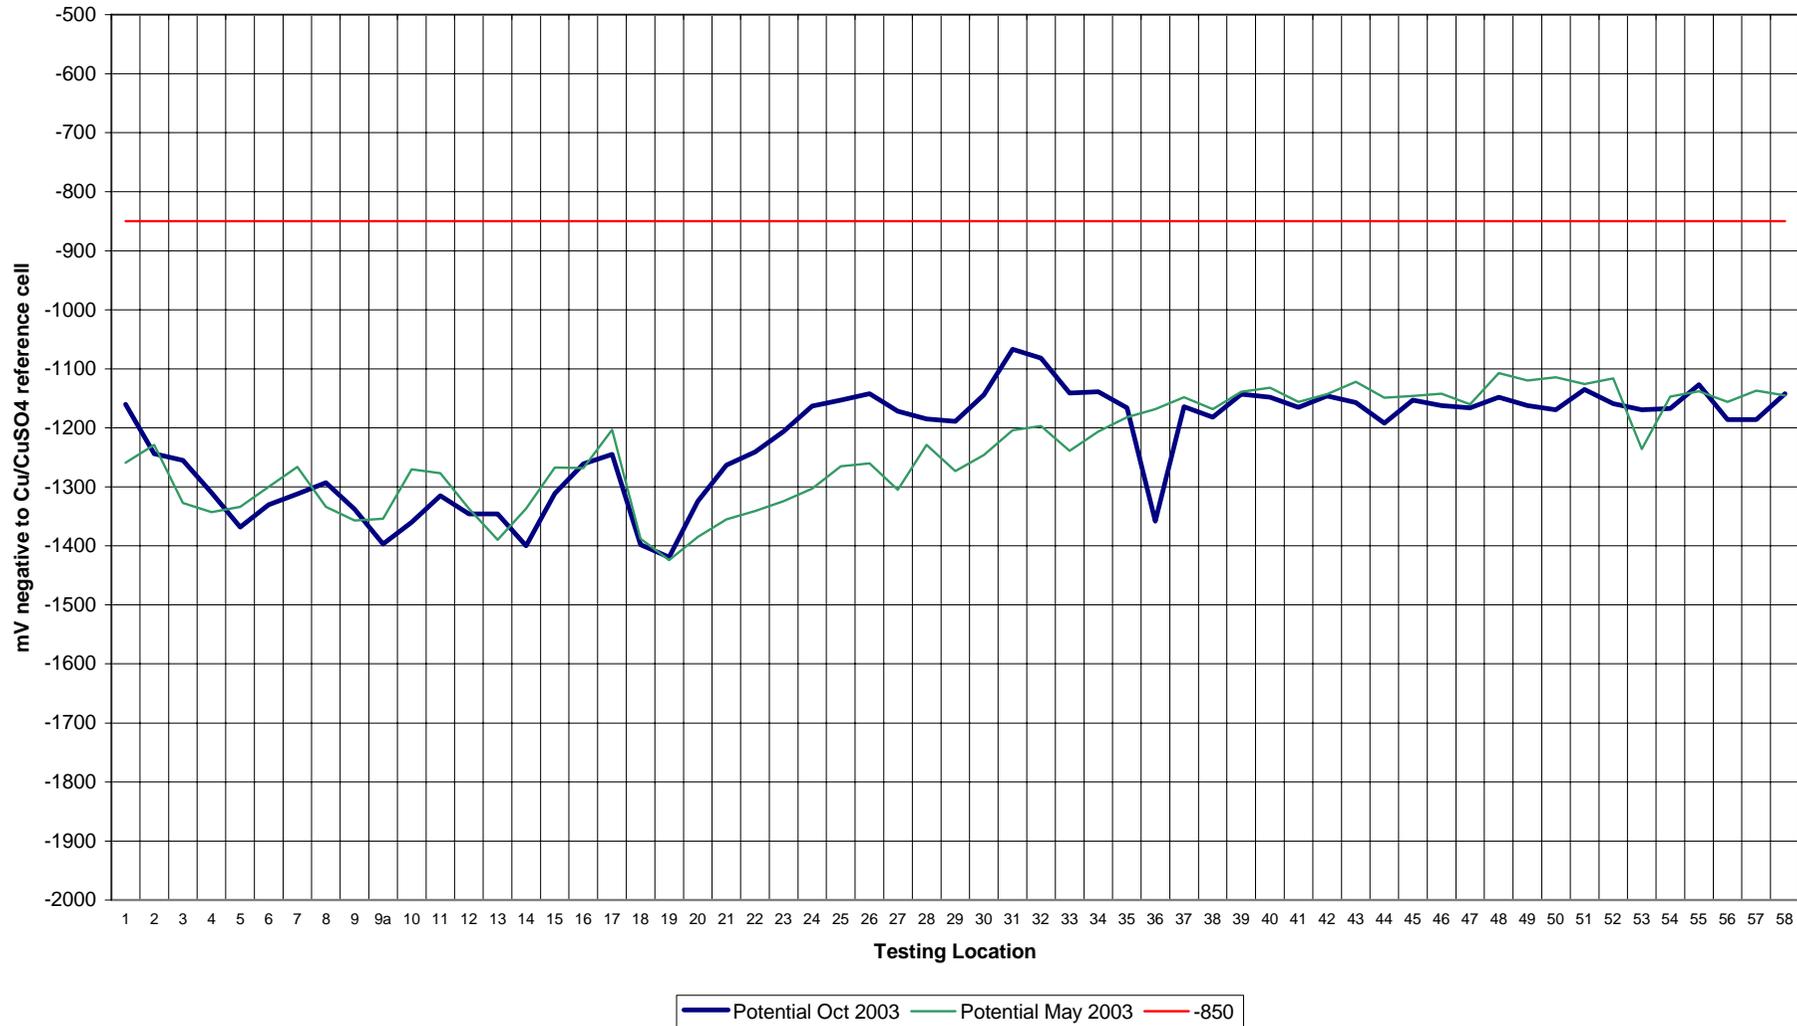
Potential Summary and Graph for Berri-Mildura Pipeline October 2003

The effectiveness of the cathodic protection is monitored by carrying out a full line potential survey. These are conducted on a six monthly basis. Routine checks of test points along the pipeline showed that all sections of the pipeline are at fully protected potentials. A summary of the CP survey results conducted during 2003 is included in Appendix 1.

Both surveys in 2003 found the pipeline to be fully protected with AS/NZ 2831.1. The 14 surge arrestors previously installed between test points 1 and 18 required to keep the earthing material isolated from the pipeline, appear to be working correctly and have assisted in stabilising cathodic protection levels between Berri off take and Main Line Valve 2 facilities.
