EPIC ENERGY
South Australia Pty Ltd

2013 Annual Report

SOUTH EAST PIPELINE

Document Number S-31-107-AR-G-010

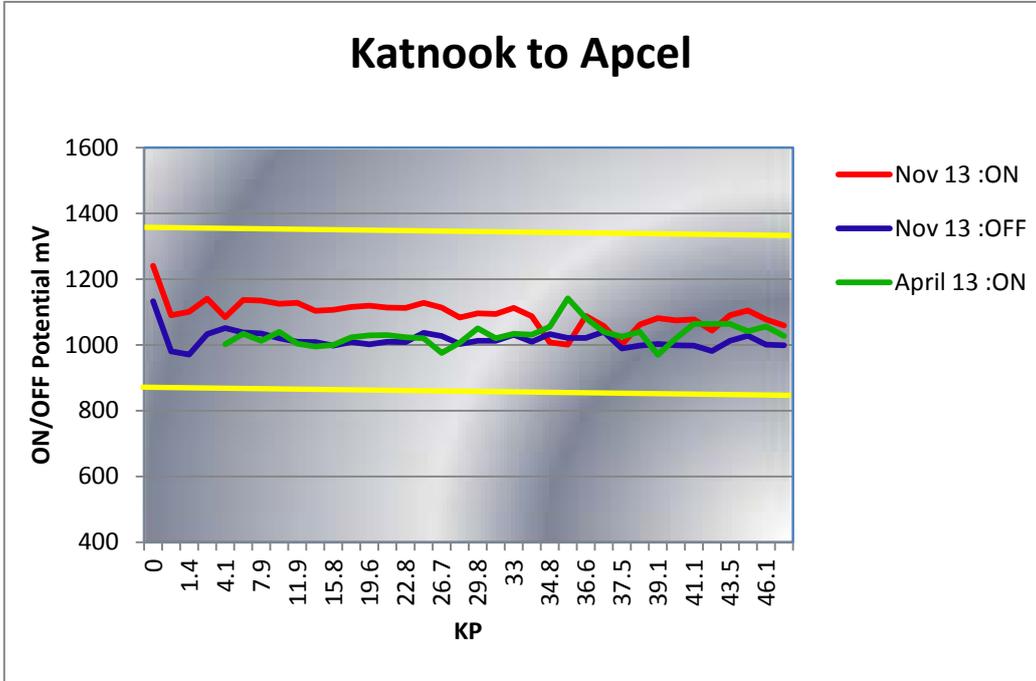
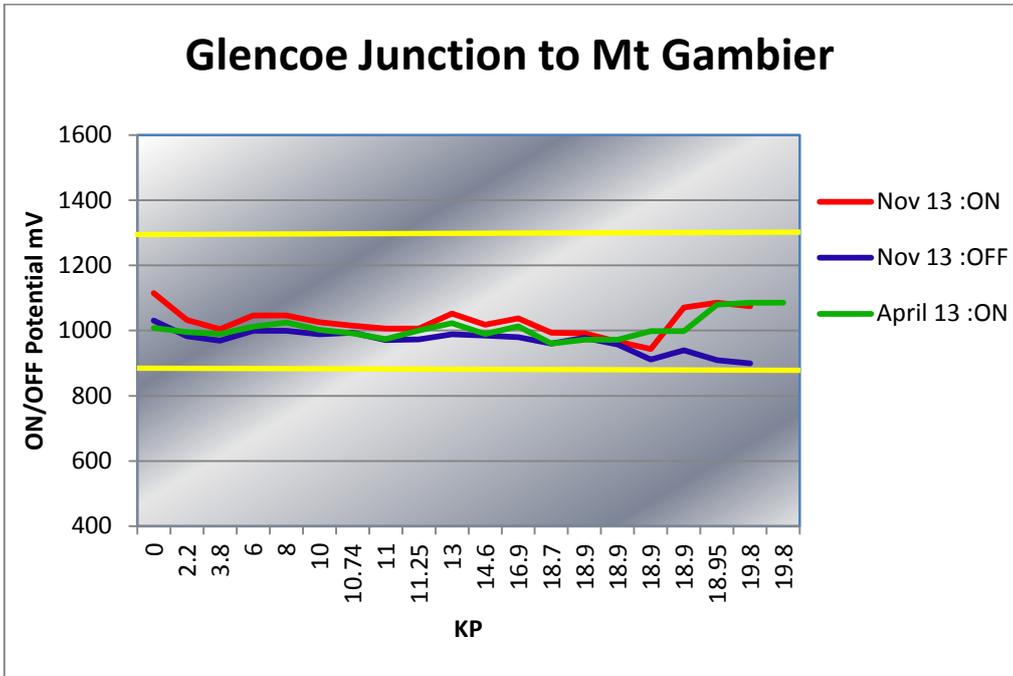
Appendix B - 2013 SEPS Cathodic Protection Data

The collection of OFF potentials provides a more direct indication of the CP system performance. As detailed by the data provided in Appendix B, CP levels on all SEPS pipelines were to the requirements of AS2832.1.
