2004 ANNUAL REPORT

**PRIMARY INDUSTRIES AND
RESOURCES SA
(Petroleum)**

Pipeline Licence No 11

Berri to Mildura Pipeline

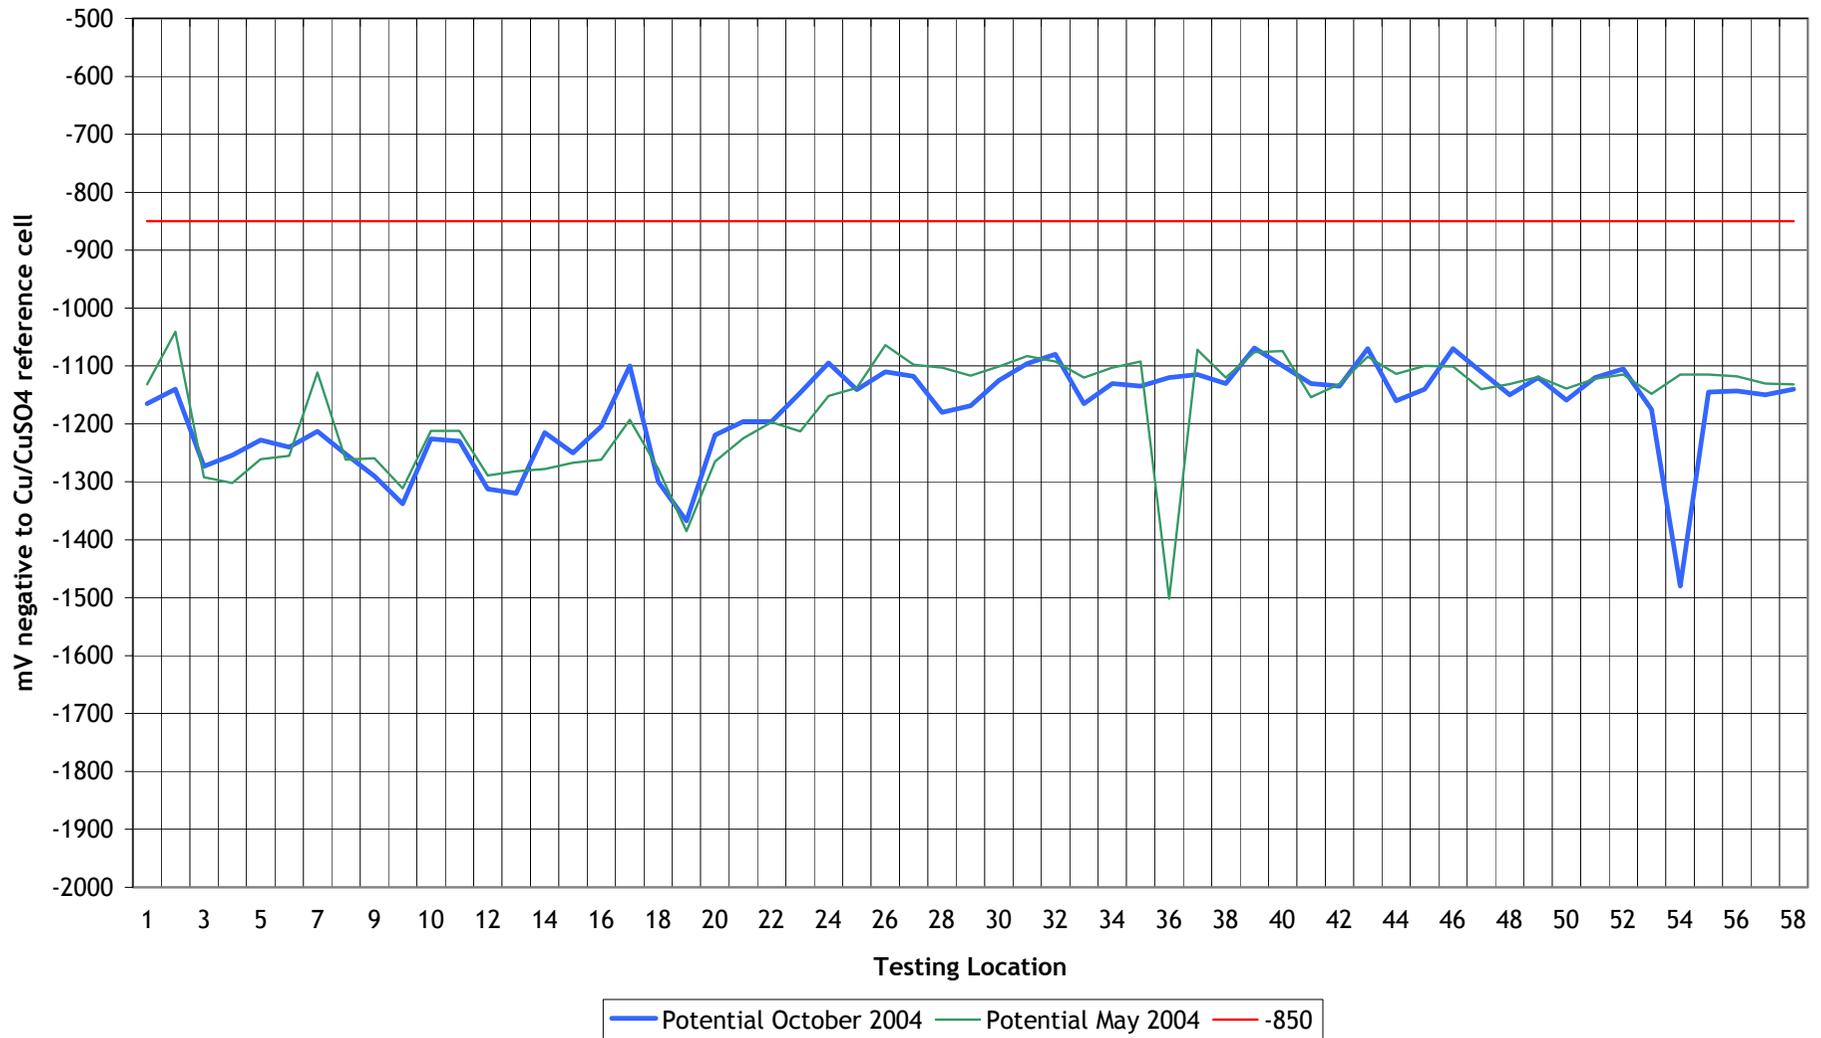
Graph 4 - Potential Survey Graph for the Berri-Mildura Pipeline
2004

The effectiveness of the cathodic protection is monitored by carrying out a full line potential survey. These are conducted on a six monthly basis. Routine checks of test points along the pipeline showed that all sections of the pipeline are at fully protected potentials. A summary of the CP survey results conducted during 2004 is included in Appendix 1.
