EPIC ENERGY  
South Australia Pty Ltd

**2014 Annual Report**

**SOUTH EAST PIPELINE**

Document Number S-31-107-AR-G-011

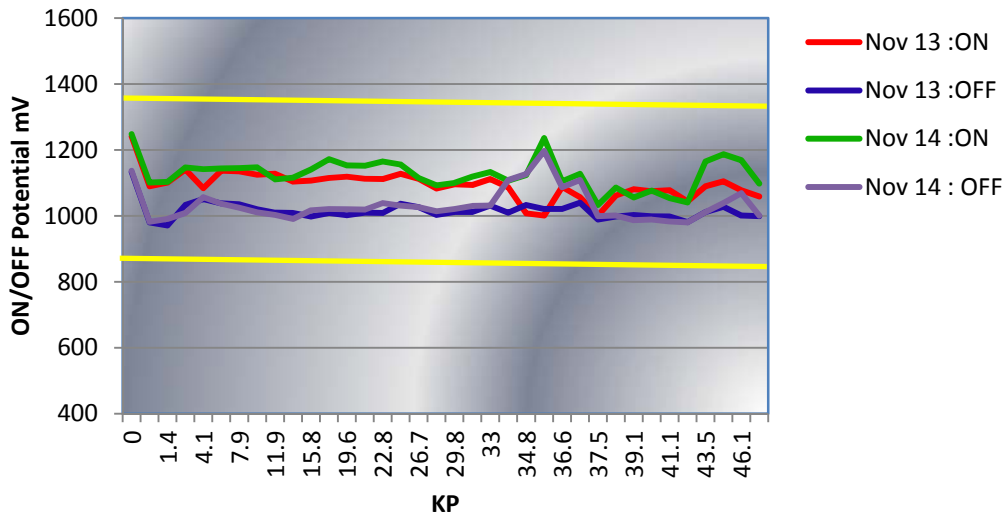
### Katnook Plant to Apcel Full line Survey Nov 2014

The collection of OFF potentials provides a more direct indication of the CP system performance. As detailed by the data provided in Appendix B, CP levels on all SEPS pipelines were compliant with AS2832.1.
