Dry Creek Saltfields PEPR 2017/001

Response to DEM Environmental Direction 10 December 2020 regarding rectification works at Little Para River crossing

Report by:	Buckland Dry Creek
Telephone:	8244 8156
Report author:	David Kingston, Engineering Manager
Report date:	11 December 2020

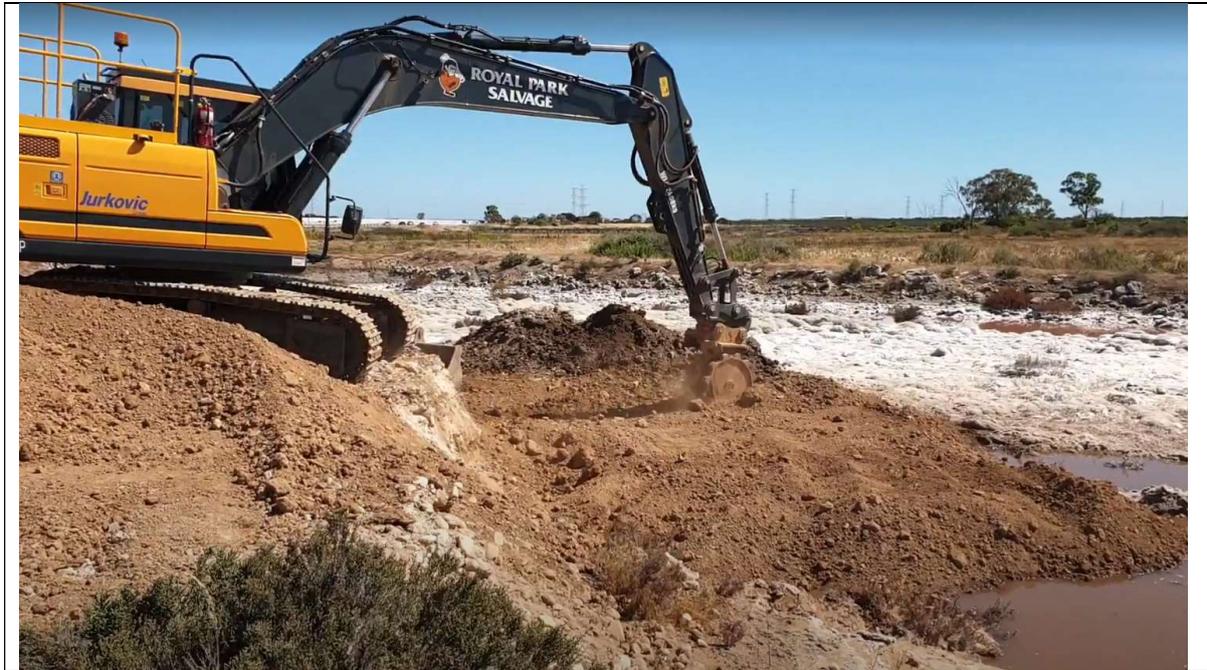
Photo 1: View south at construction of new bund wall in PA11 extension. 10 Dec.

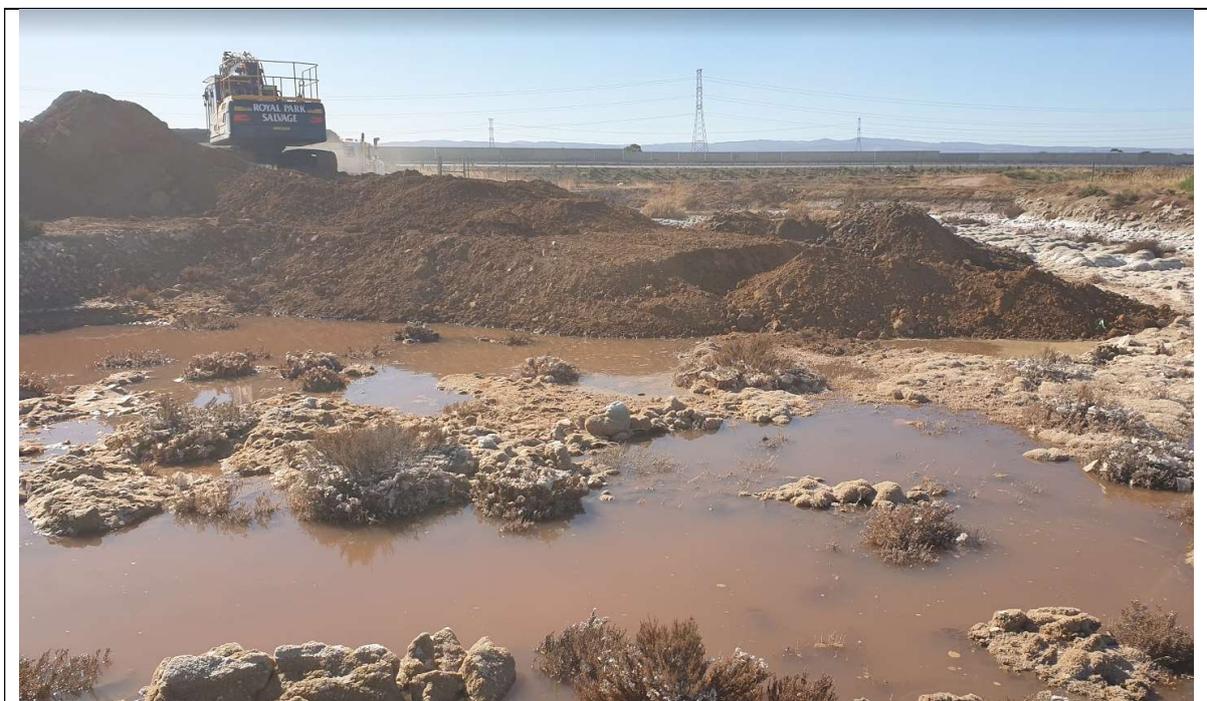
Photo 2: View SE at construction of new bund wall in PA11 extension. 11 Dec.

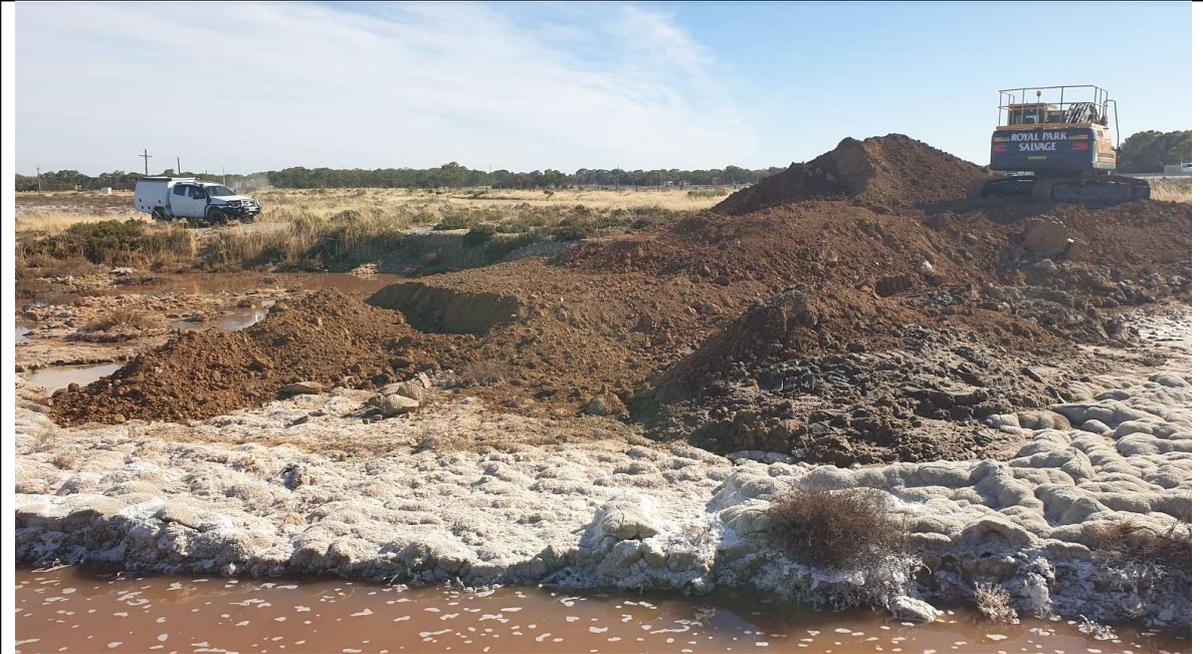
Photo 3: View N at new bund under construction. Existing gypsum is placed on the downstream side of the bund. 11 Dec.

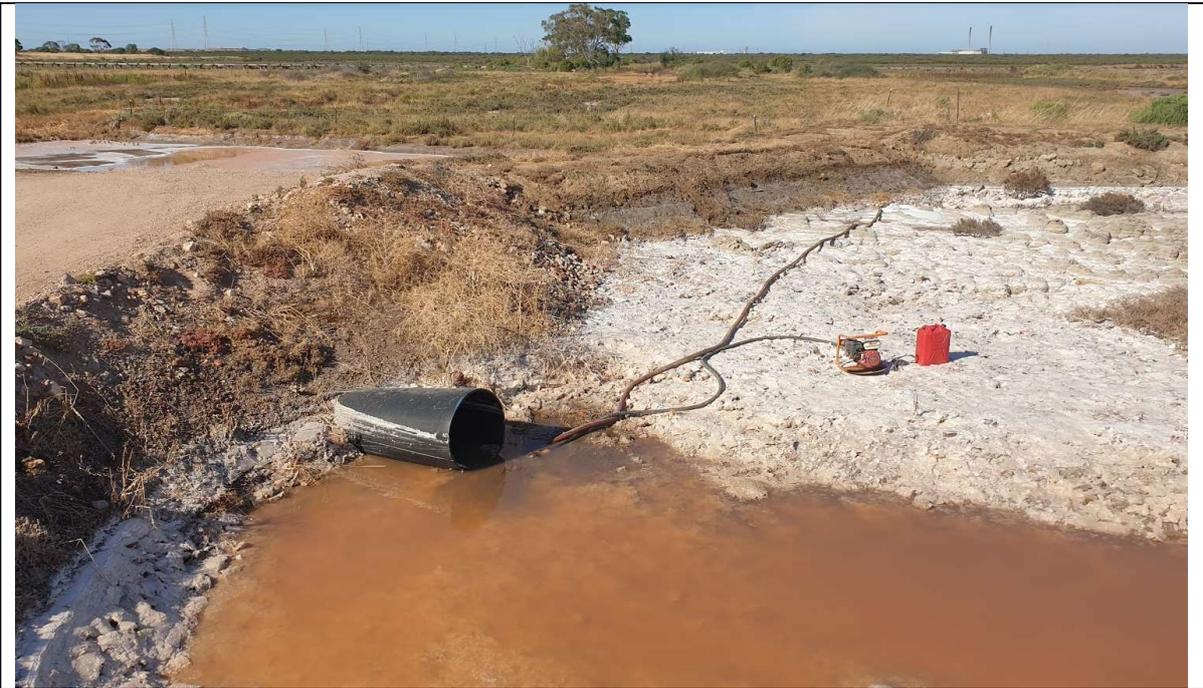
Photo 4: View NW at pumping of brine upstream to PA11 from existing pipe inlet. 11 Dec.

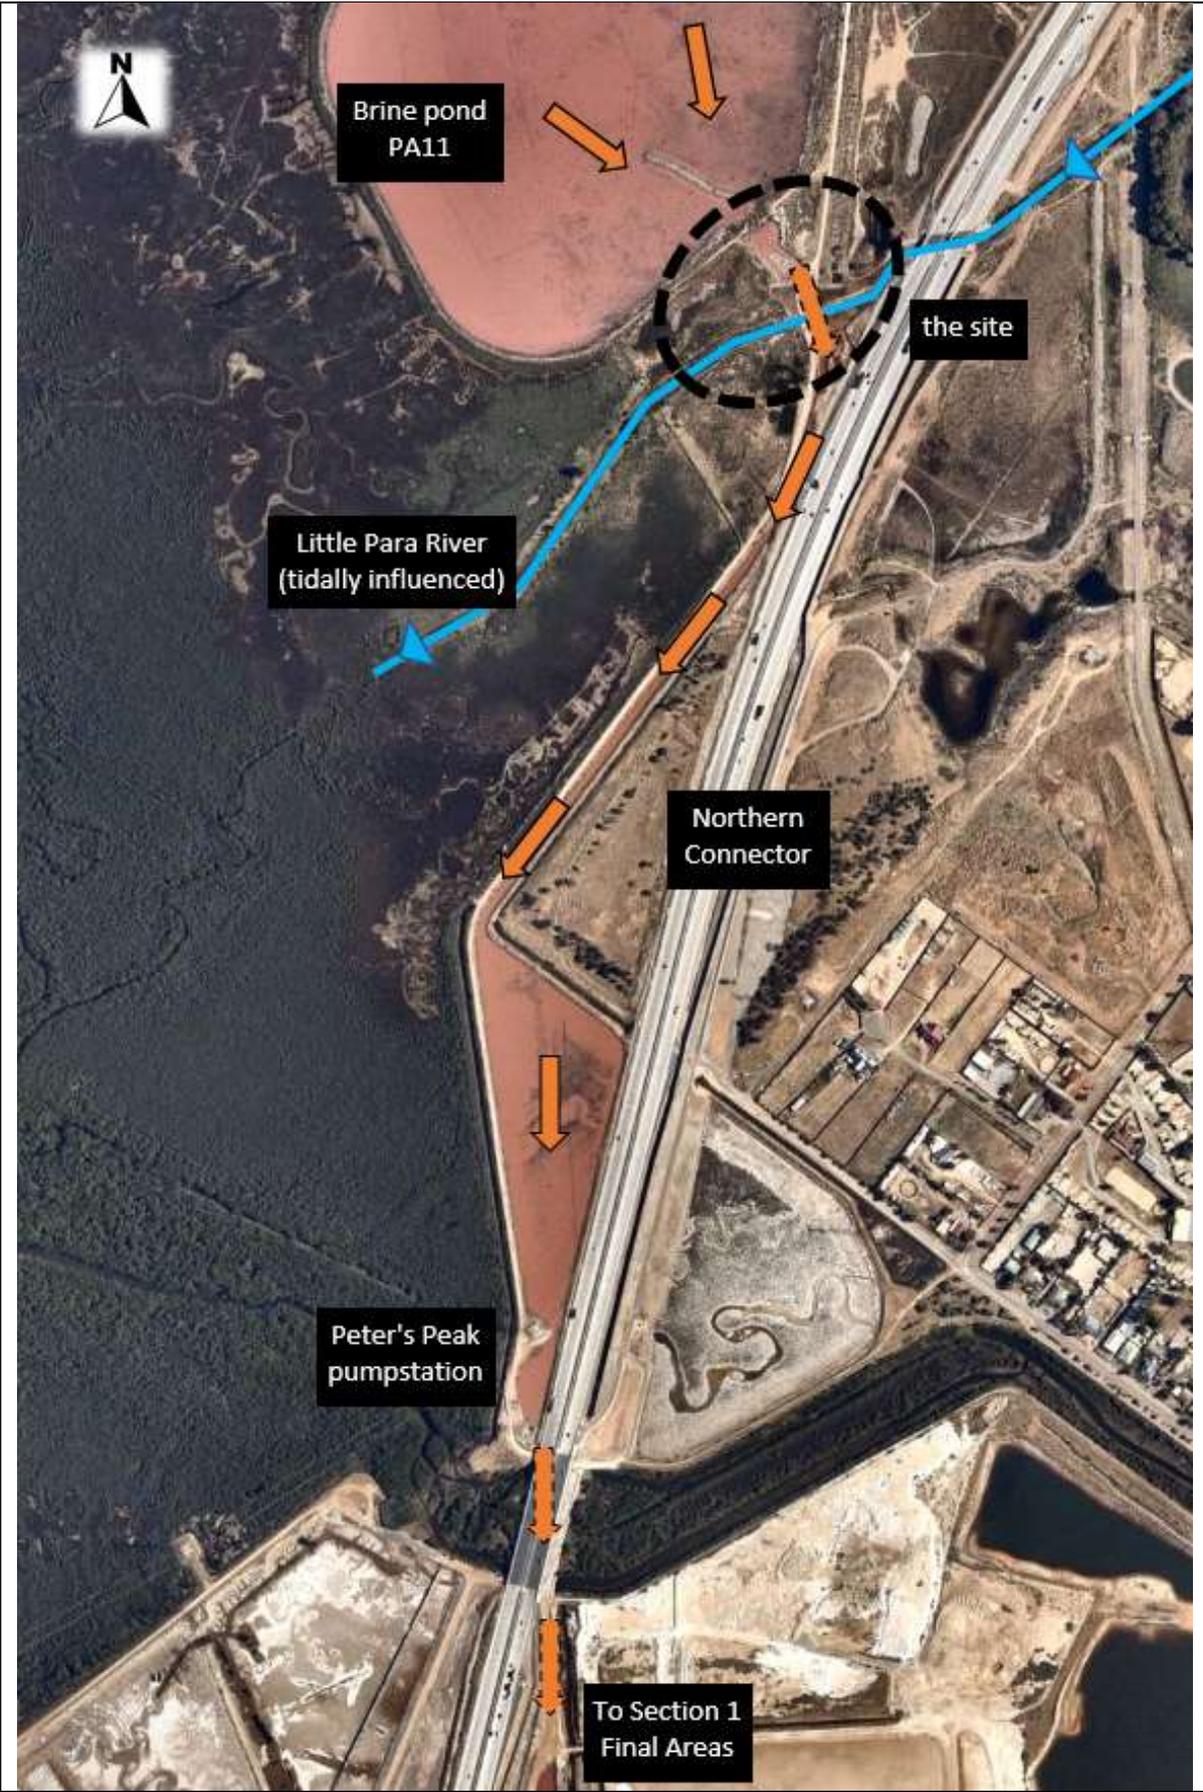
Figure 1: Site location and context

The site as referred to in this report is shown on **Figure 1** and roughly consists of the land between the Northern Connector, brine pond PA11 and the land immediately downstream of the Little Para River bed-level crossing.

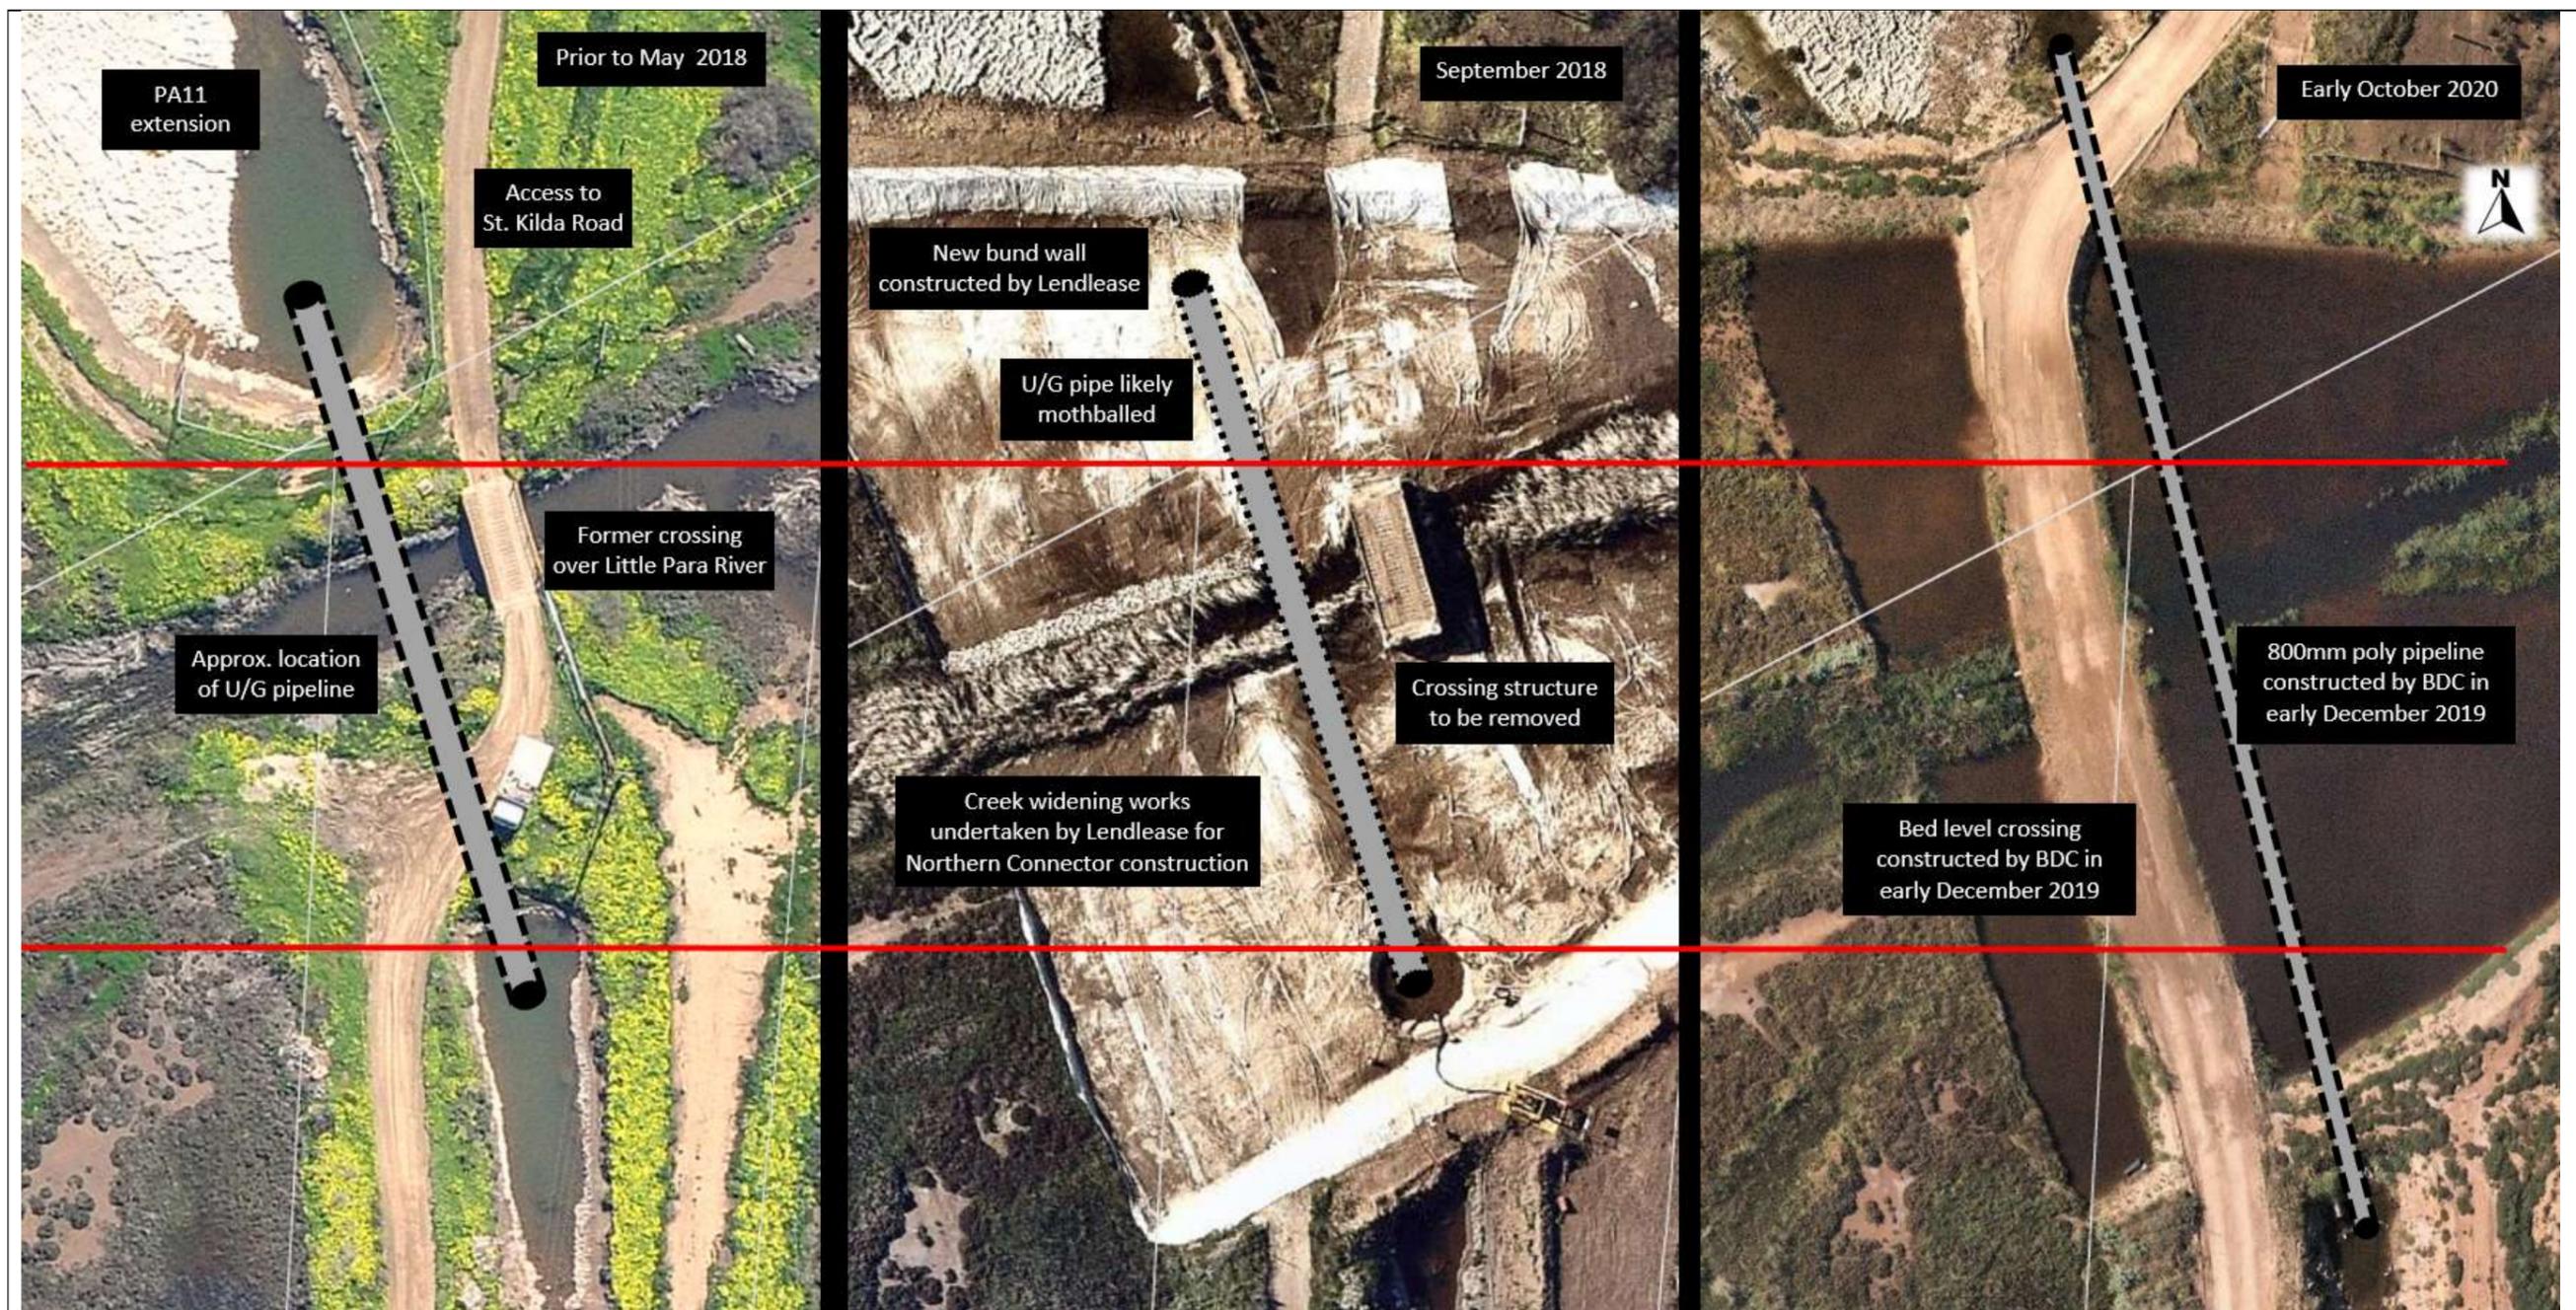
Figure 2: Changes to site due to construction of Northern Connector

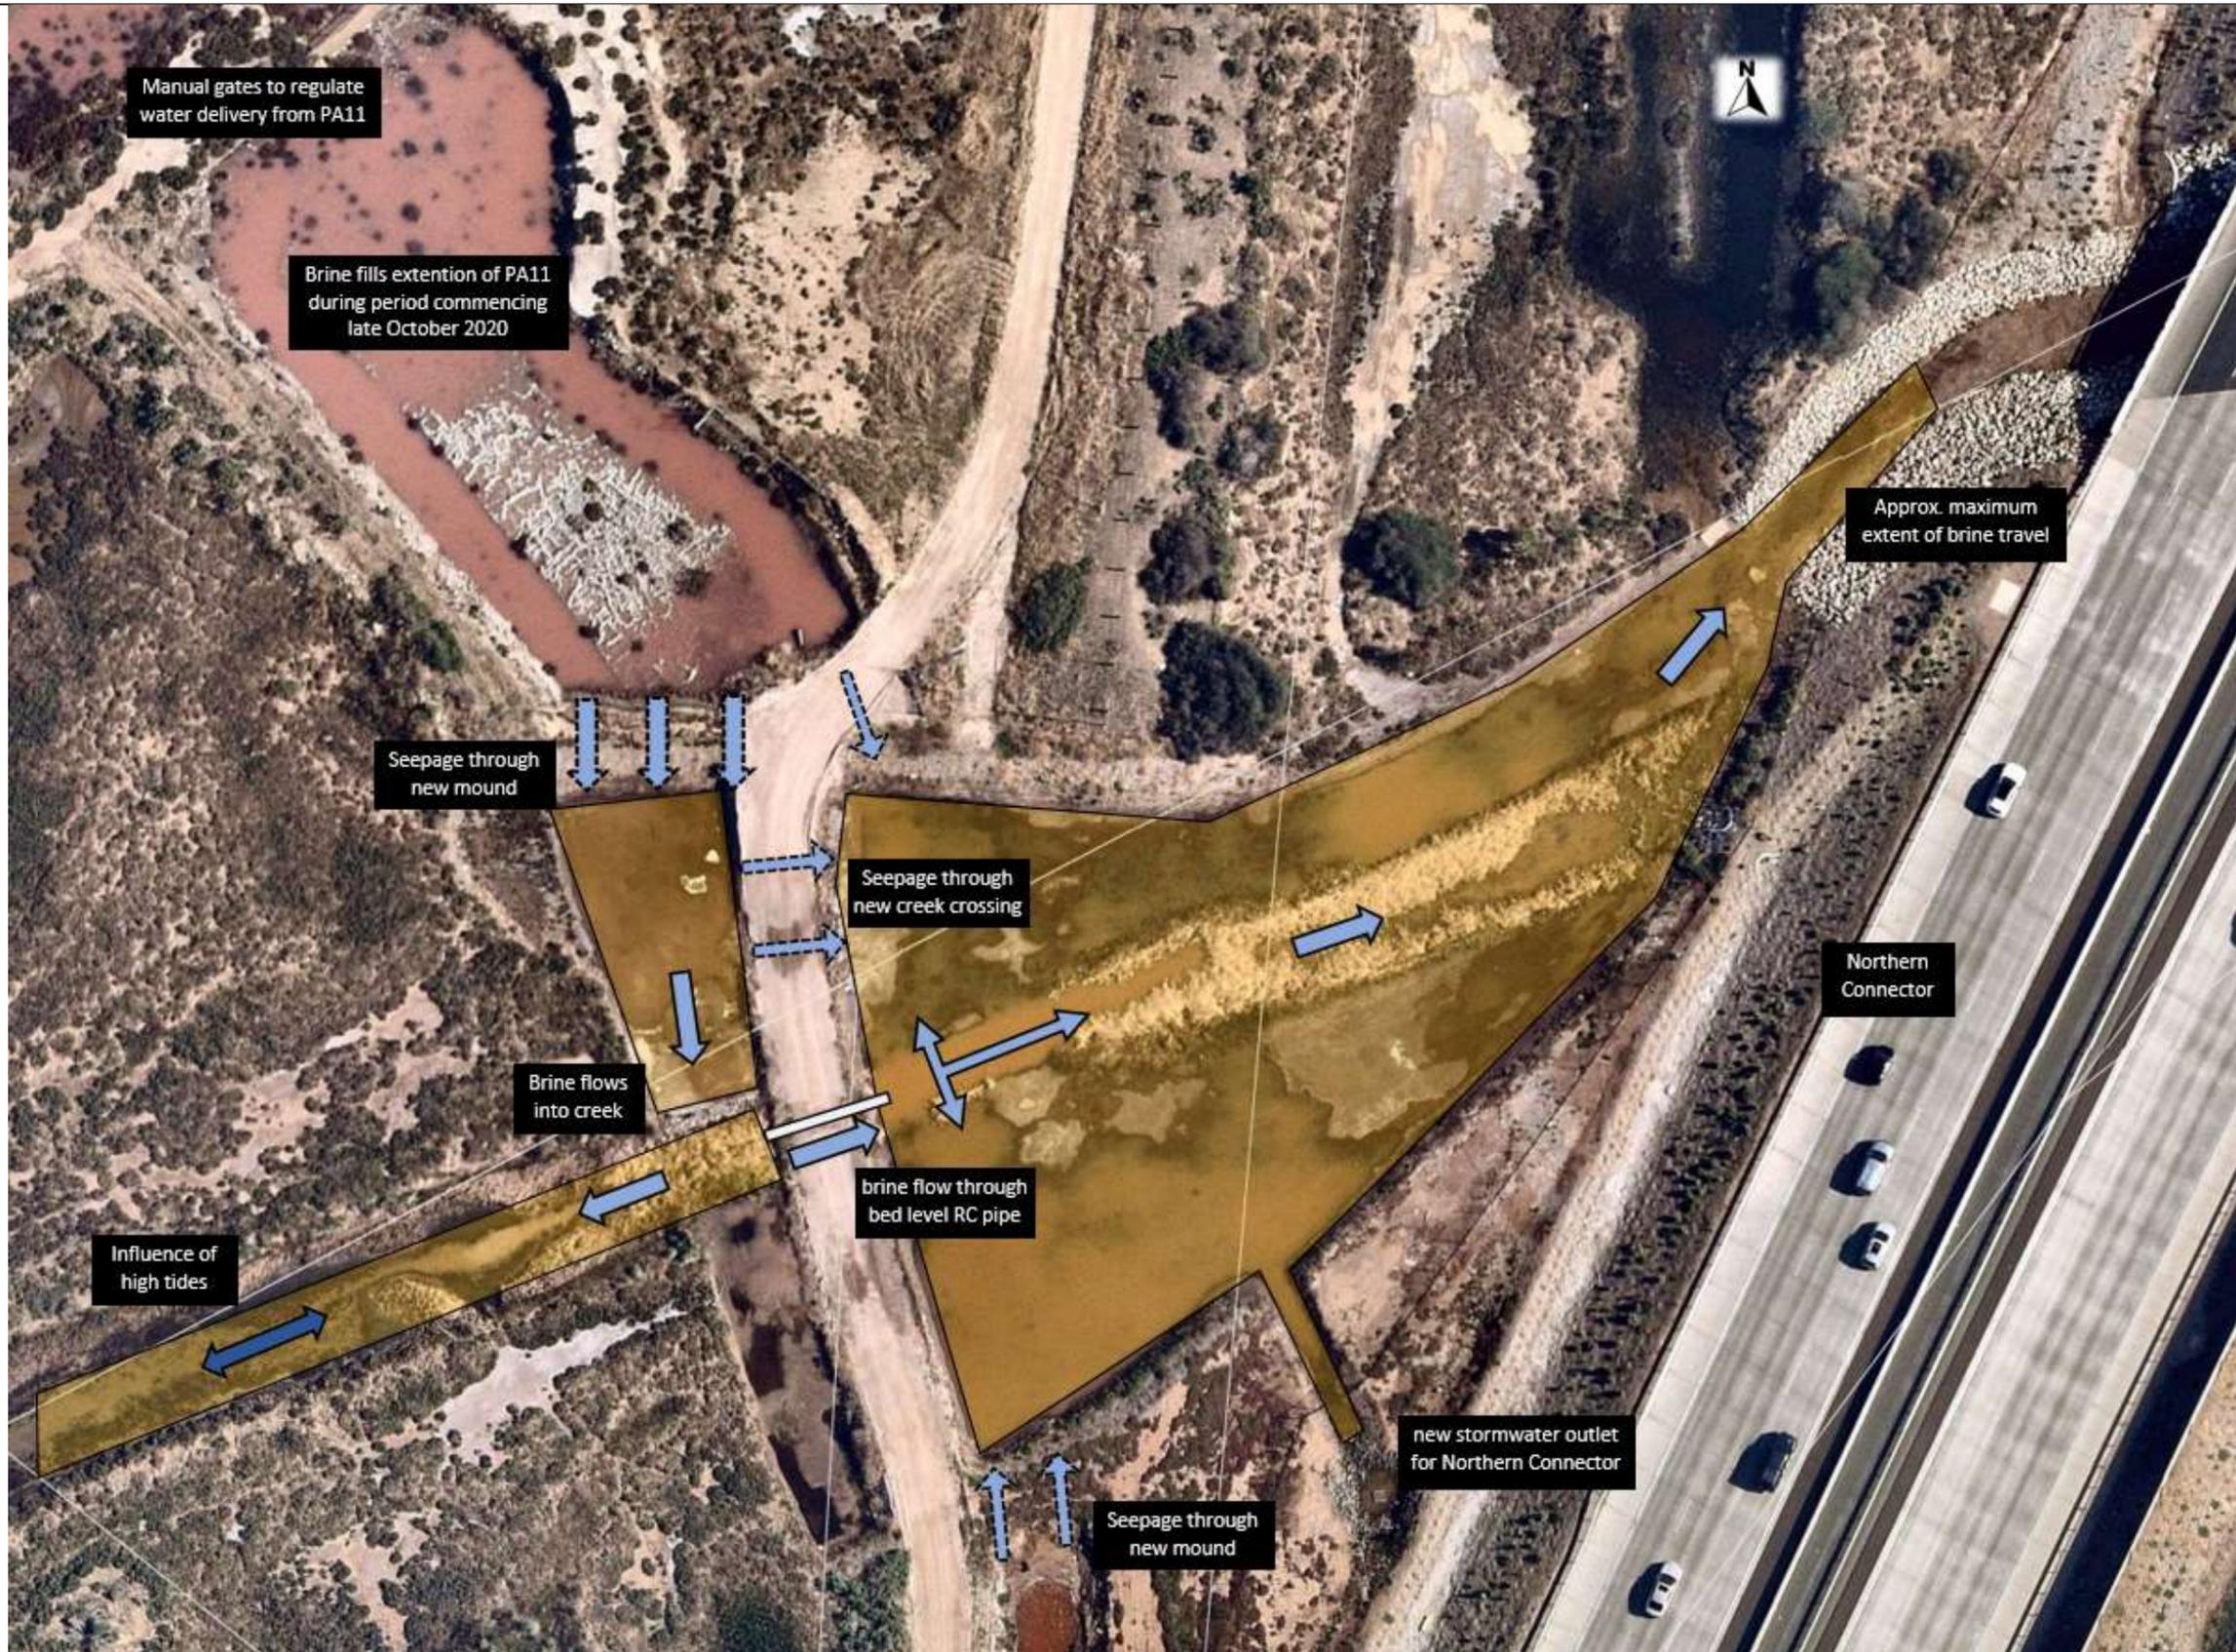
Figure 3: Apparent distribution and mode of travel of brine

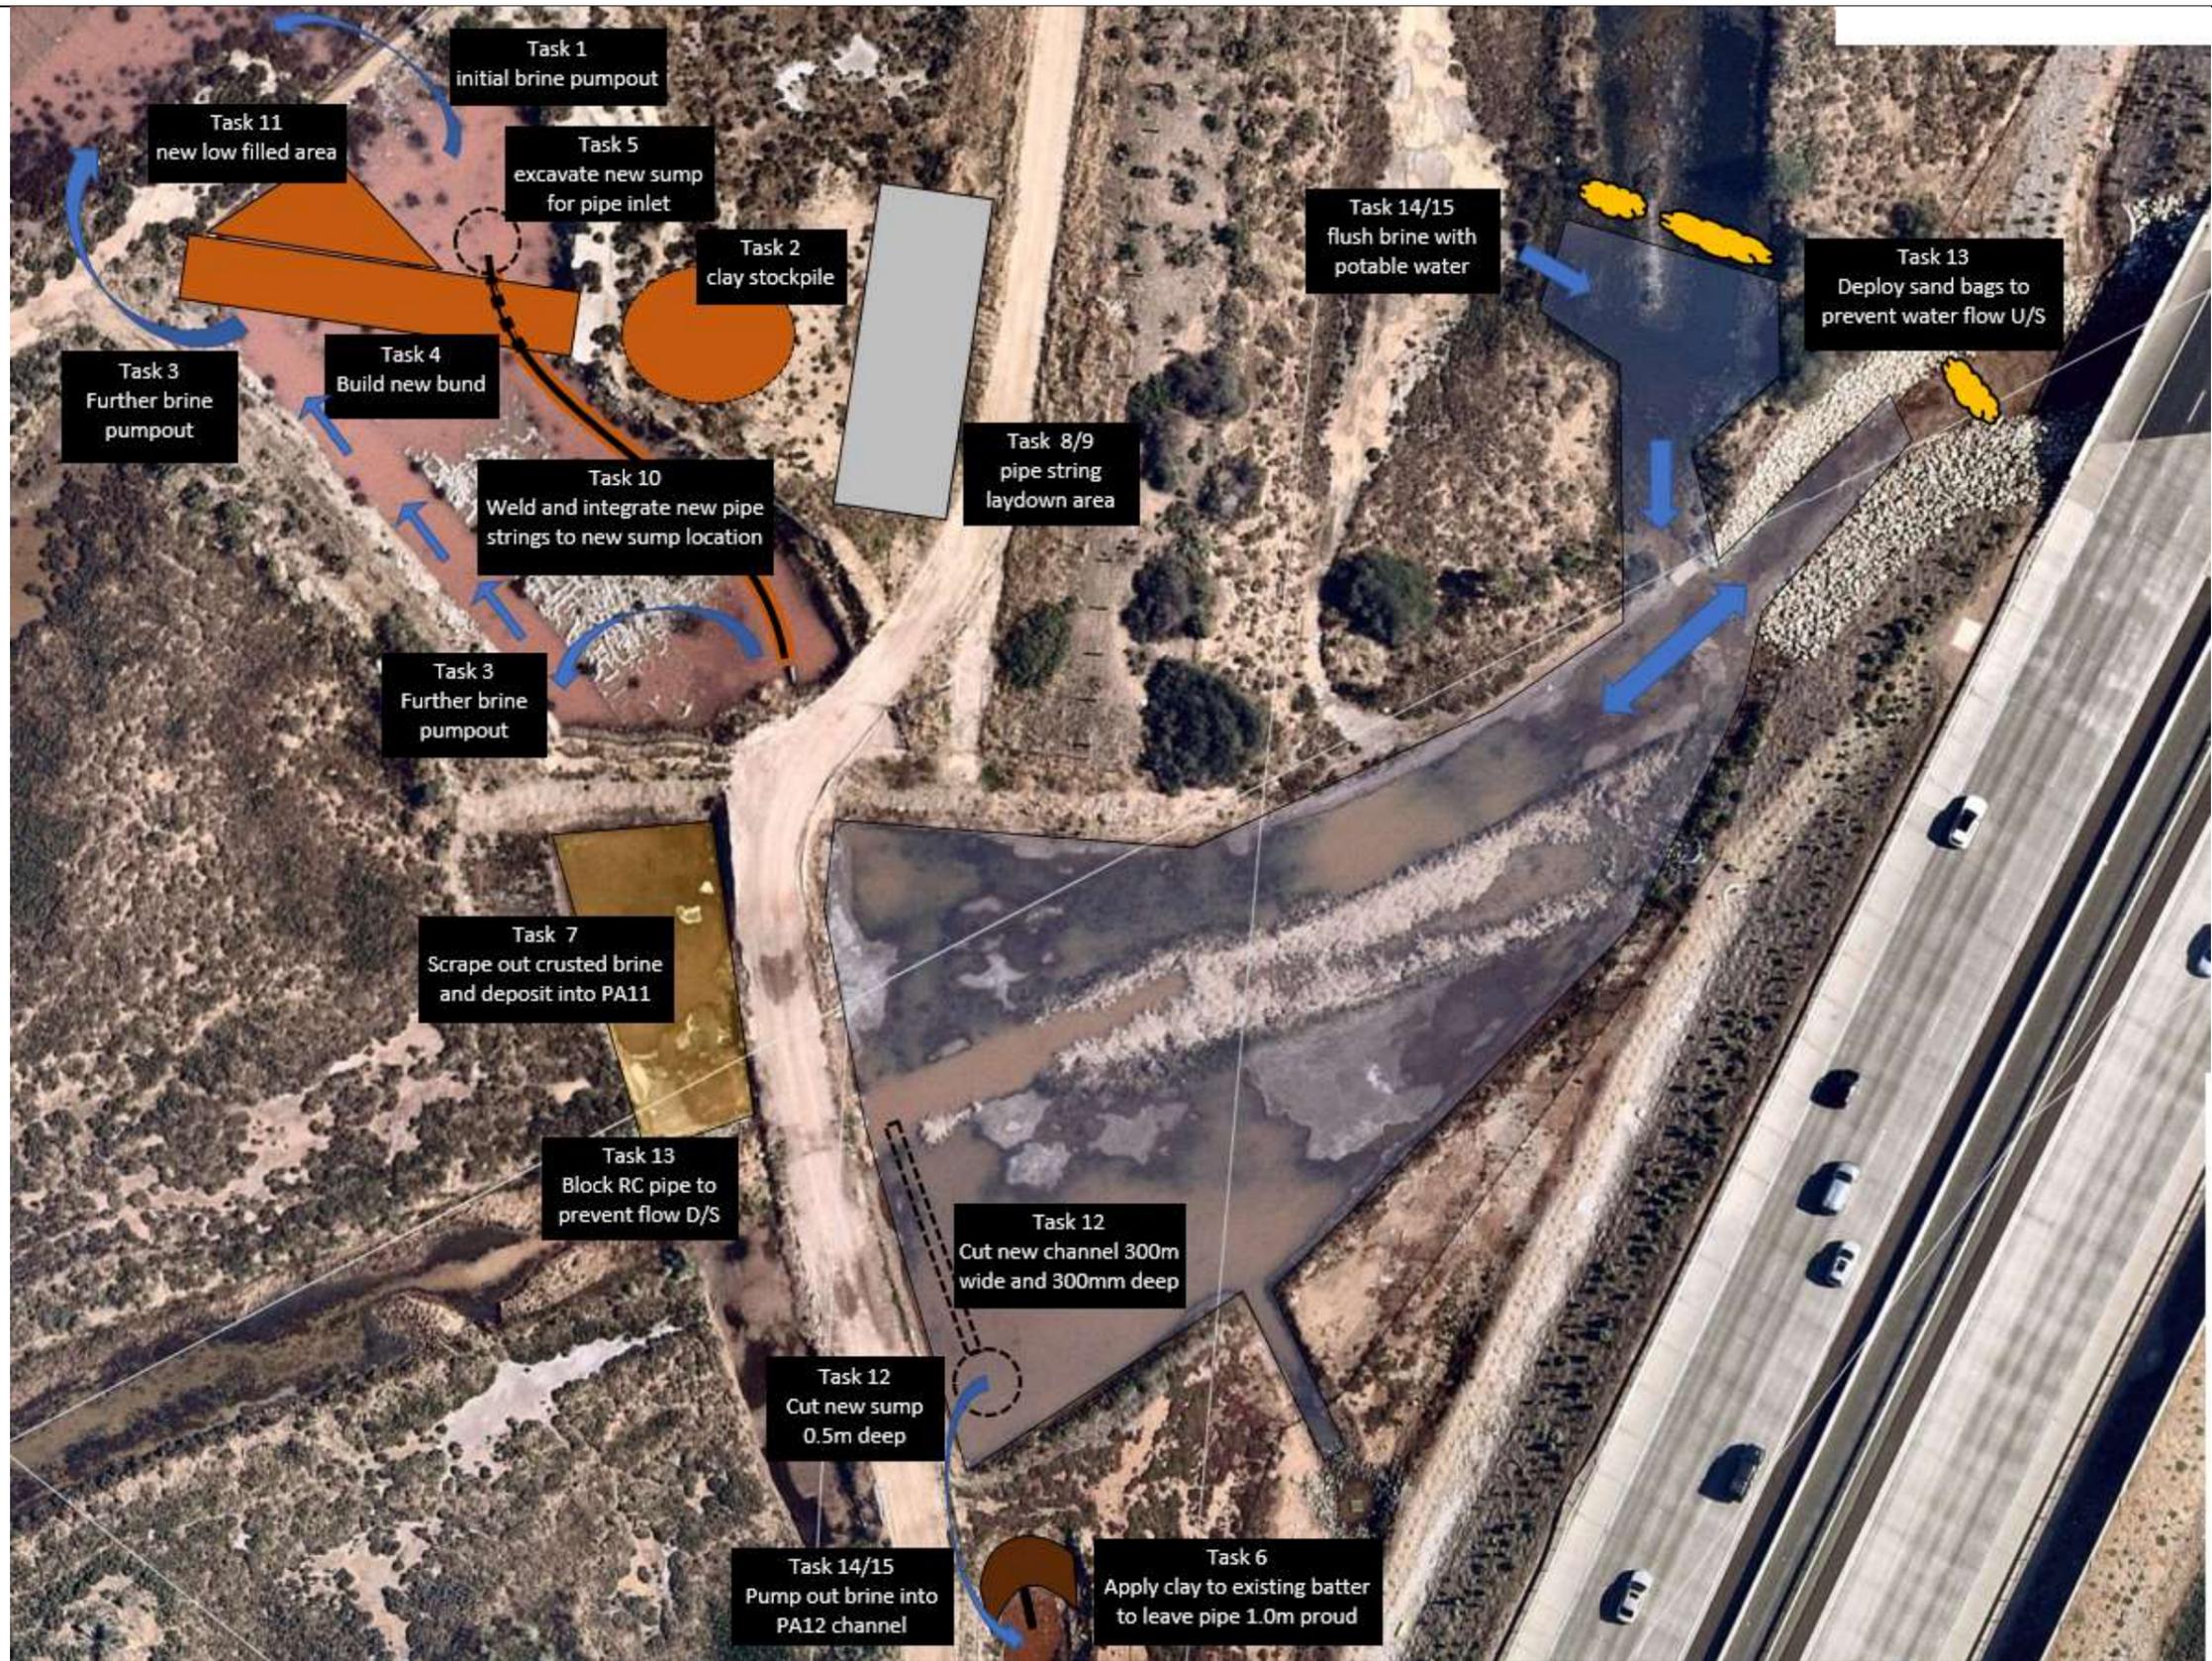
Figure 4: Remedial work scope

The work scope is denoted on **Figure 4**. **Table 2** sets out individual work tasks in approximate sequential order.

Task	Description	Date(s)
1	Commence pumping of brine from PA11 extension back into PA11	10 Dec
2	Deliver approx. 1,000t low permeability clay to site	10-11 Dec
3	Continue pumping of brine from PA11 extension back into PA11	11 Dec
4	Strip gypsum from pond base to find existing clay layer as foundation and place/compact clay above into new trapezoidal bund 1.2m high and approx. 6.0m wide at base. Gypsum is placed on the downstream side of the bund.	10-12 Dec
5	Excavate sump at new pipe inlet point in PA11 extension	14 Dec
6	Apply clay to start of PA12 channel to prevent back seepage of brine to creek	14 Dec
7	Trim and remove crusted brine from western side of bed level crossing and deposit in PA11.	14 Dec
8	Prepare PA11 extension for delivery of new pipe strings, shape landform, cut trench through bund, excavate area for welding frames	14 Dec
9	Receive 4 x 12m pipe strings and undertake stringing preparations	15 Dec

10	Weld and integrate pipe strings from existing inlet to new inlet point	16 Dec
11	Fill new bund trench and additional area with surplus clay to aid in suppression of seepage potential	16 Dec
12	Excavate shallow channel (300mm depth and width) as well as a new sump 500mm deep at southern corner of creek expansion area	16 Dec
13	Deploy temporary sand bags to creek bed near Northern Connector crossing to prevent water flush travelling upstream. Block existing RC pipe at bed level crossing to prevent water flush travelling downstream	17 Dec
14	Deliver 2x 20,000L potable water to release point with water tankers. Commence pumping from sump to PA12 channel and slowly release water from truck to flush brine towards sump. Ensure no overflow of bed level crossing.	17 Dec
15	Repeat Task 14 until all brine is visibly removed from creek area	17 Dec
16	Remove sandbags, unblock bed level RC pipe, perform final site trim and cleanup.	18 Dec
