YOUNGS QUARRY (PM 214)

# Mine Operations Plan

**Prepared for:** C.L. Land Management Pty Ltd

**File Reference:** 2449.610.001V2

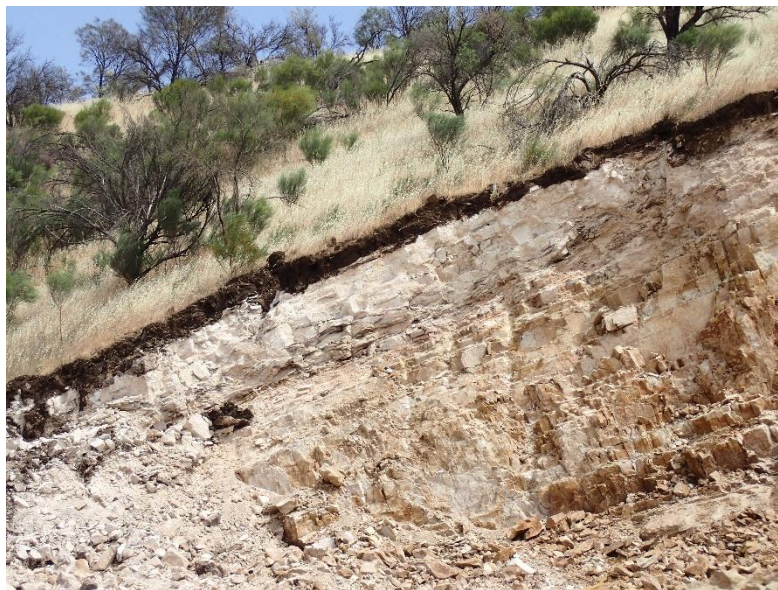
Topsoil thickness varies across the Site ranging between 50-300 mm in the eastern operational portion of the Site. Topsoils are stony sandy and calcareous loams over rock with very limited subsoil as shown in the below photo, taken on 30 October 2019. However generally topsoil is noted as minimal throughout the area as shown below in **Photo 1 – Topsoil Profile** and has been conservatively estimated as 50 mm for the remaining unextracted areas of the Site for the purposes of this MOP.

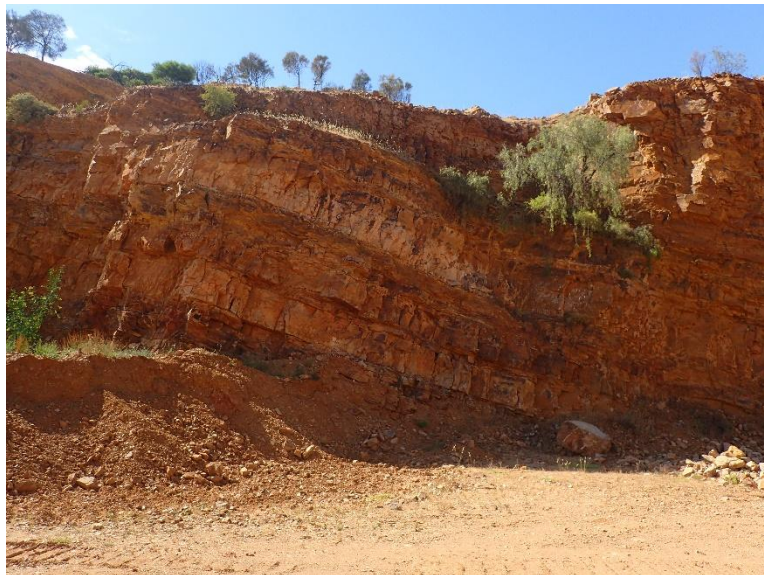
Existing and future development within the operational areas target the Bungaree Quartzite (the main pit) and Skillogallee Dolomite rock types (eastern pit). Refer to **Photo 2 – East Pit South Wall Geological Profile** for an example of the typical rock profile within the Site.

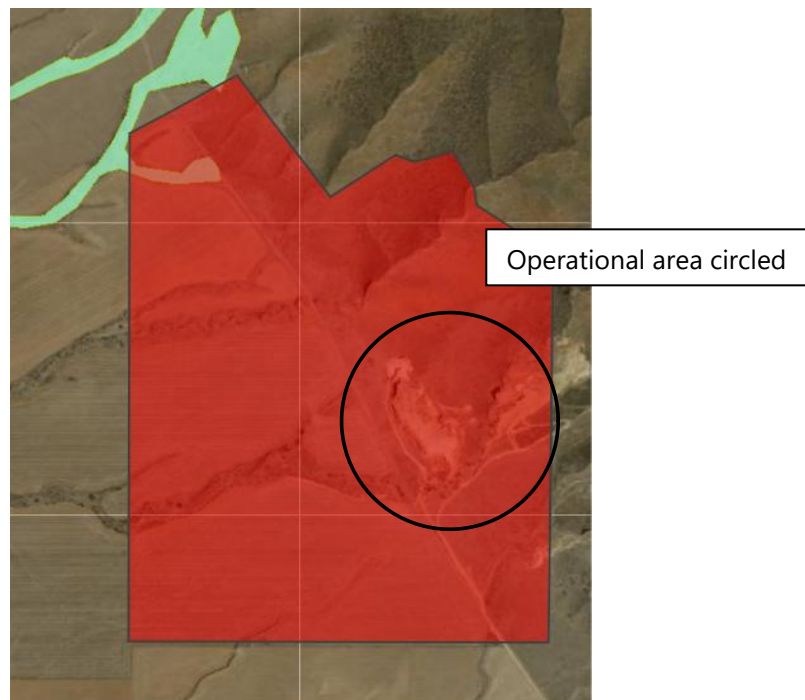
**Figure 1 – PM and Groundwater Dependent Ecosystems**

A search of the BoM Groundwater Dependent Ecosystem Atlas indicates that one (1) low potential Terrestrial Groundwater Dependent Ecosystems (GDE) is recorded within the north west corner of the PM and 870 m north west of the operational area of the PM refer to **Figure 1 – PM and Groundwater Dependent Ecosystems**.

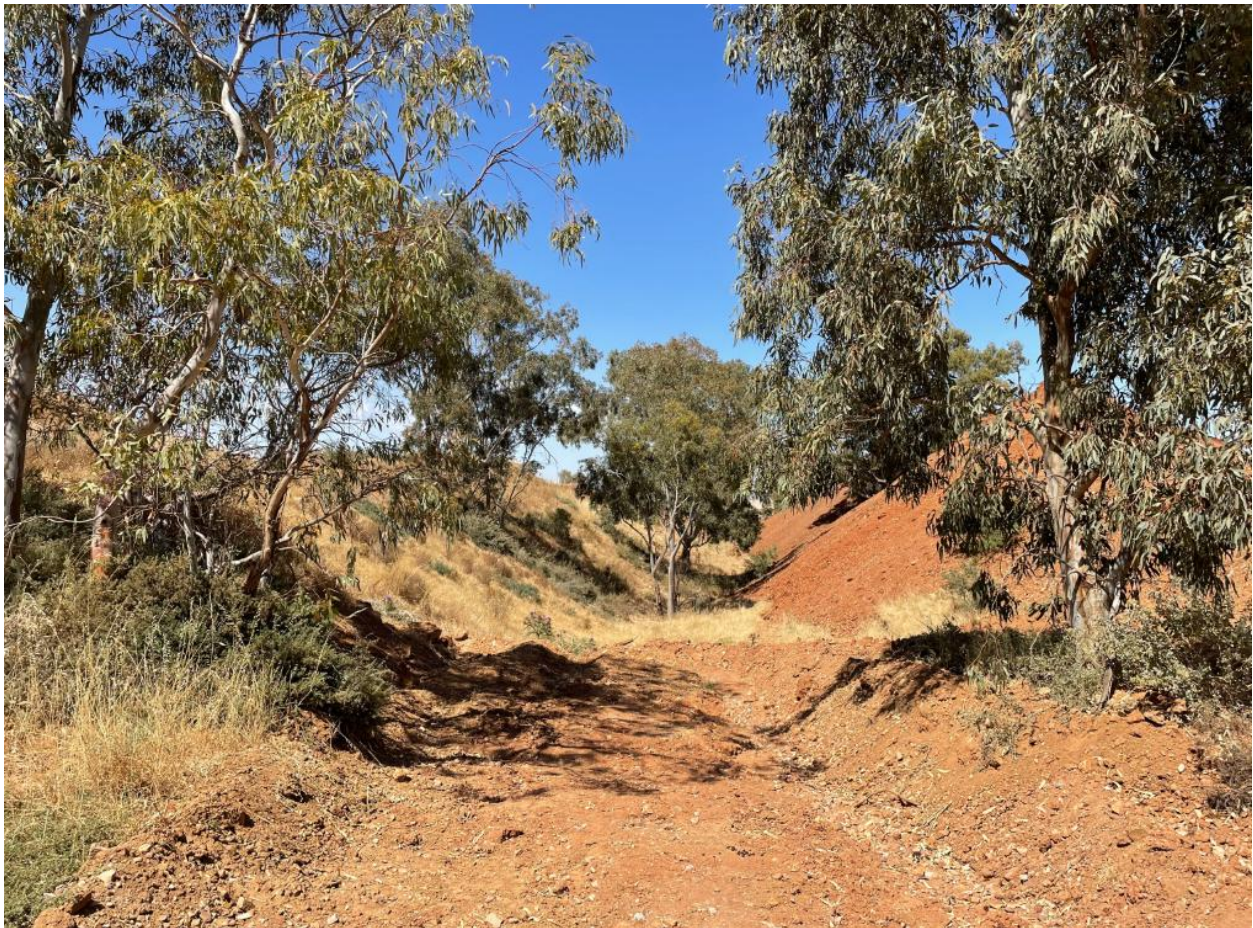
The greater PM has multiple mapped watercourses varying in order from Stream order 1 to Stream order 3 following drainage lines and topography of the area refer to **Drawing No. 2449.DRG.008 – Topographic Map**. There are two (2) mapped watercourses that intersect the operational areas of the Site. One (1) is a Third Order stream running from north east to south west of the Site shown as Operational area stream. This is described as an ephemeral creek, vegetated with scattered eucalyptus and does not receive regular flows. Consultation with the Landowner (and Tenement Holder) and the adjacent landowner where the creek line exits to the south have confirmed the creek does not flow. Testimony from both advised the last recorded flow of the creek line was after the region had experienced a bushfire in 2014 that would have altered flow paths upstream that have since revegetated, and the first larger rainfall event occurred. Refer to **Photo 3 – Main Creek Line** demonstrating the typical presentation of the watercourse.

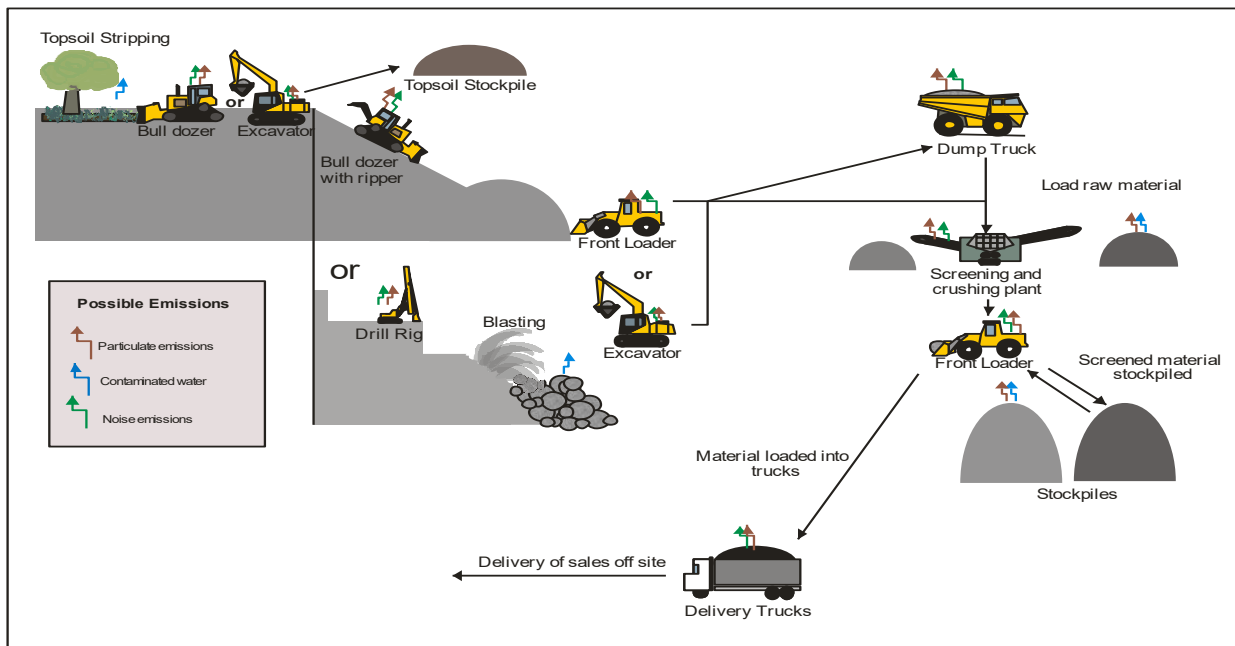
**Diagram 1 – Conceptual Extraction Operations.**

Refer to **Drawing No. 2449.DRG.019B – Site Layout Map - PM 214** for the primary crushing and screening and stockpiling location within the PM and **Diagram 1 – Conceptual Extraction Operations** for an illustration of the quarrying methodology.

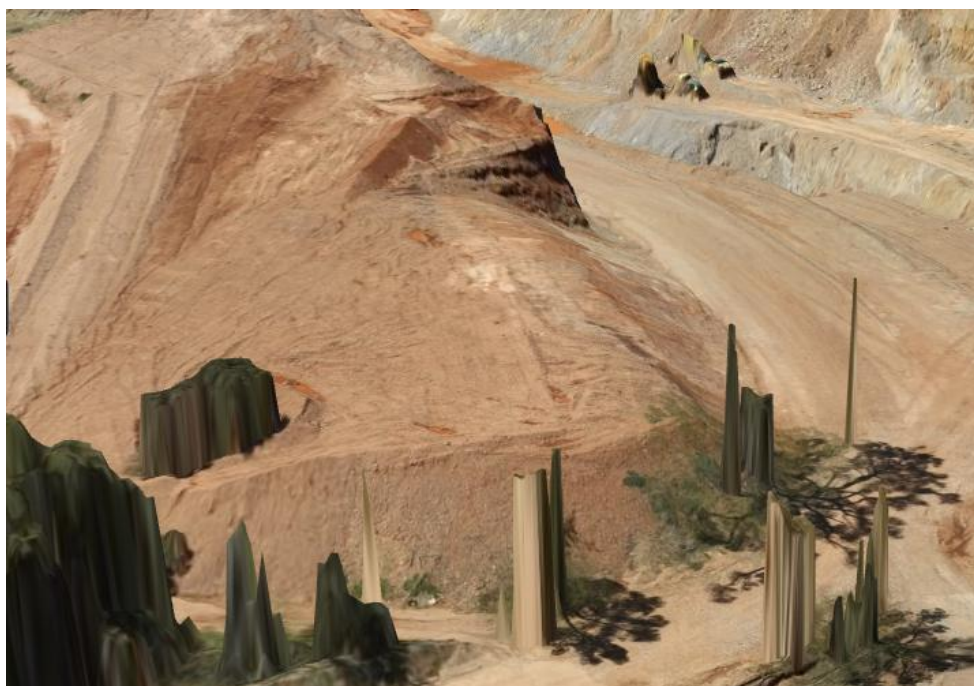
**Photo 4 - Battered wall face / rehabilitated area**

**Photo 4 – Battered wall face / rehabilitated area** below taken from aerial survey demonstrates this rehabilitation process and completed area:

Therefore, the timeframe frame for rehabilitation of this pit wall over the course of 60 m sections will be approximately 3 – 4 years.

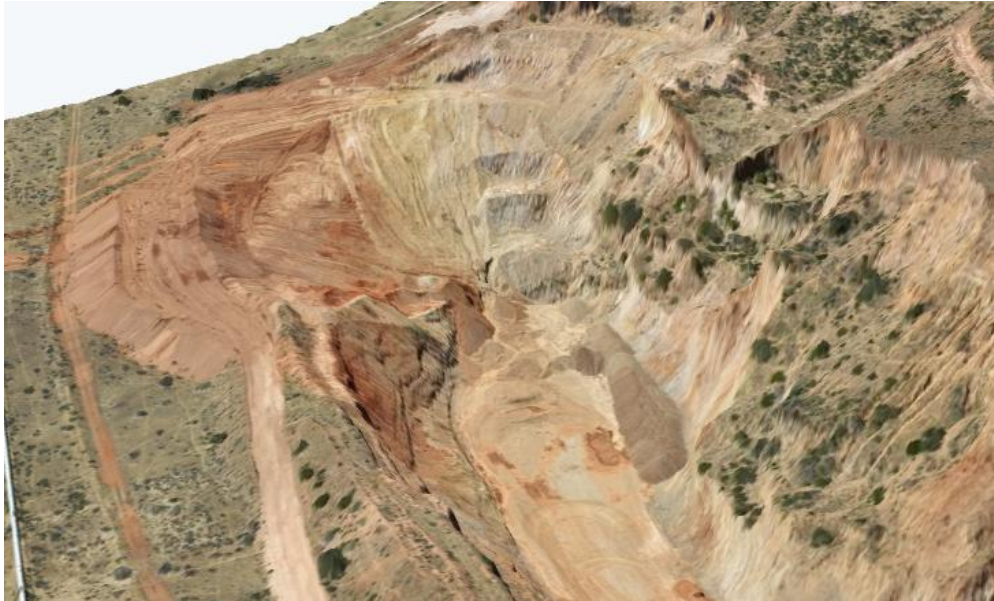
This stage focuses on works within the north western end. **Photo 5 – North West Rehabilitation** and ramp development demonstrates the extraction and battering of the northern wall, and the creation of the access road for potential future extraction of the eastern faces.

Final rehabilitation is planned for the terminal batters of the western wall faces. Rehabilitation includes completion of contouring, application of topsoil, scarification of the soil and planted with pasture grass seed to stabilise the batters.

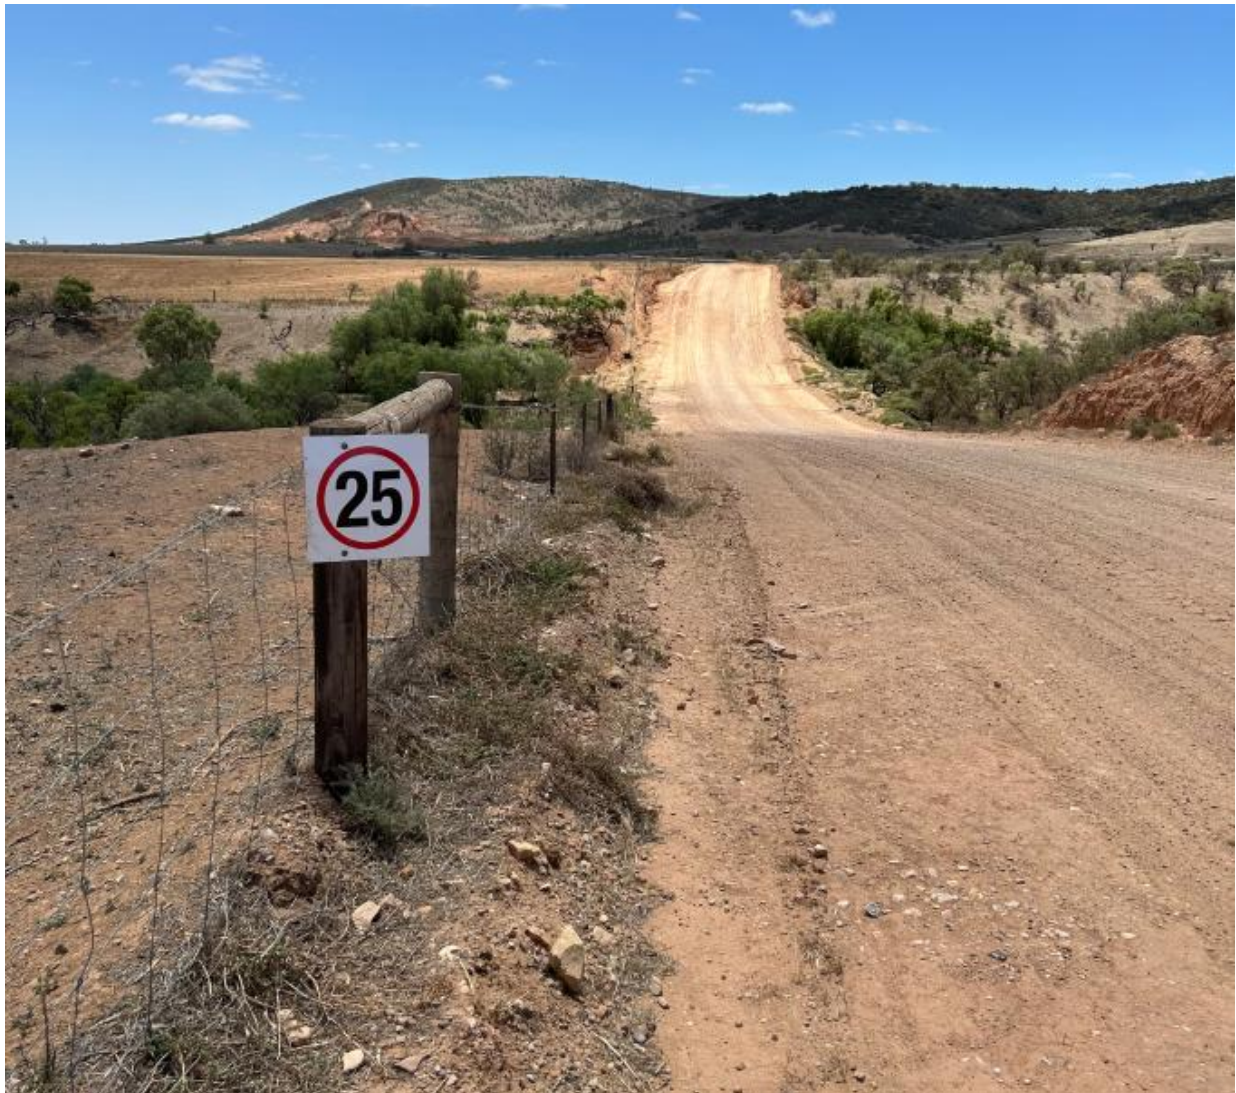
**Photo 6 – Traffic Signage**

A speed limit of 25 km p/h is signed on the access road from Collaby Hill Road turn off into the operational area. Refer to **Photo 6 – Traffic Signage**. This area is demonstrated in **Drawing No. 2449.DRG.023 – Traffic Route Map**.

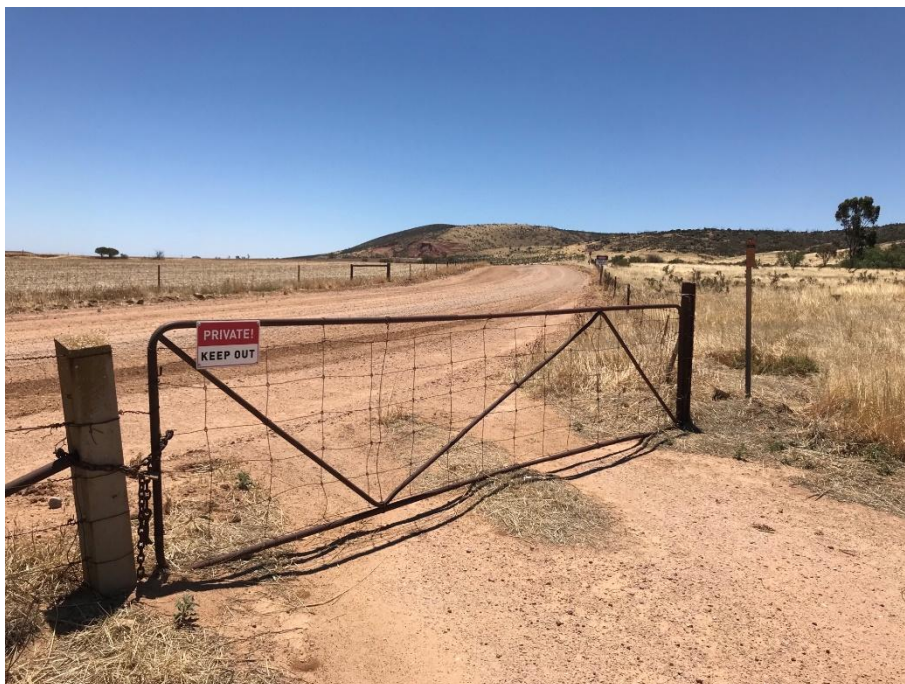
**Photo 7 – Site access road gate on Collaby Hill Rd**

Fences are located around the majority of Site’s operational western perimeter along access roads and at Site entry / exits are established with standard stock fencing and gates that are lockable, as shown in the below images (refer to **Photo 7 – Site access road gate onto Collaby Hill Rd** and **Photo 8 – Site access road fencing**). Additional fencing exists within the greater PM property boundaries maintained by those landowners.

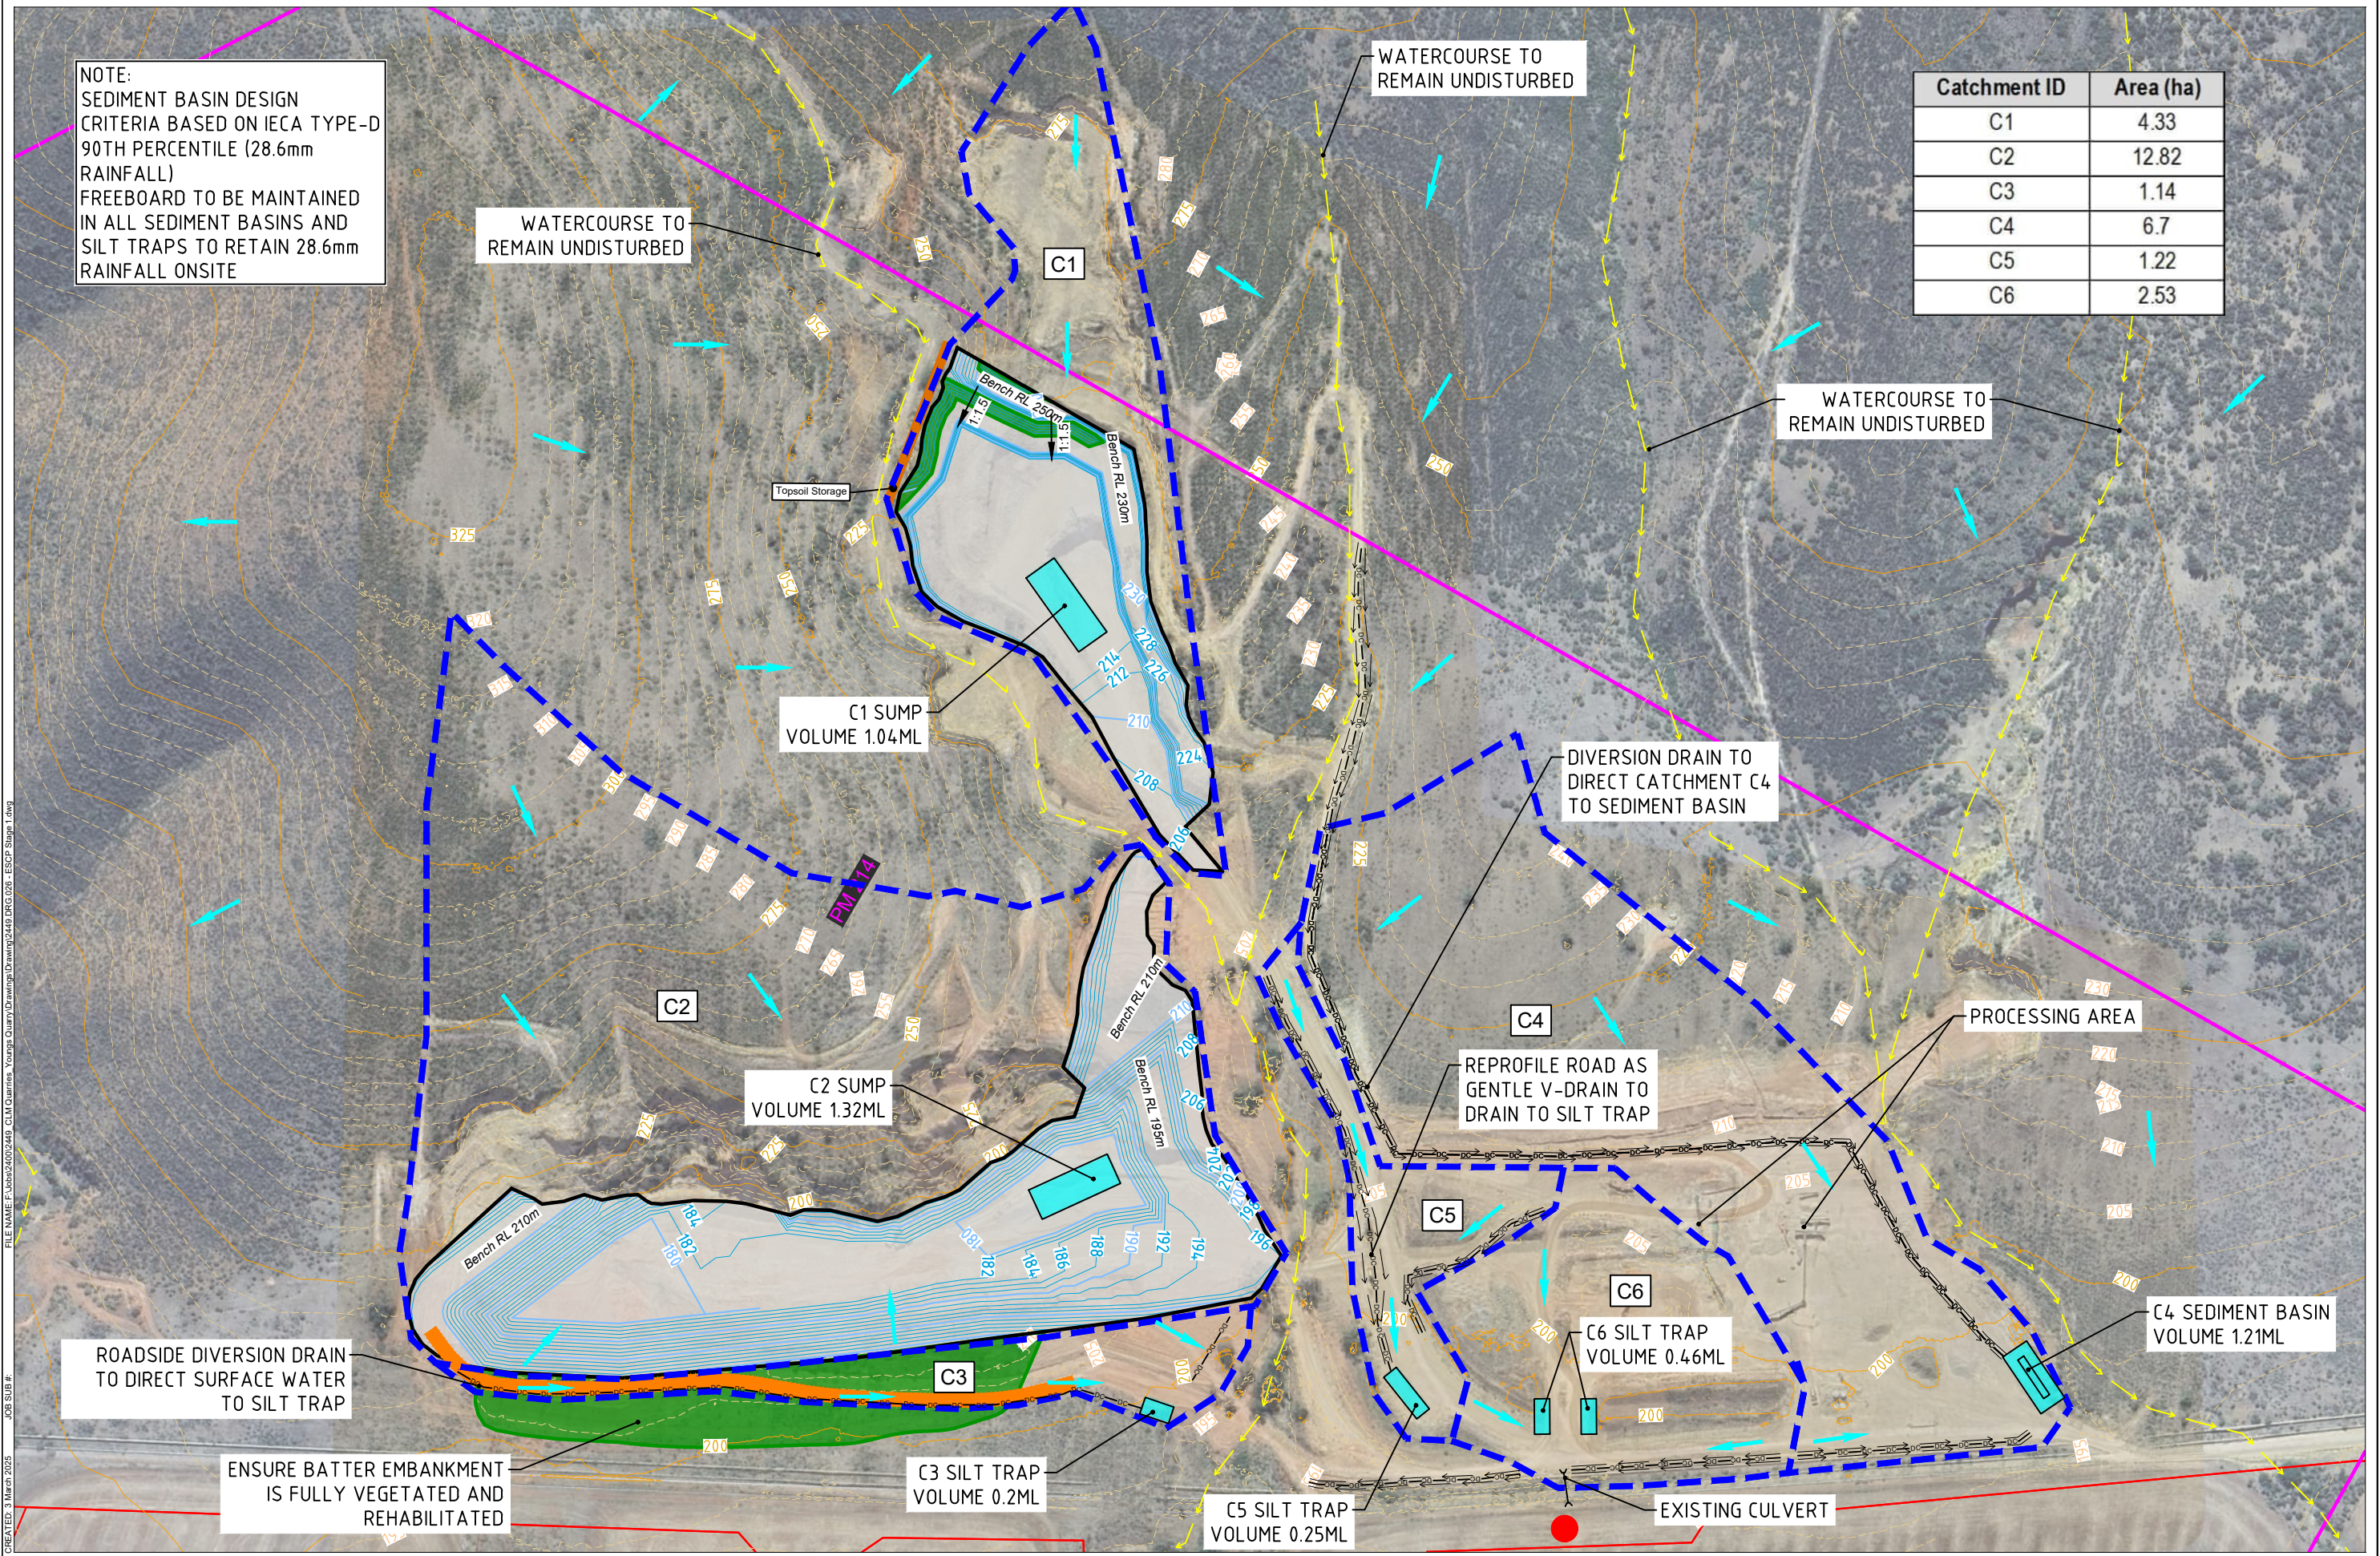
| Catchment ID | Area (ha) |
| C1 | 4.33 |

**Drawing No. 2449.DRG.027AR1 – Erosion and Sediment Control Plan – Stage 1** and **Drawing No. 2449.DRG.027BR1 – Erosion and Sediment Control Plan – Stage 2** identifying six (6) catchment areas within the operational area of the PM, the mapped watercourses that remain undisturbed and the proposed combination of sediment basins, silt traps, diversion drains and reprofiled roads to direct surface water to sediment basins. The catchment areas have been based on topographic conditions in relation to the different operational areas.

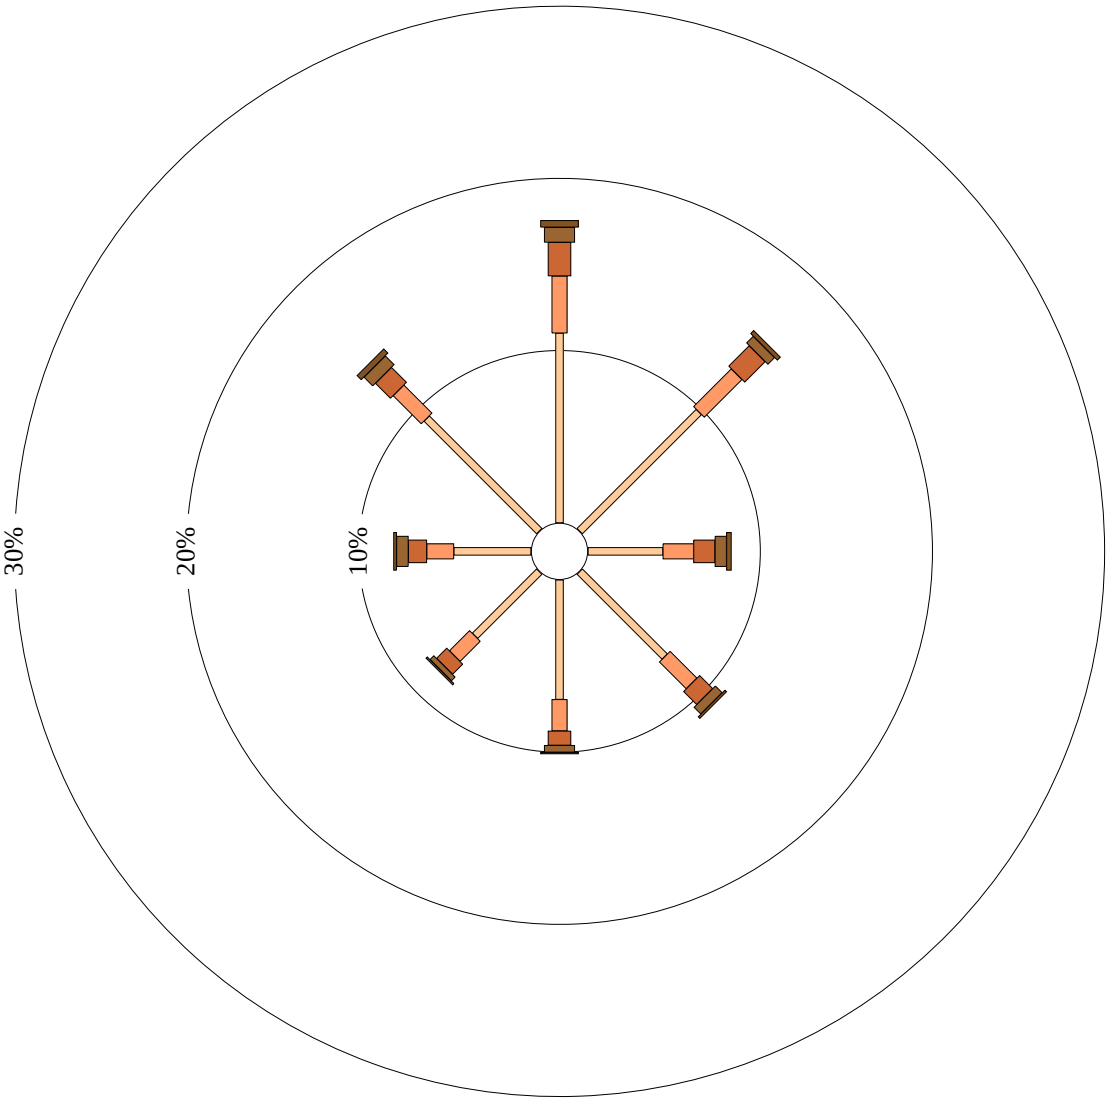
Rose of Wind direction versus Wind speed in km/h (01 Jan 1957 to 29 Oct 1976)

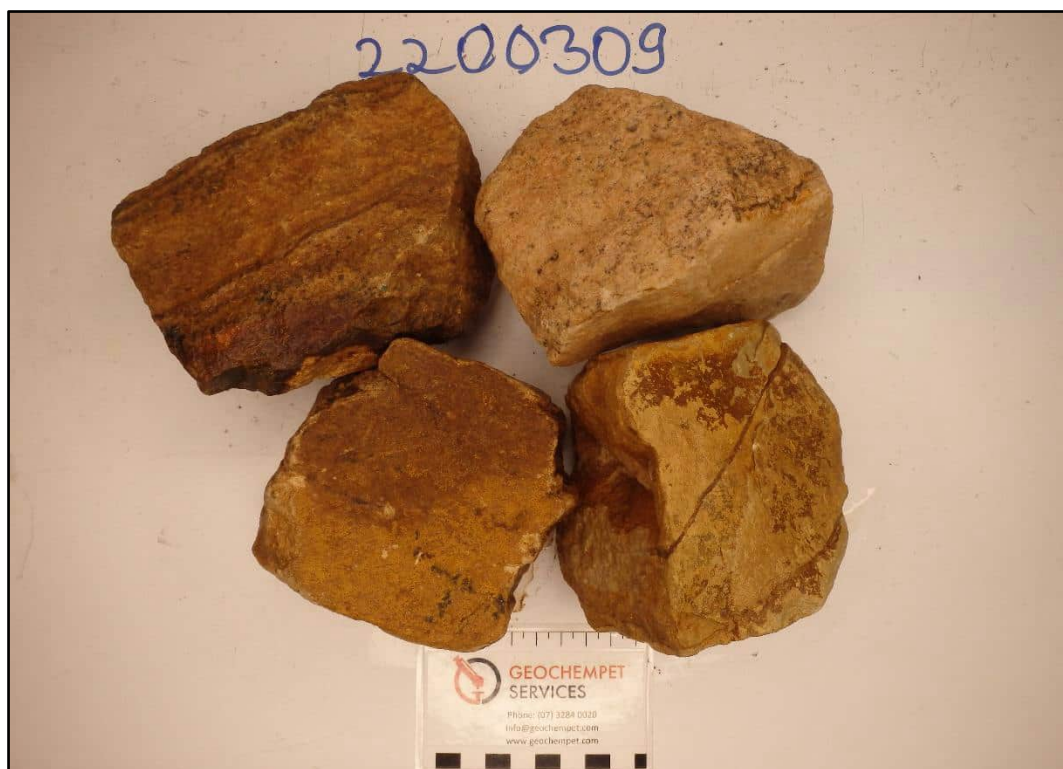
The sample consisted of four hand specimens of moderately weathered, finely bedded, light brown, fine-grained sandstone. The rock can be lightly scratched with a steel tool.

**Figure 1:** Image of supplied rock samples.

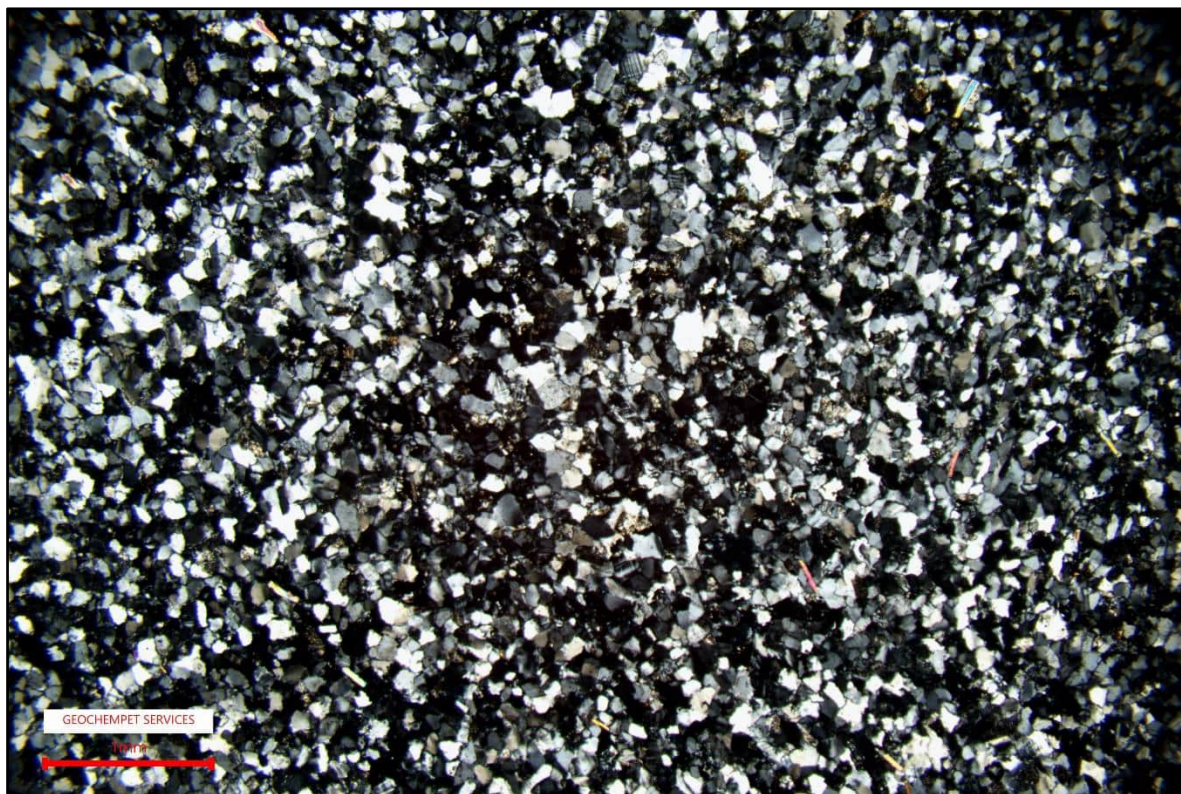
**Figure 1:** Microscopic image of supplied rock spall sample submitted for petrographic analysis, taken at low magnification with transmitted cross polarised light. Image shows the sandstone is dominated by quartz and feldspar grains and a few acid volcanic/tuffaceous clasts in the hematite/goethite matrix.

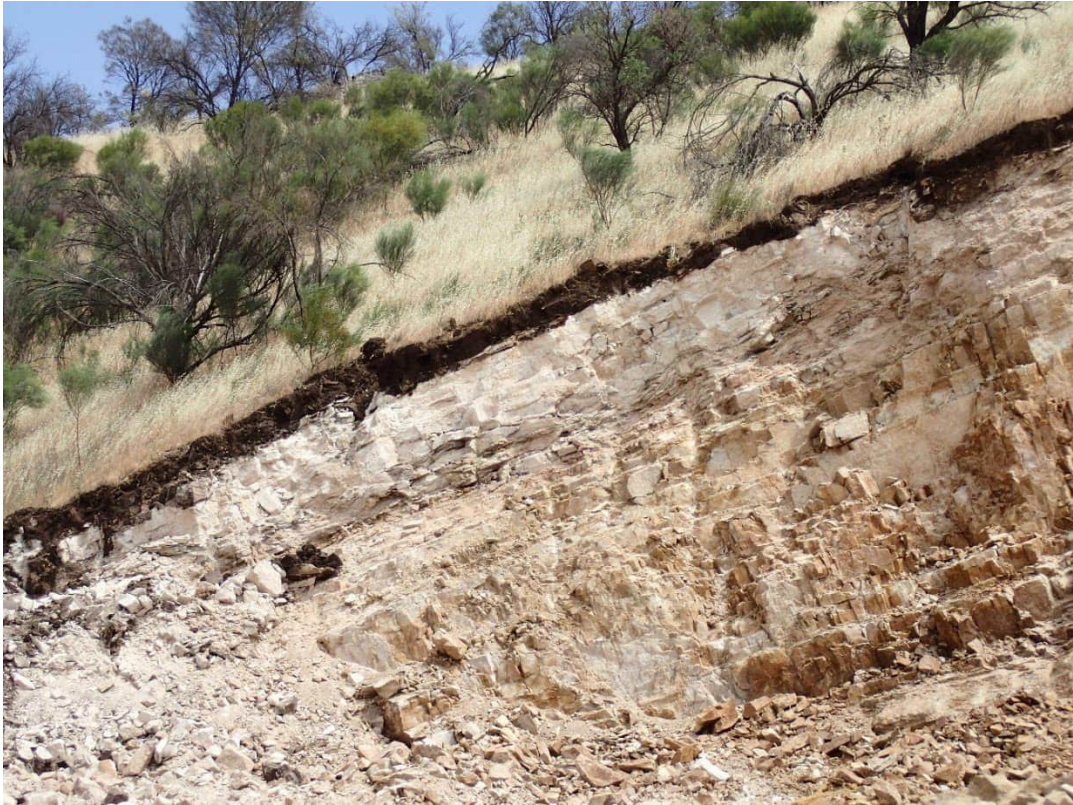
Figure 1: Image displaying the tabular to prismatic blocks of the dolomite rock mass.

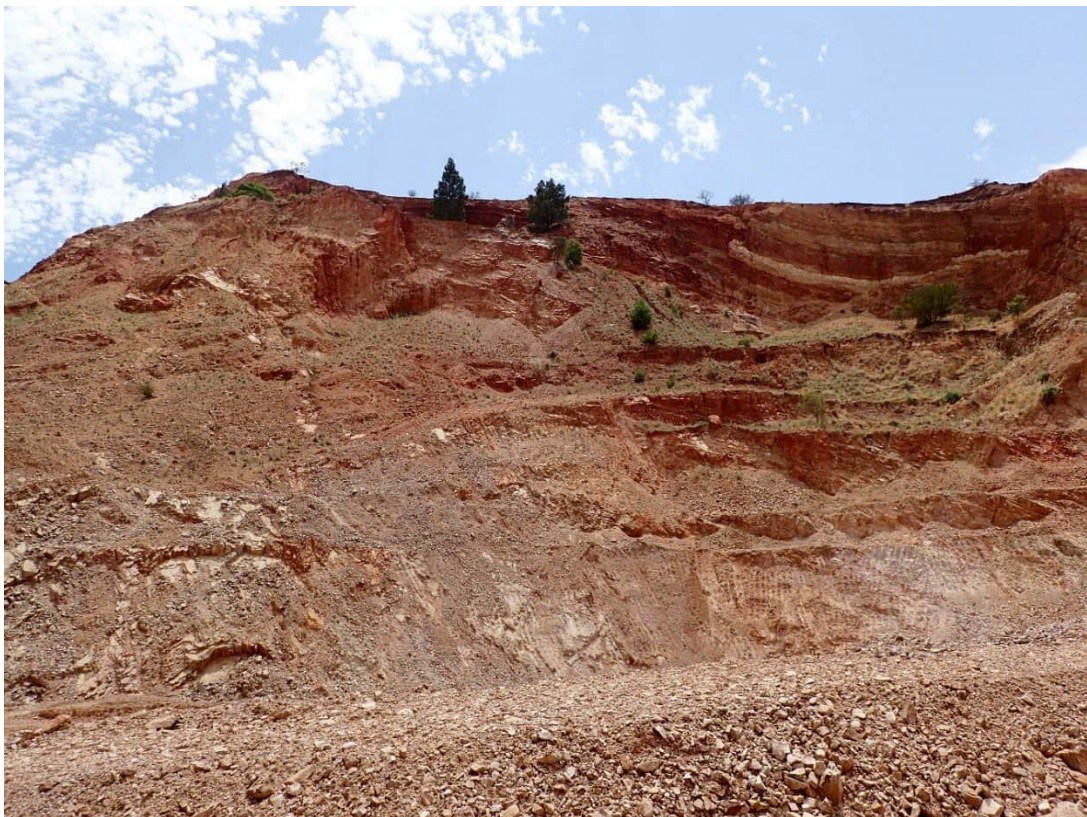
Figure 2: Image displaying the fold structures in the historical highwall workings.

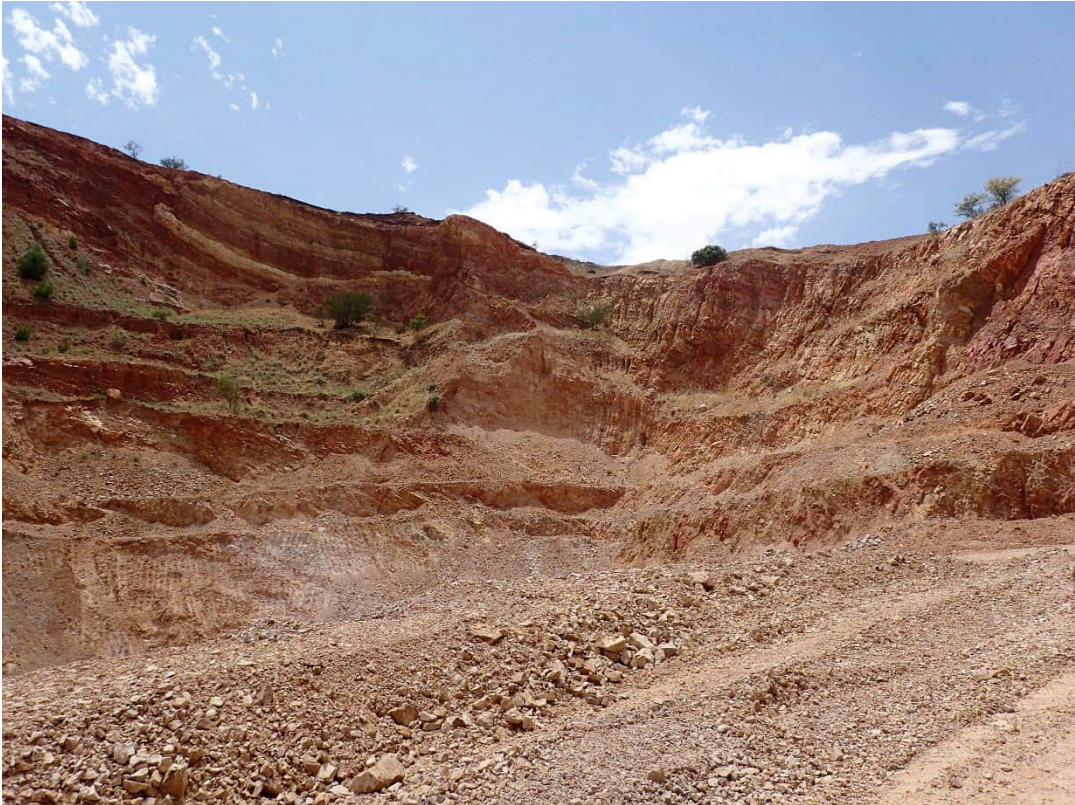
Figure 3: Image displaying the fold structures in the historical highwall workings.

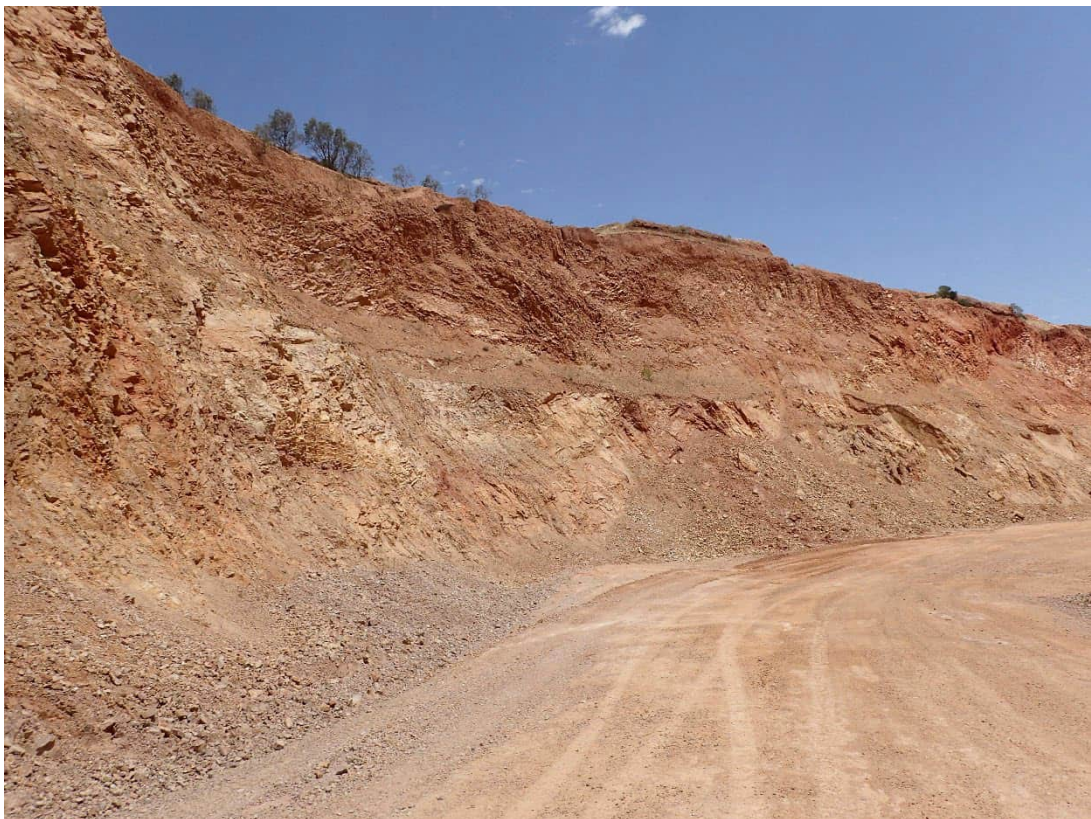
Figure 4: Image displaying the jointed and broken nature of the highwall rock mass.

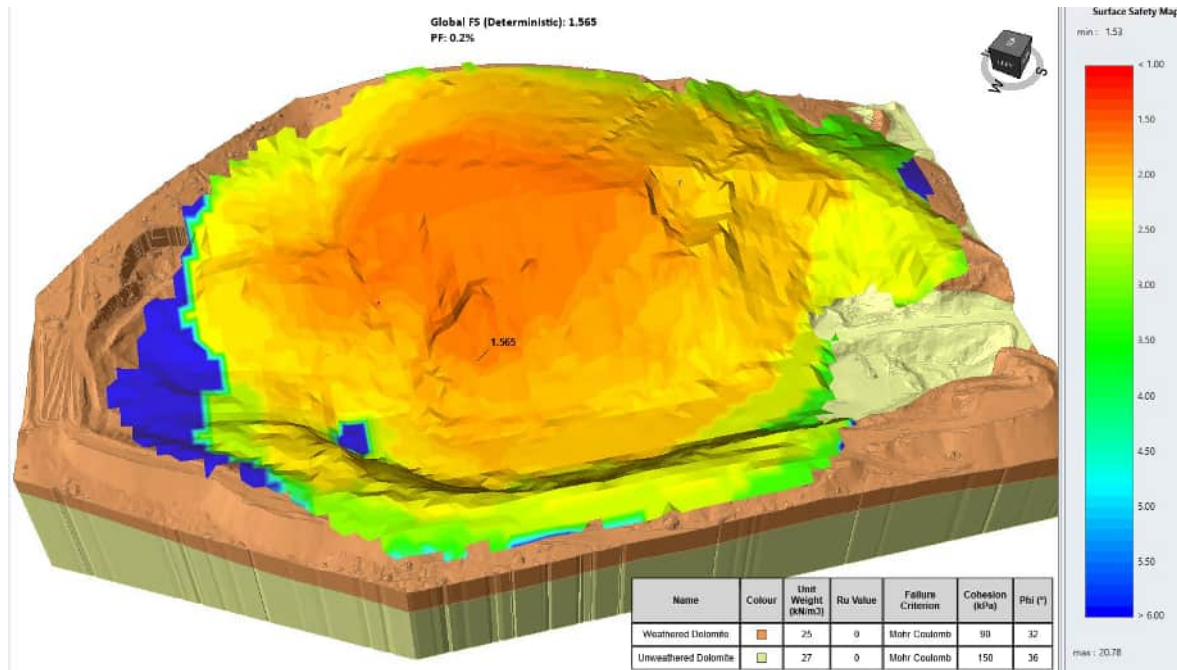
Figure 7: Slide 3 results for the highwall area displaying spatial variation in FOS. The highwall exhibits a FOS of 1.565 and a POF of 0.2% for the current site and highwall conditions.

In regard to the FOS and POF acceptance criteria outlined in the preceding section, the limit equilibrium analysis results for Youngs Quarry somewhat meet the established minimum acceptance criteria for open pit mining as detailed by Read and Stacey in "Guidelines for Open Pit Slope Design" (2009); however, FOS results over 1.5 are generally acceptable. It is essential to emphasise that this analysis strictly applies to the current pit and bench geometry, assumed groundwater conditions and material shear strength parameters. Future amendments to pit geometry, including changes in bench heights, widths, deviations in hydrogeological conditions, or results from material testing, necessitate a subsequent stability reassessment under the new conditions.

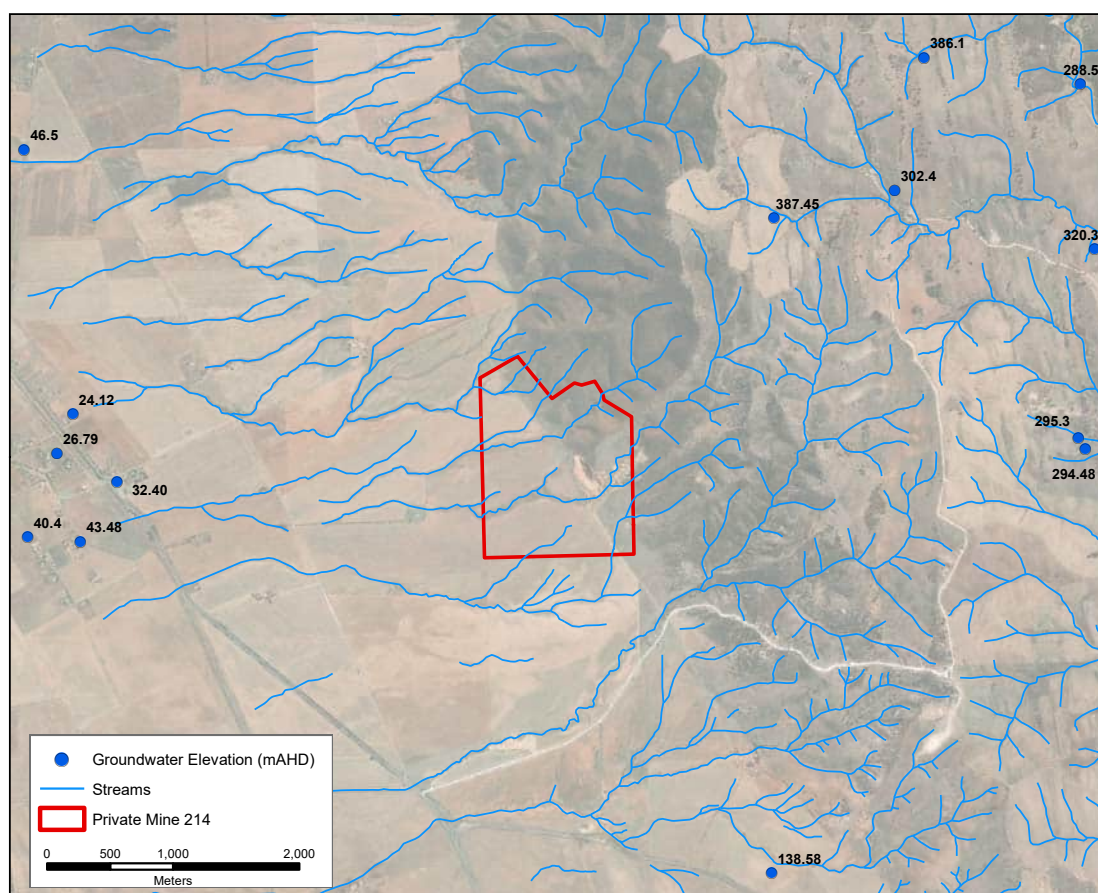
**Figure 5. Groundwater Elevations at 3<sup>rd</sup> party wells, referenced to mAHD.**

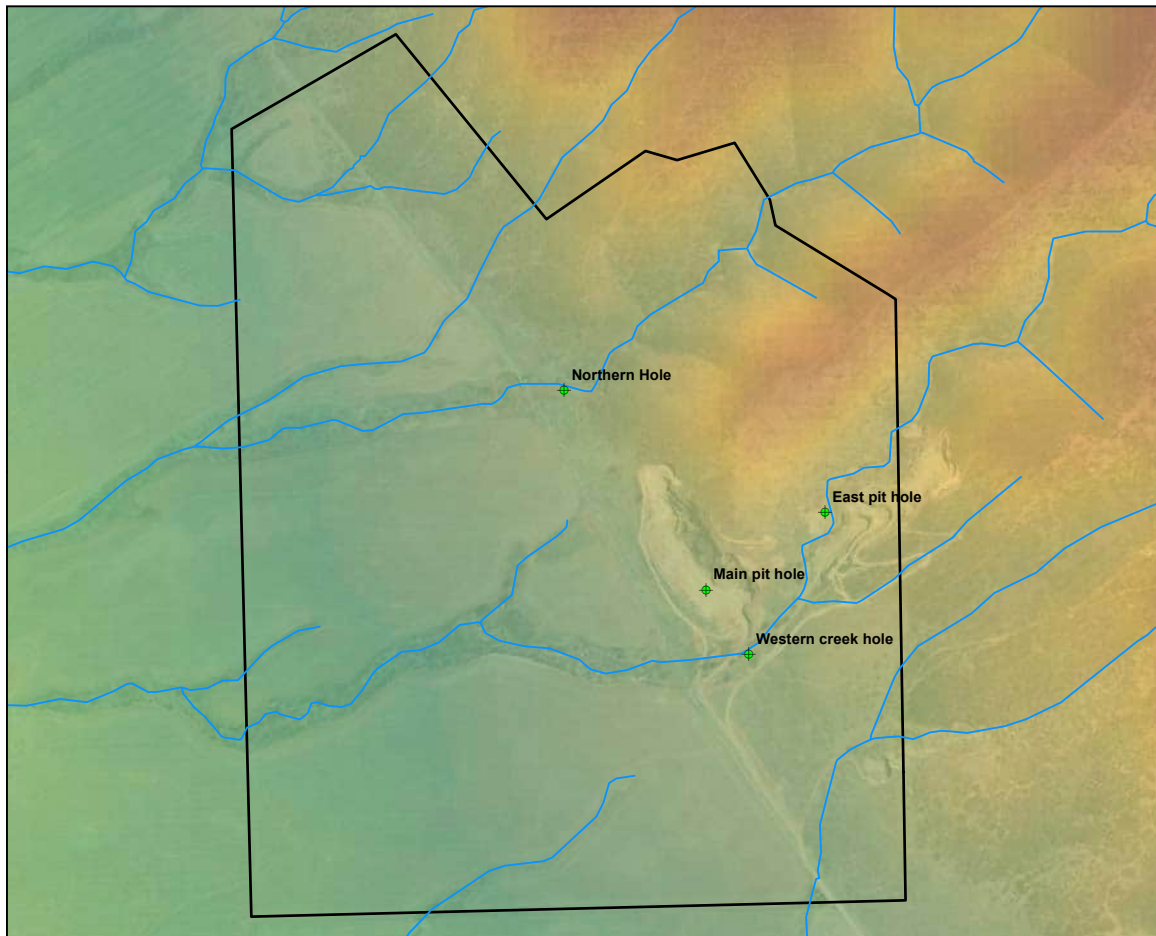
**Figure 6. Locations of Shallow Percussion Drillholes, April 2021.**

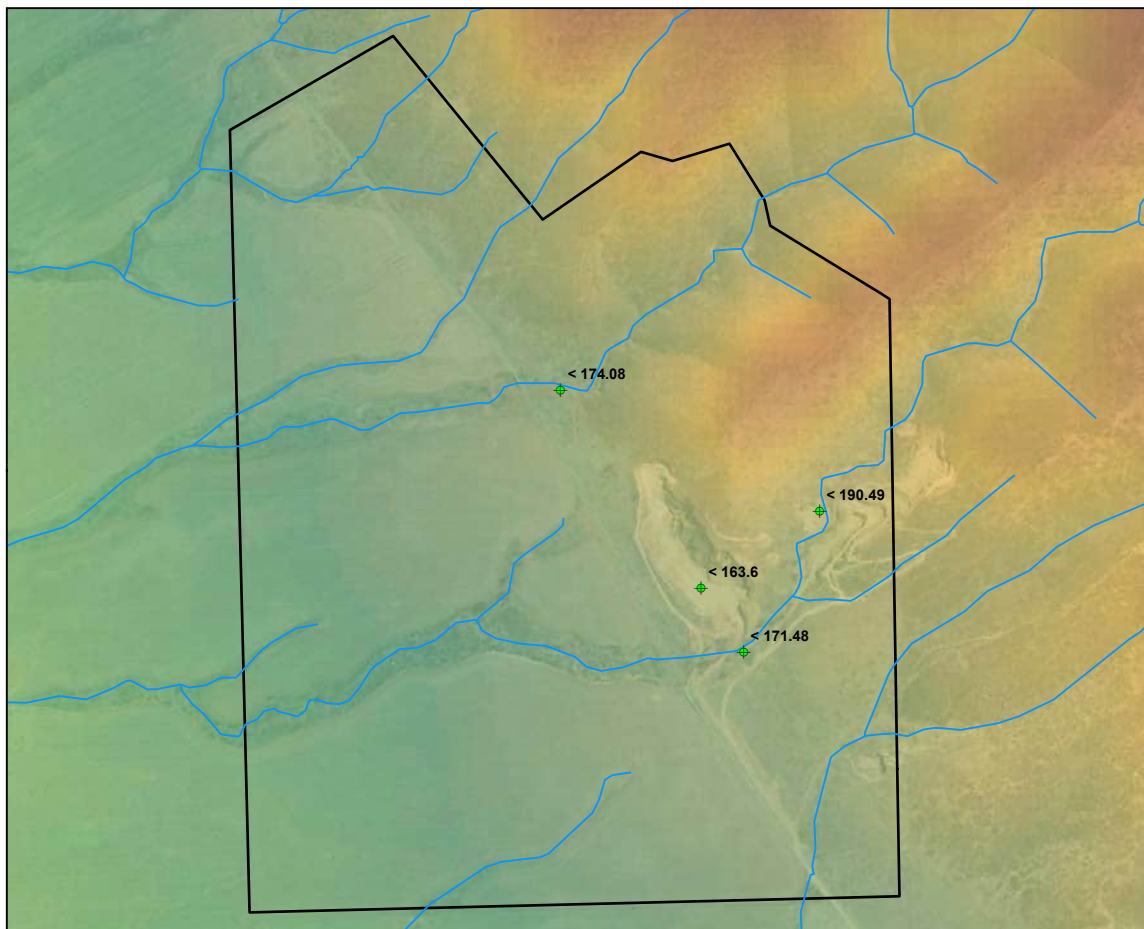
**Figure 7. Groundwater elevation (mAHD) at percussion drillholes. NOTE: all wells were dry and levels represent base of the drillhole.**
