YOUNGS QUARRY (PM 214)

# Mine Operations Plan

**Prepared for:** C.L. Land Management Pty Ltd

**File Reference:** 2449.610.001V2

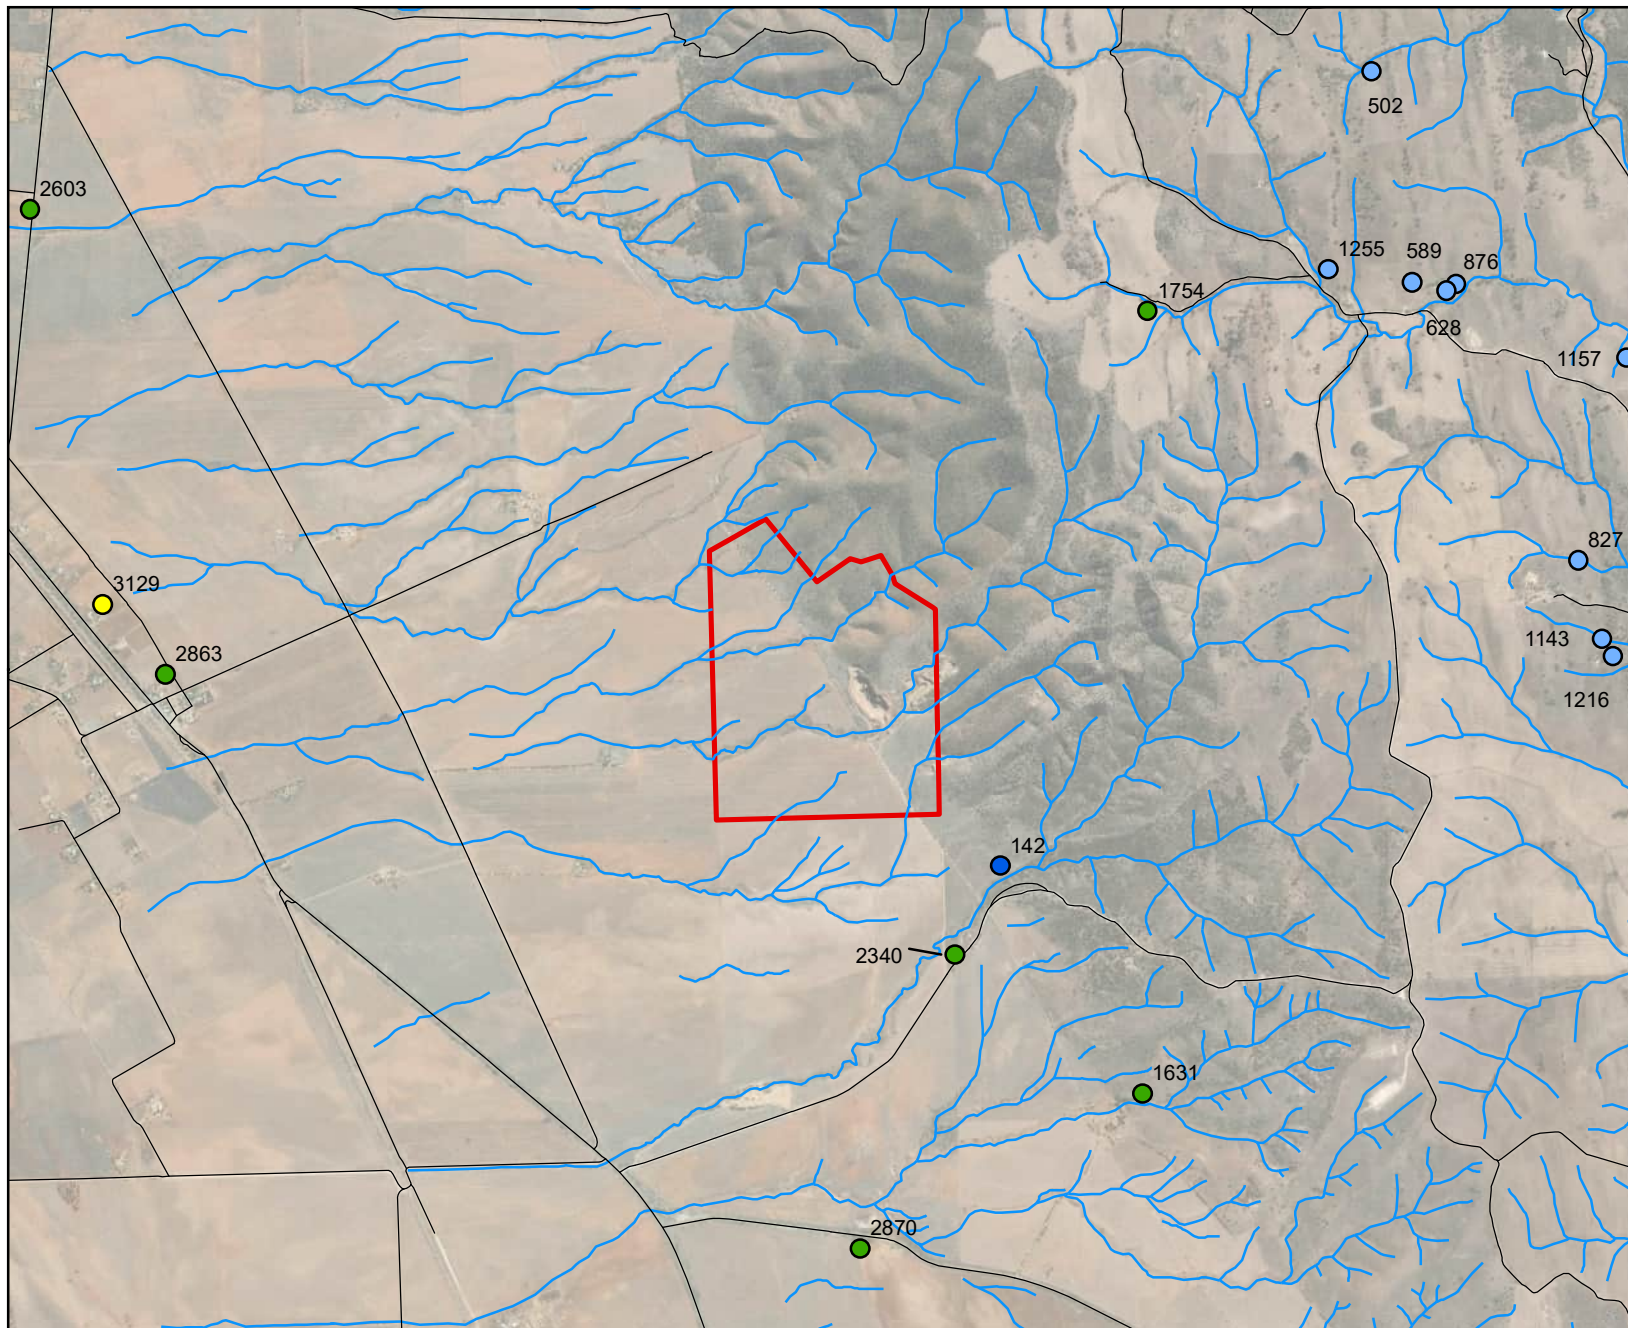
**Figure 8.**

Figure 8 displays yield data at nearby wells. Yields are reported less than 2 L/s.

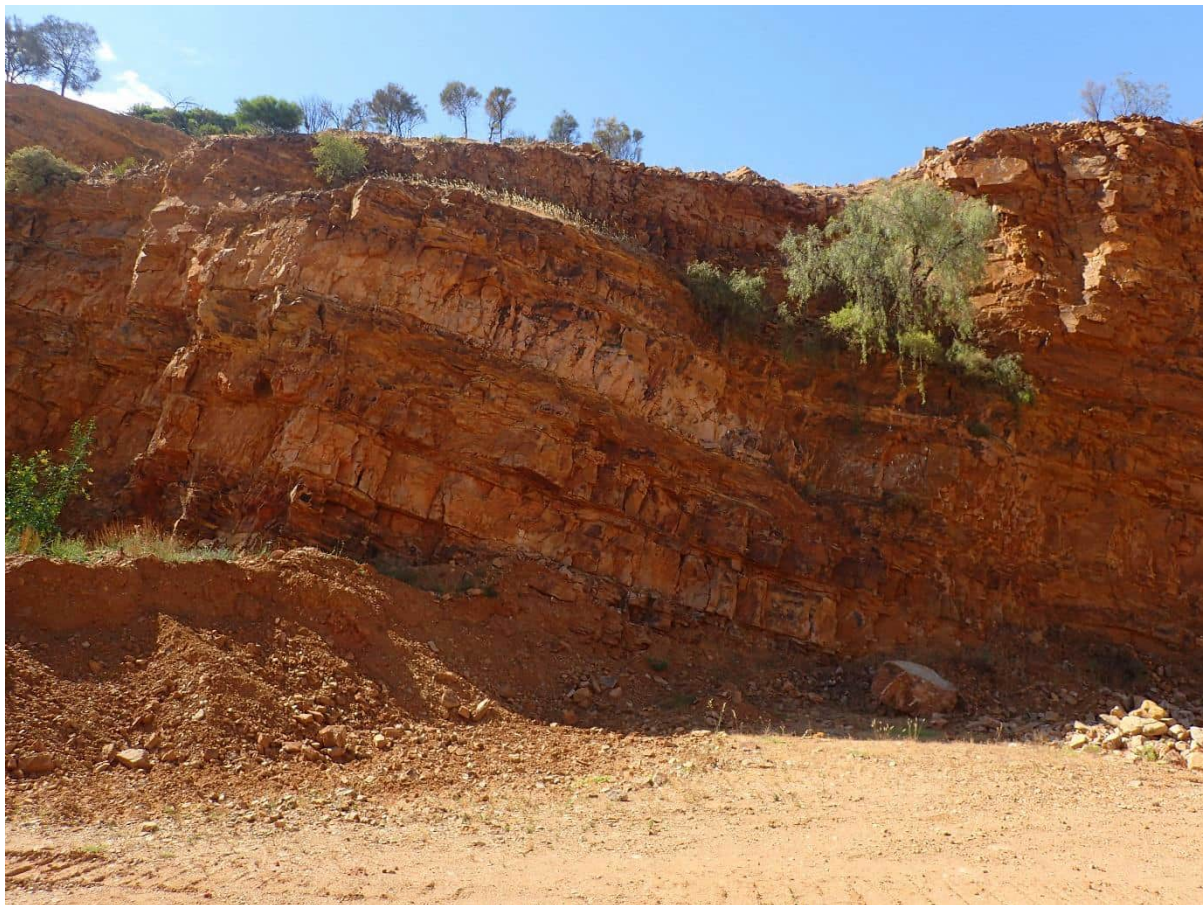
**Eastern Dolomitic Pit looking east – Pit floor is at relative level of 205 mAHD, 8 m below adjacent drainage line. Floor level measured by unmanned aerial vehicle survey (UAV) and accessed via Propeller (2020).**

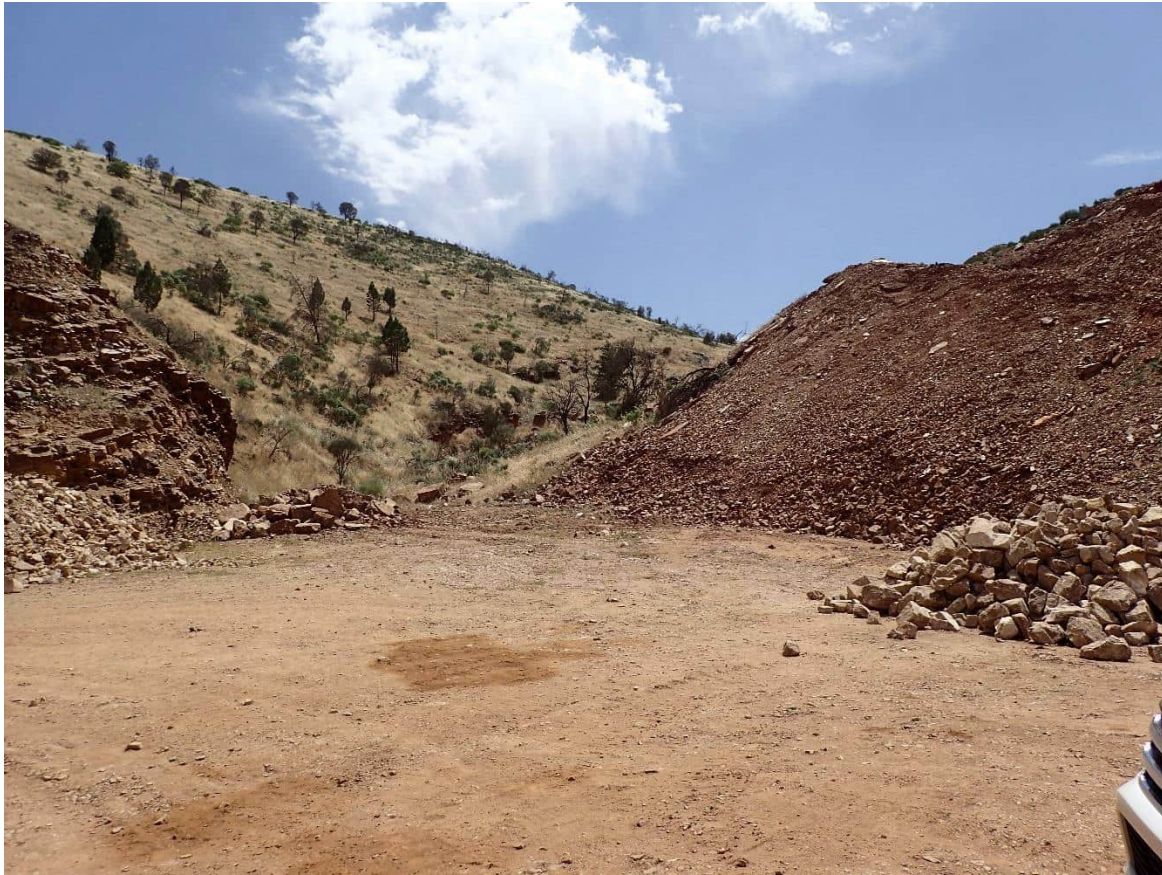
**Eastern Dolomitic Pit looking west – Pit floor is at relative level of 213 mAHD. Floor level measured by unmanned aerial vehicle survey (UAV) and accessed via Propeller (2020).**

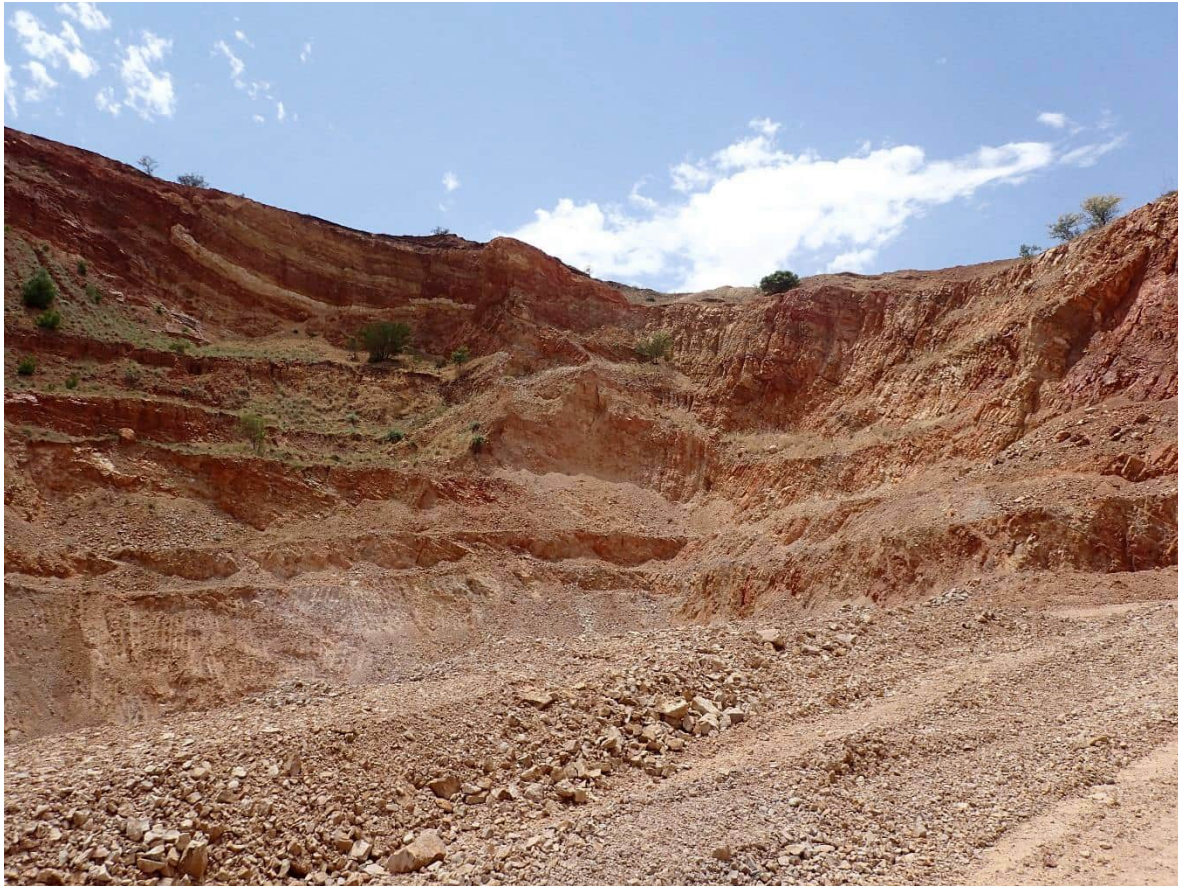
**Northern quartzite pit looking south. Minimum floor level is at 183.7 mAHD, 13 m below adjacent drainage line. Floor elevations measured by unmanned aerial vehicle survey (UAV) and accessed via Propeller (2020).**

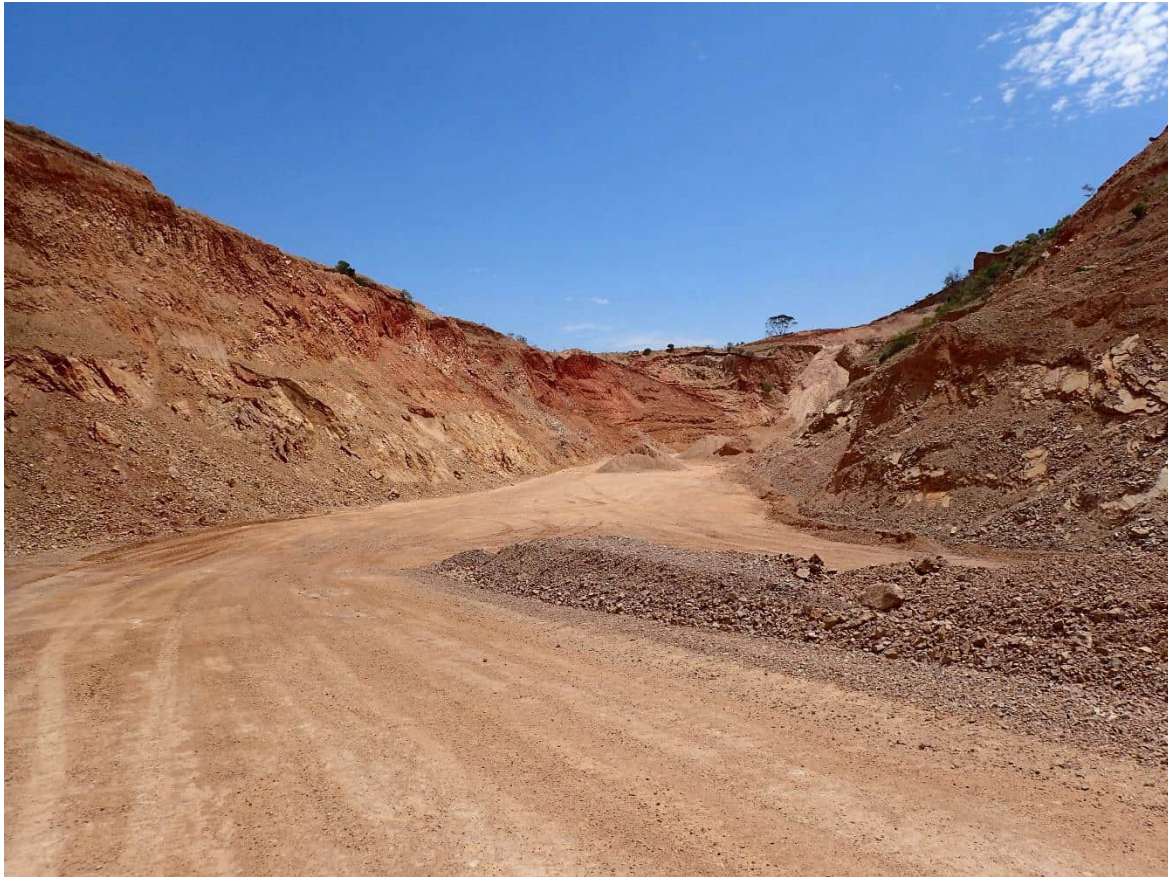
**Northern quartzite pit looking north. Minimum floor level is at 183.7 mAHD, 13 m below adjacent drainage line. Floor elevations measured by unmanned aerial vehicle survey (UAV) and accessed via Propeller (2020).**
