Gas space heating appliances with split/damaged heat exchangers

Gas Bulletin #24

Issued February 2023

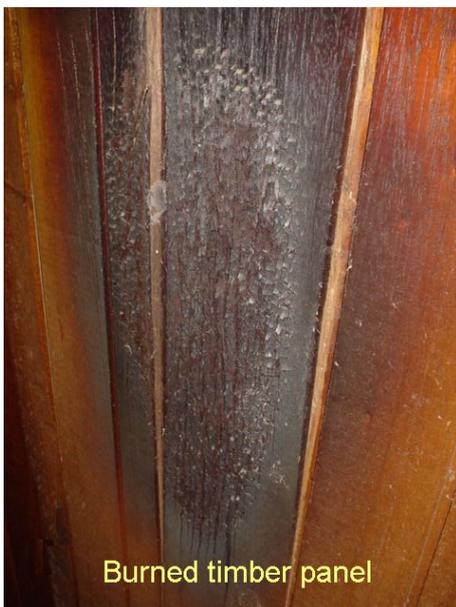
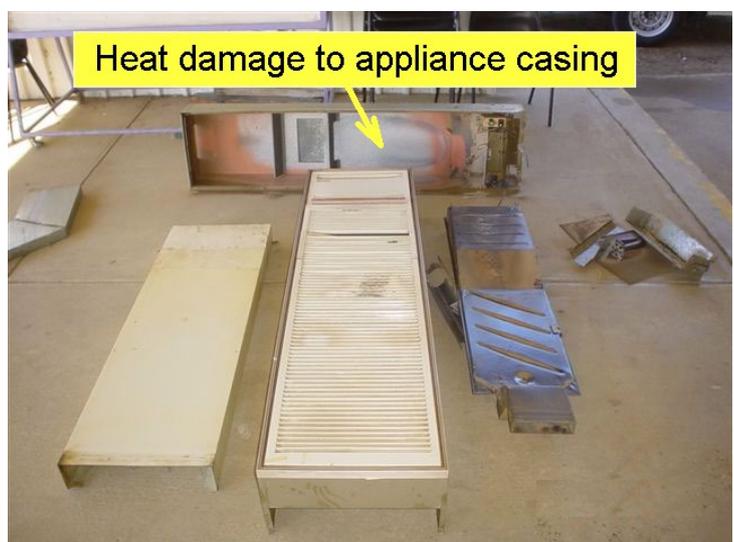
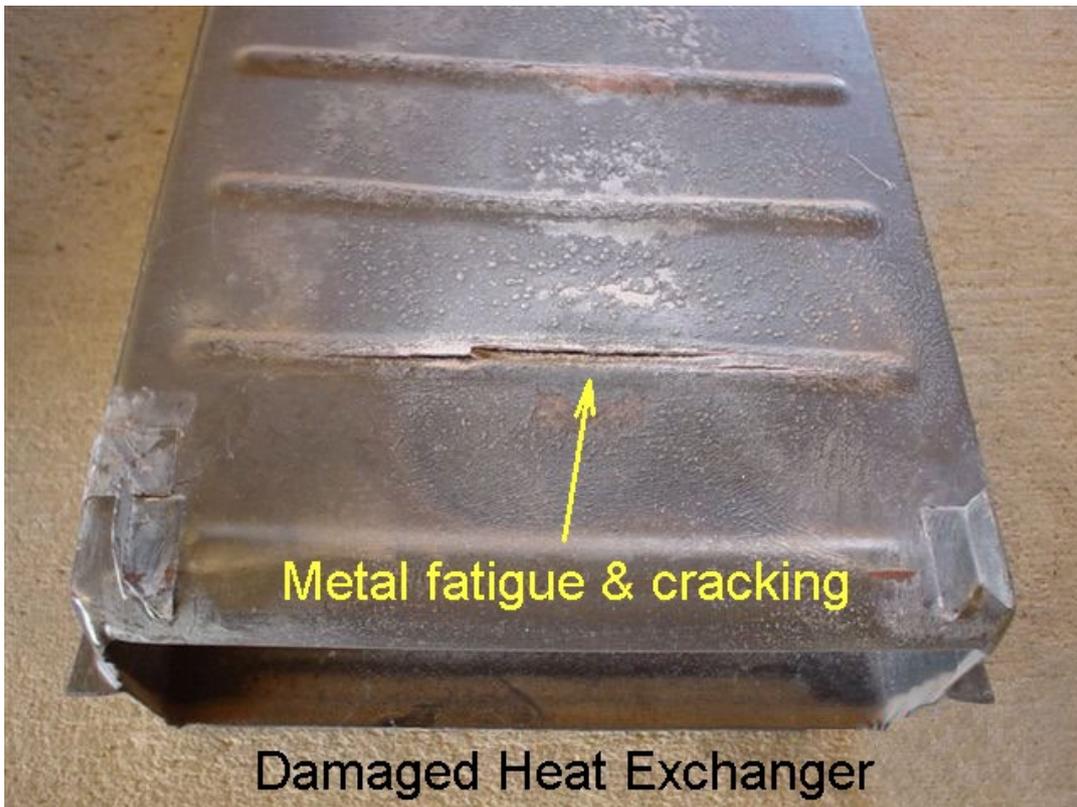
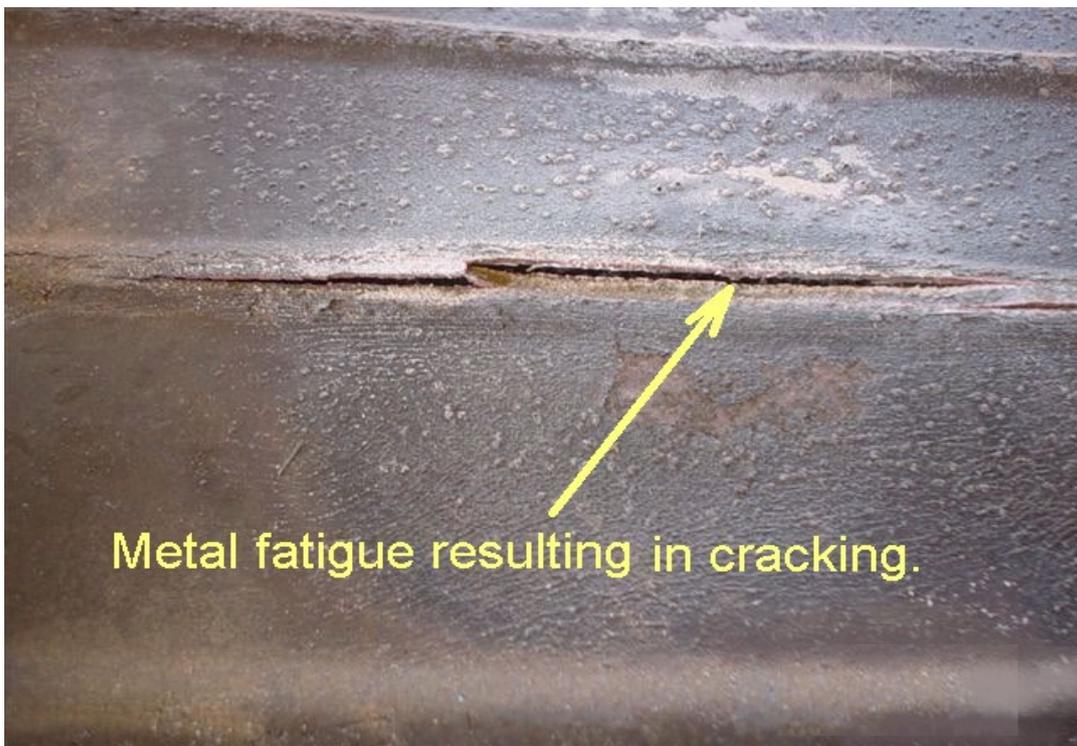
If you are working on an old gas space heating appliance and notice that it has developed a crack or split in the heat exchanger, then it should be condemned as unsafe, tagged and isolated

The split may be caused by the age of the appliance, metal fatigue or other factors and is generally not something that can be economically repaired.

Burnt flue gases that are normally vented safely via the heat exchanger to the flue, may spill into the room via the damaged heat exchanger. This is potentially dangerous to persons in the room, particularly if Carbon Monoxide is present in the flue gases.

The Gas Act requires the gas fitter bring this matter to the attention of the user and or the owner in the interest of their safety, isolate the appliance and place a safety (do not operate) tag on the appliance.

This tag must not be removed until the matter is rectified safely. You may be able to advise your customer on whether spare parts are available and the likely cost of repairs or if a replacement appliance is the best option.
