## **Program for Environment Protection and Rehabilitation**

Date:	19.10.2020
Name of Tenement Holder(s):	Southern Contracting Group PTY LTD
Name of Operation:	Sherlock Pit
Tenement No:	EML6516
Size (Ha):	24.64
Contact Details	<p>Name: Matthew Ramke</p> <p>Phone: 0437 597 365</p> <p>Email: matt@scg.net.au</p>

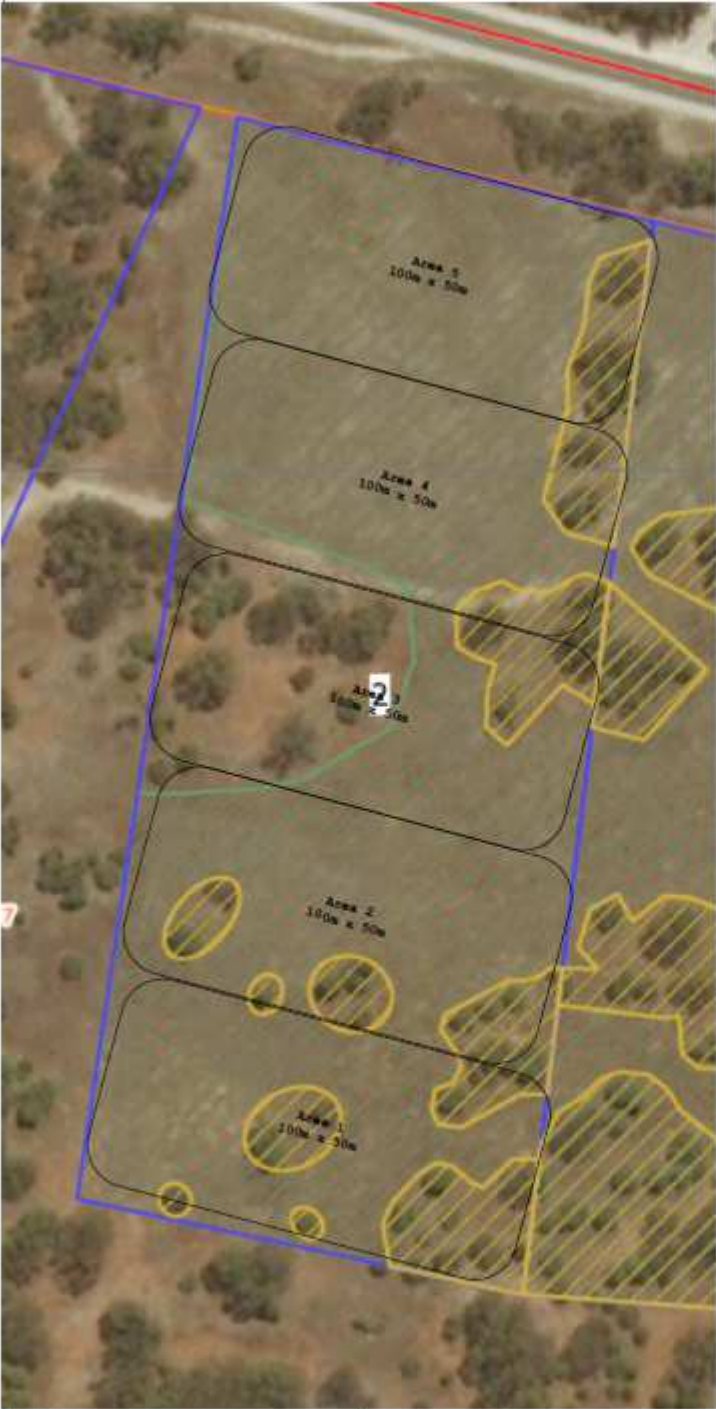
EML6516- Appendix 8

Stage 2 Area's

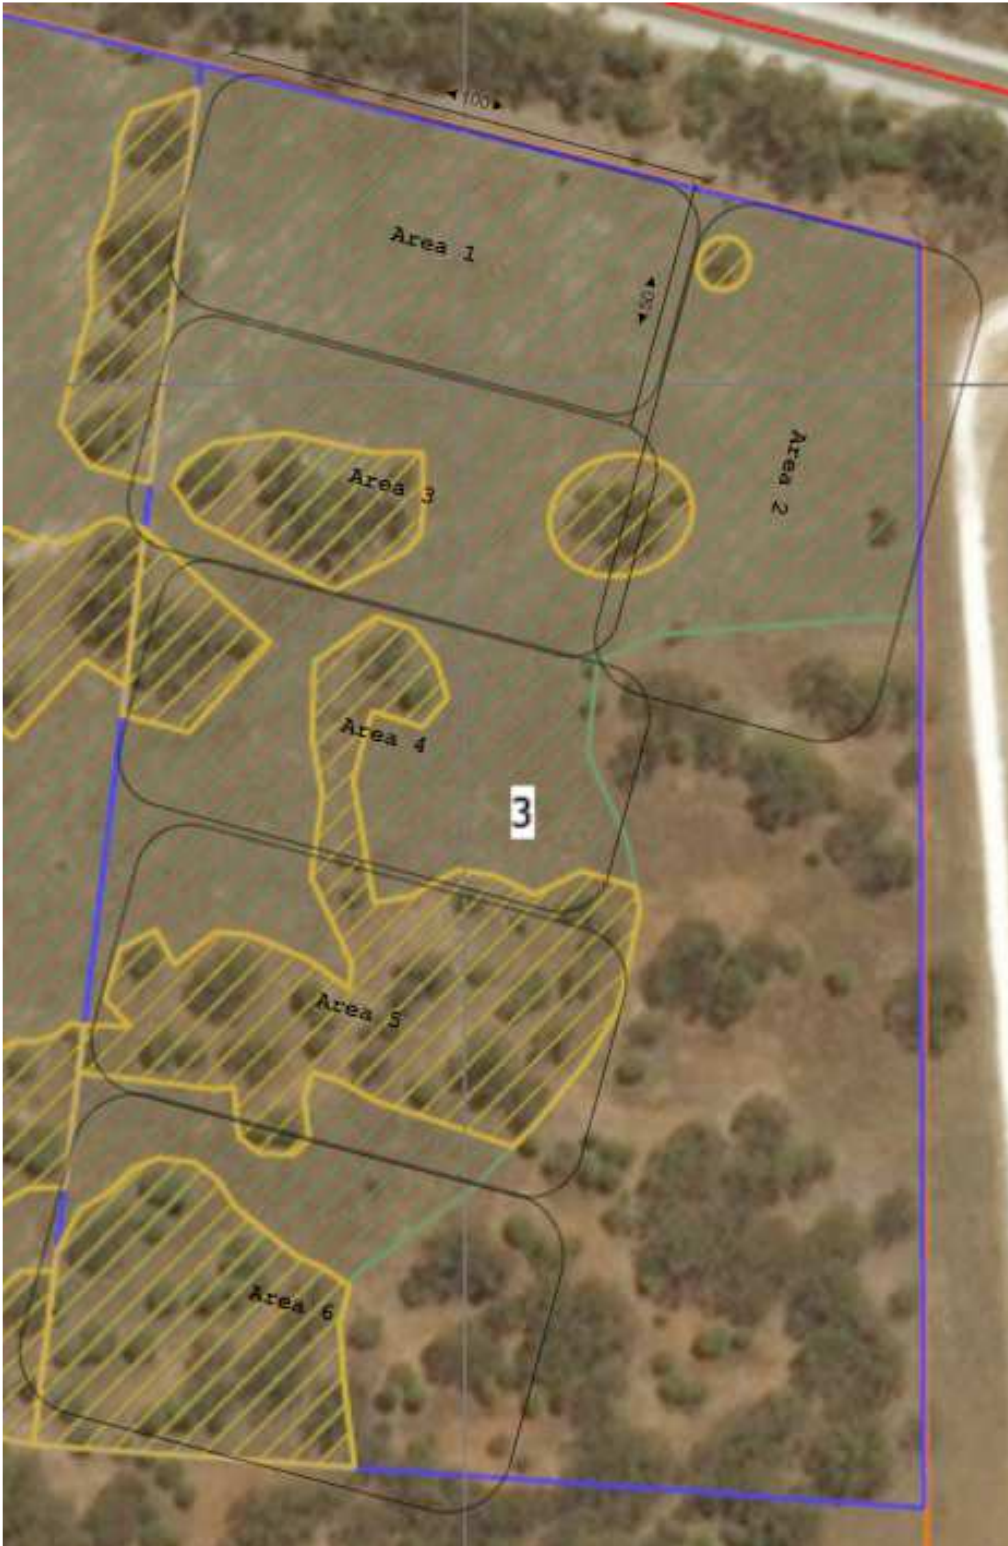
EML 6516- Appendix 9

Stage 3 Area

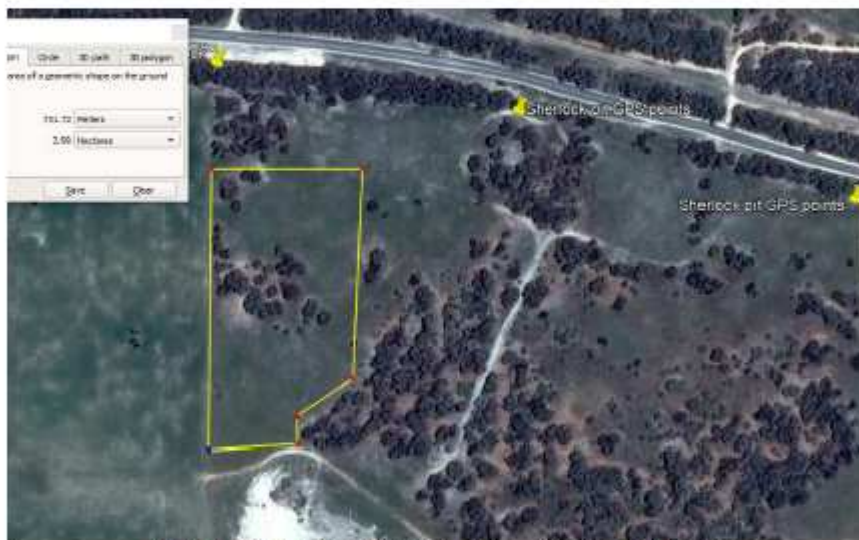
Figure 1. Original Stage 1 intended area of clearance in yellow

Southern Contracting Group originally intended to open a large section of the Site to the south west of the block for Stage 1 (see Figure 1 below), which would result in a larger clearance area for that stage, but has reduced the scale of works to potentially impact small groups and individual trees / shrubs in the more open areas, or at the very edge of the remnant patches assessed. Drawing No. 2463.DRG.002 – Staged Vegetation Clearance outlines the proposed clearance throughout all stages of quarry development which have been designed to restrict native vegetation clearance to the more degraded sections of the remnant vegetation.
