# Brukunga Mine Site

## Notes for Visitors

november 2012

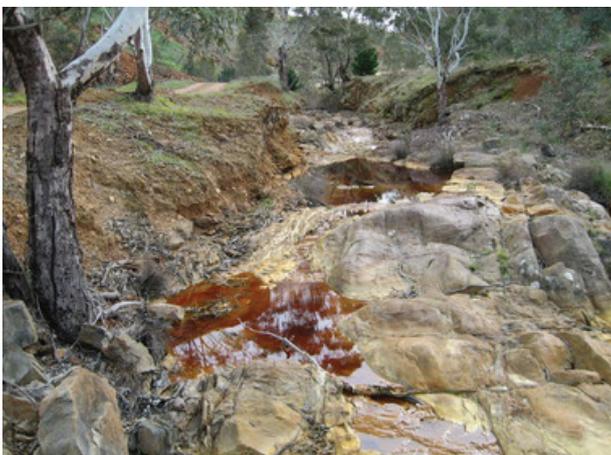
Acid and metalliferous drainage contaminating Dawesley Creek at Brukunga Mine

The main environmental concern at Brukunga is caused by the natural oxidation of pyrite minerals in air and water to form sulphuric acid, known as Acid and Metalliferous Drainage (AMD). The small amount of pyrite still remaining in the waste rock dumps and the tailings dam causes AMD to seep out at base of the dumps. The acid waters also dissolve small amounts of other metals from the minerals.

Dawesley Creek flows north to south through the Mine site and picks up contaminants, carrying them downstream into Mount Barker Creek, Bremer River and into Lake Alexandrina. Soon after the mine opened and up to a construction bypass of the creek in 2003 the water from the Mine was so contaminated with sulphate and heavy metals such as aluminium, iron, cadmium, and manganese. The water was unsuitable for livestock and irrigation use up to 55 km downstream of the Mine site.

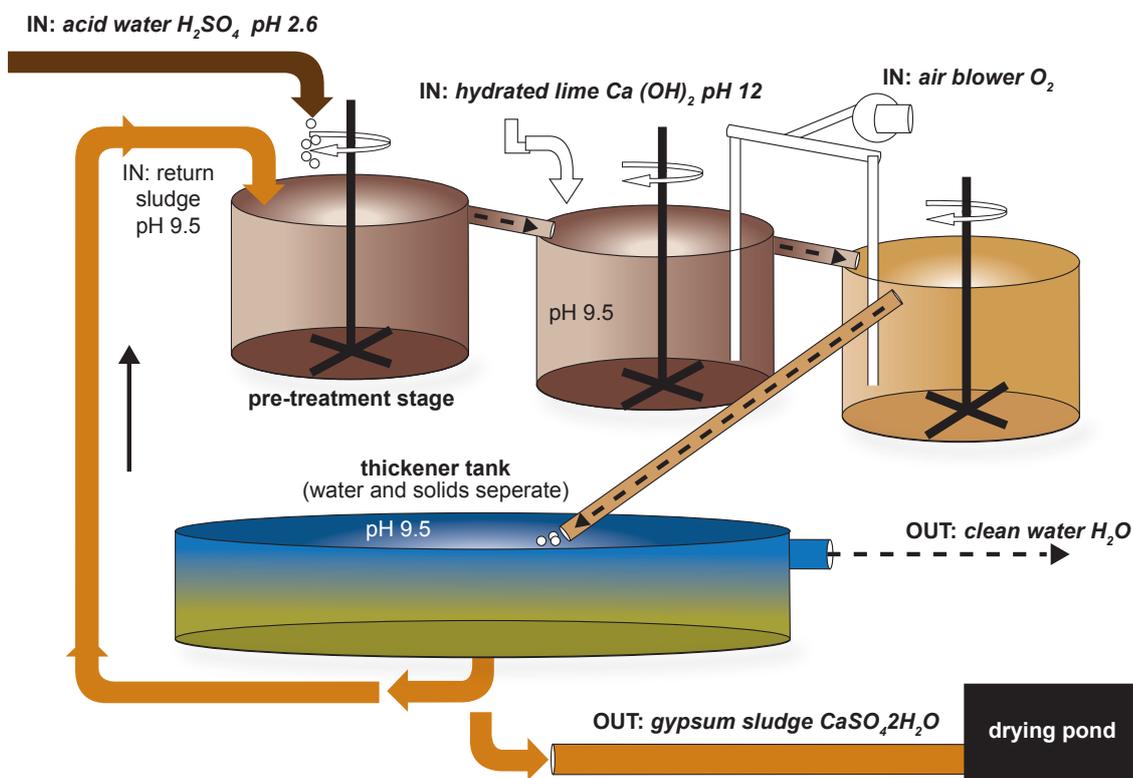
The neutralisation process occurs in a series of 3 mixing tanks, which provides sufficient retention time for completion of the chemical reactions.

The inputs to the plant are hydrated lime and carbide lime ( $\text{Ca}(\text{OH})_2$ ), at pH 12, dilute sulphuric acid waters ( $\text{H}_2\text{SO}_4$ ) at pH 2.3 and oxygen ( $\text{O}_2$ ) provided by air blowers to ensure the chemical reactions are complete before the mix leaves the plant. The outputs are gypsum precipitate ( $\text{CaSO}_4 \cdot 2\text{H}_2\text{O}$ ) and water ( $\text{H}_2\text{O}$ ), which are physically separated in the thickener (large dewatering tank). The precipitate sinks to the bottom and is drawn from underneath by variable speed hose-pumps. The water overflows into the trough around the top of the tank. The overflow water is clarified in a large concrete lined pond, providing time for residual particles to settle before the water is returned to the creek via an open channel. The plant process schematic is provided in the following diagram.

The process of lime neutralisation occurs in a series of three mixing tanks providing retention time for completion of the chemical reactions. In May 2005 a second parallel series of three larger tanks were installed to effectively double the treatment capacity of the plant.

The plant process is pH controlled. Dissolved heavy metals come out of solution over differing pH ranges. As the pH is raised in the plant the metals attach themselves to the gypsum particles. A variable-speed hose-pump is used to adjust the lime feed to maintain the pH in the thickener tank at pH 9 to 9.5 to ensure the removal of cadmium and manganese from solution.

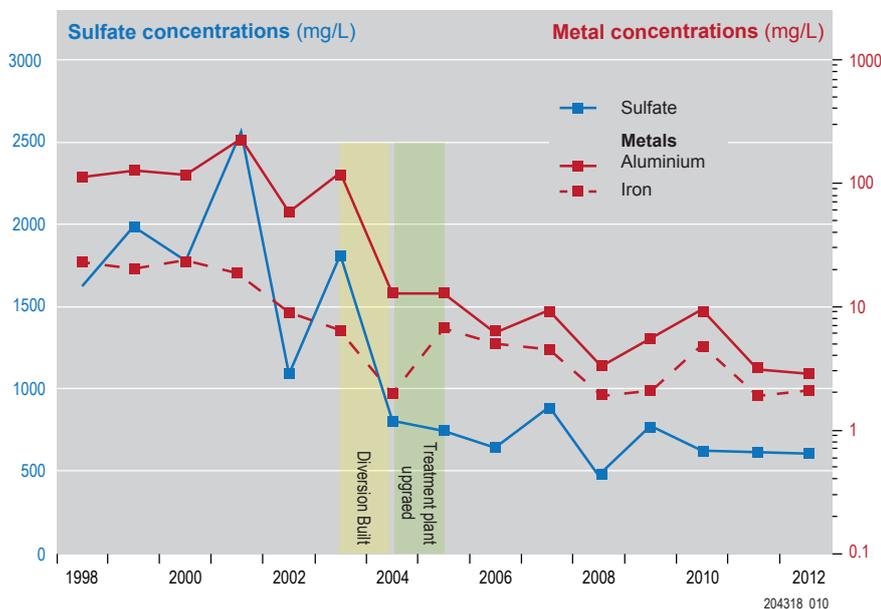
Concentrations of sulfate and metals downstream of Brukungu Mine. Water quality has improved since 2003 (as indicated by decreasing concentrations of sulfate and metals) following diversion of part of Dawesley Creek around the mine.

In 2001 after considering various studies the BMSRB recommended a \$26M program of new initiatives to the Minister and Government. The Government approved the program and Stage 1 - the diversion of Dawesley Creek past the Mine was successfully completed in June 2003. The drain isolates contaminated water at the Mine site. The 1.7 km diversion included 780 m of 1.5 m diameter pipes, 175 m plastic pipe and 750 m of drilled and blasted open channel. The isolated section of creek now provides a sink for the collection of acid seepage that previously evaded the system and was released into Dawesley Creek
