**GAS INCIDENT REPORT NO # 258**

DATE OF INVESTIGATION	5/12/2018
ADDRESS	Incident reported on 26/11/18. [REDACTED]
OWNER	[REDACTED]
CONTACT	[REDACTED] [REDACTED]
INSTALLATION/APPLIANCE DETAILS	Electrolux cooker Model GCLUXW-P
GAS SUPPLIER	Elgas
GAS TYPE	LPG
INSTALLER LICENSED	Unknown
INSTALLER NAME	Unknown
INSTALLER ADDRESS	Unknown
DATE OF INSTALLATION	Unknown
OVERPRESSURE PROTECTION REQUIRED?	Yes
COMPLIANCE WITH AUSTRALIAN STANDARDS?	Yes
TEST FOR SOUNDNESS	Gas Escape at appliance and service
OTHER APPLIANCE (S)	Heatlie BBQ Wonder Fire Type 2
APPLIANCE PURCHASED FROM	Unknown

## **DESCRIPTION OF INCIDENT**

## **INVESTIGATION SUMMARY**

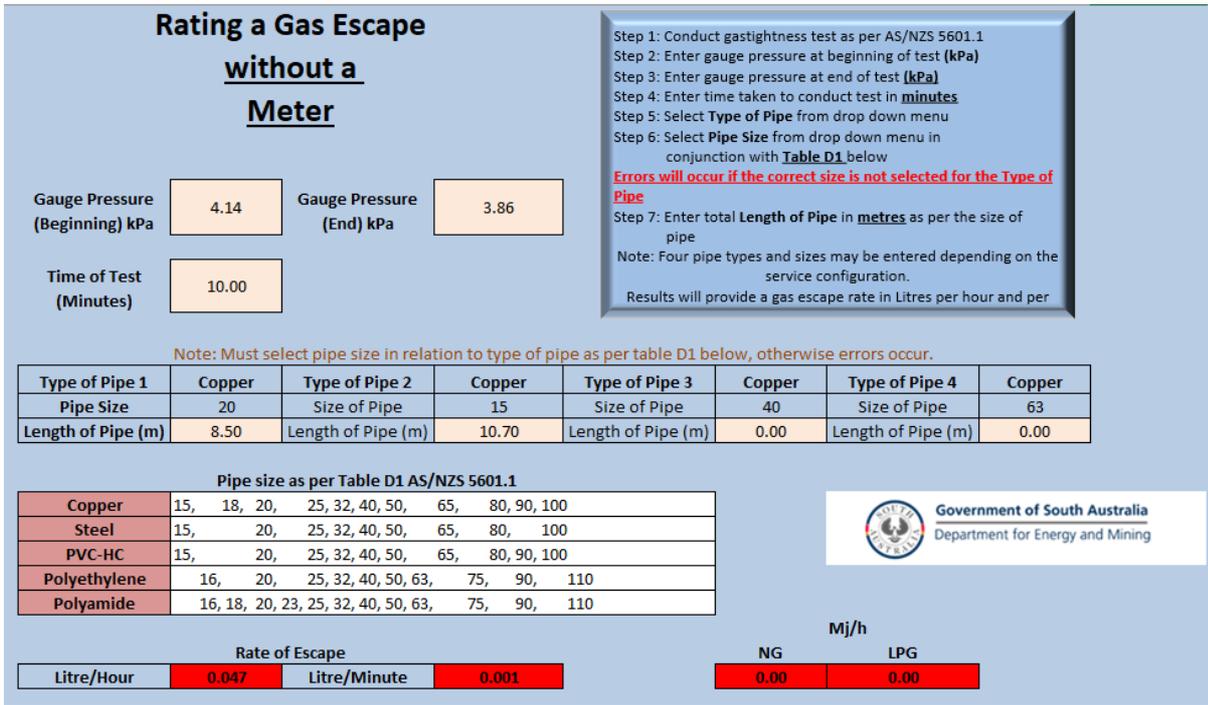
- Using test tee and water manometer, pressurised the whole installation with air to 4.14 kPa. Performed test for 10 minutes, pressure dropped to 3.86 kPa

- Using spreadsheet, calculated an estimate pipe volume and knowing the pressure drop over time, it is estimated the drop equalled 0.047 ltr/hr (appendix A, figure 1)

**Figure 1 Pressure test of complete service**

A very small gas escape of 0.047 lt/hr was identified through manometer pressure testing the entire installation. The rate of this escape measured was insufficient to cause an incident.

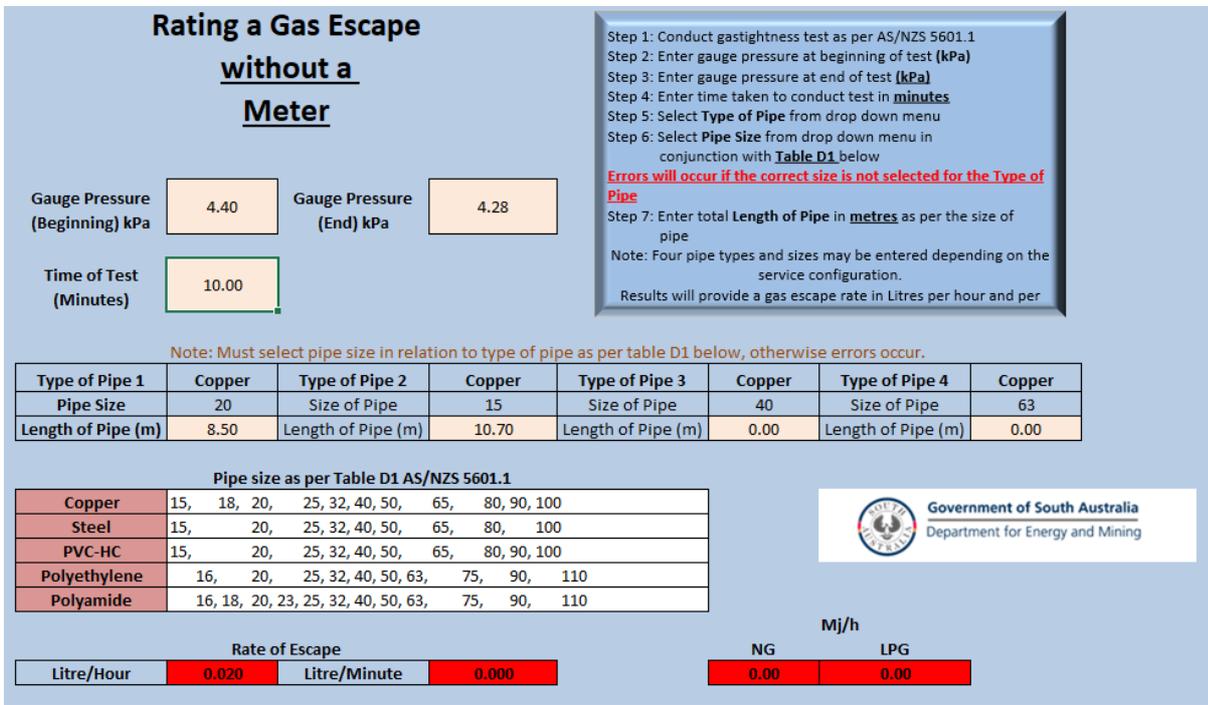
- Duplicated the pressure test with the cooker isolation valve turned off at 4.4 kPa, 10minutes, pressure dropped to 4.28 kPa
    - Using the same estimate pipe volume and knowing the pressure drop over time, it is estimated the drop equalled 0.02 ltr/hr (appendix A, figure 2)

**Figure 2 Pressure test with cooker isolated**

- Therefore, the gas escape at the cooker =  $0.047 - 0.02 = 0.027$  ltr/hr
  - Turned gas supply on and attempted to locate the small gas leak at the cooker with soapy water and a gas detector. Checked accessible connections within the oven, griller, top burners and under the cooker

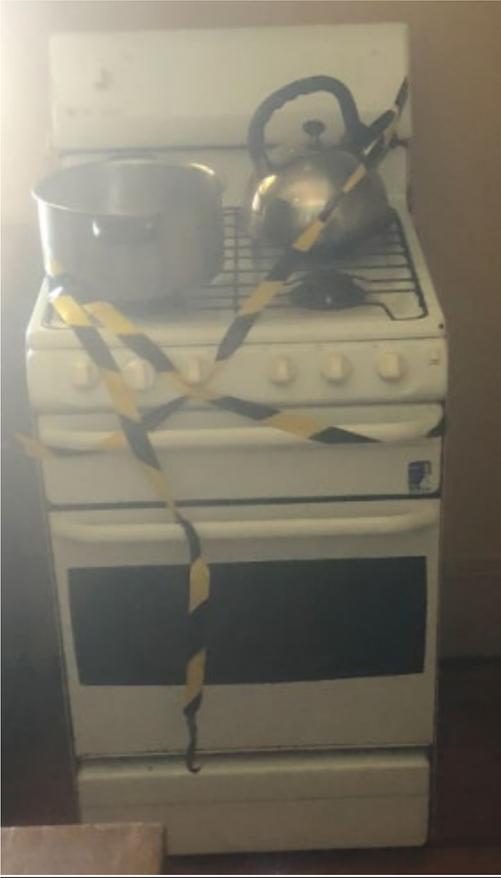
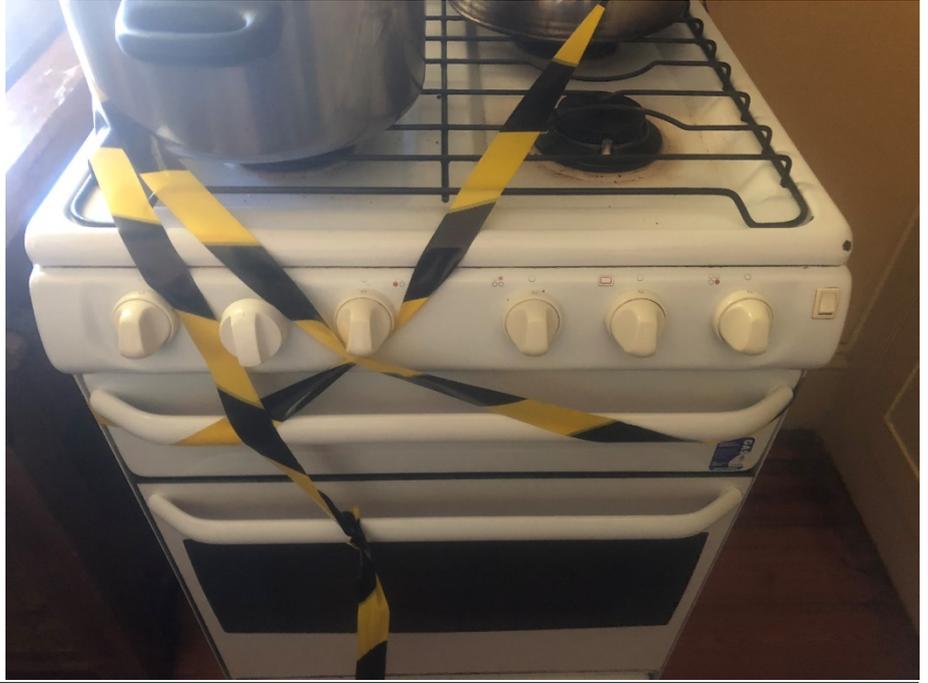
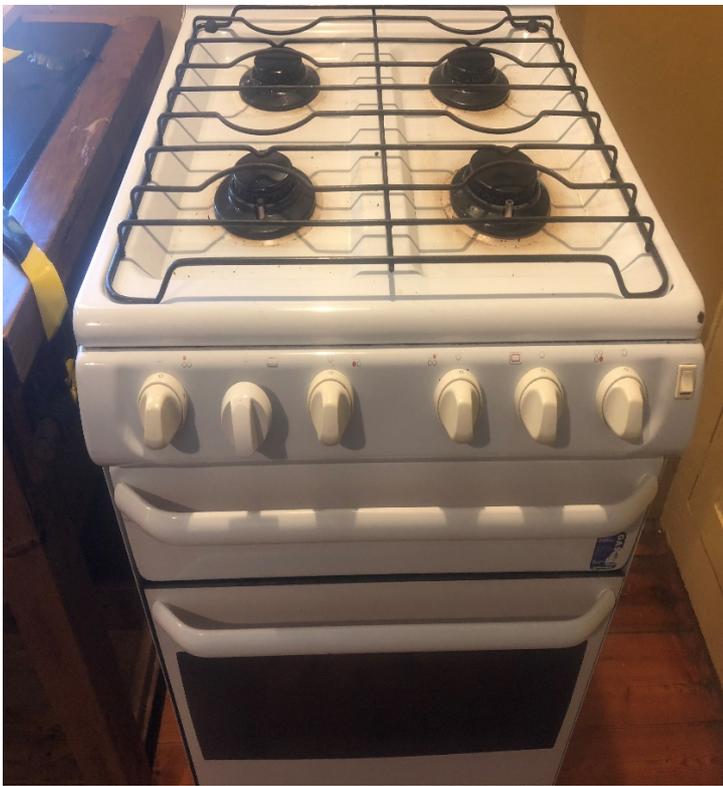
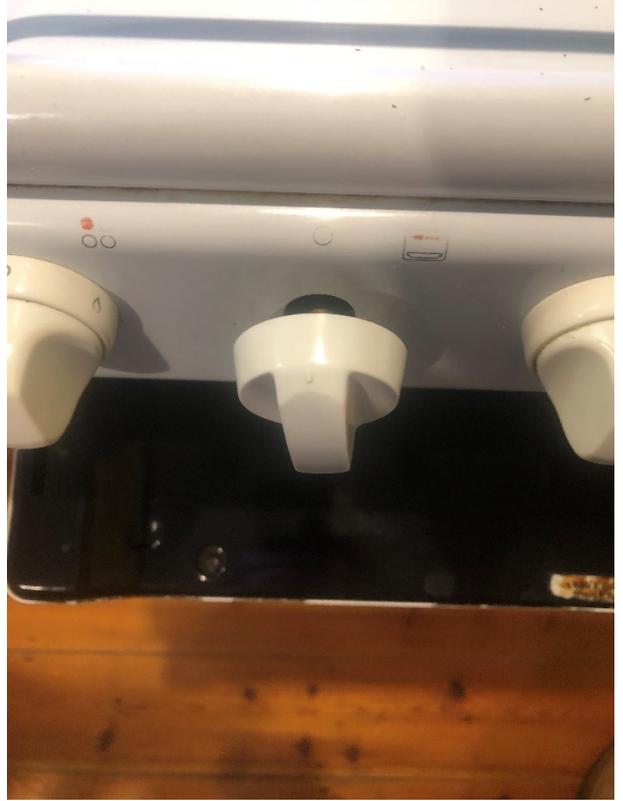
Appendix B

The likely scenario is attributed to accidental operator error, due to operating control knob without adequate markings to indicate On-Off, High-Low burner operating position.

It is recommended that the OEM instructions for operation and safe shutdown are placed in an obvious and accessible location for future users. These instructions should detail how to light each burner with and without power using the ignitor fitted to the cooker. Also provide the steps to be taken in the event of a gas leak, including turning off the gas supply at the cylinders and seeking professional assistance.

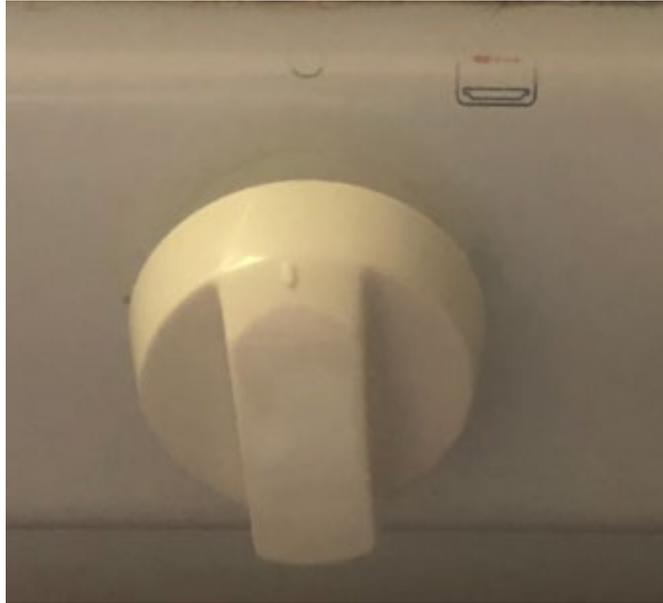
Griller knob

The aftermarket universal griller knob was found to be different to the others and there was no control panel (backing plate) with indicators showing the knob operating positions (On-Off, Hi-Low). This is likely to have created operator uncertainty whether the griller control knob was in the desired position.

It was noted that a non-OEM griller knob had been fitted. This knob was not clearly marked to indicate On-Off, High-Low so there was a degree of ambiguity as to the position of the operating control.

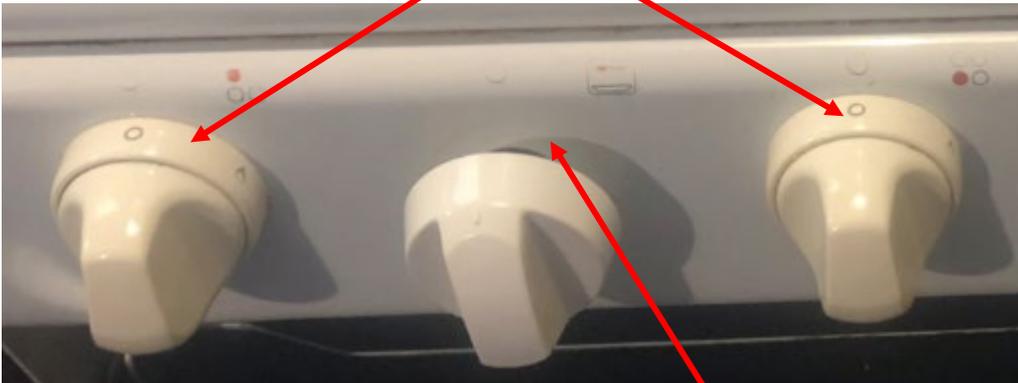
Control Panels

- Cooker had been taped off with hazard tape
- All cooker gas knobs turned off
- Knobs fitted to all cooker rail taps
- Griller rail tap knob not the same as the others, not Original Equipment Manufacturer (OEM)
- Griller rail tap has no control panel (back plate) with off/simmer/high indicators marked on it
- Installation of cooker compliant with installation standards
- Gas supply isolated at two 210kg LPG cylinders
- Gas pipework all copper, except flexi-hose to BBQ
- Heatlie BBQ installed at external BBQ area
- Wonder Fire Type 2 installed in front room

No Control Panel

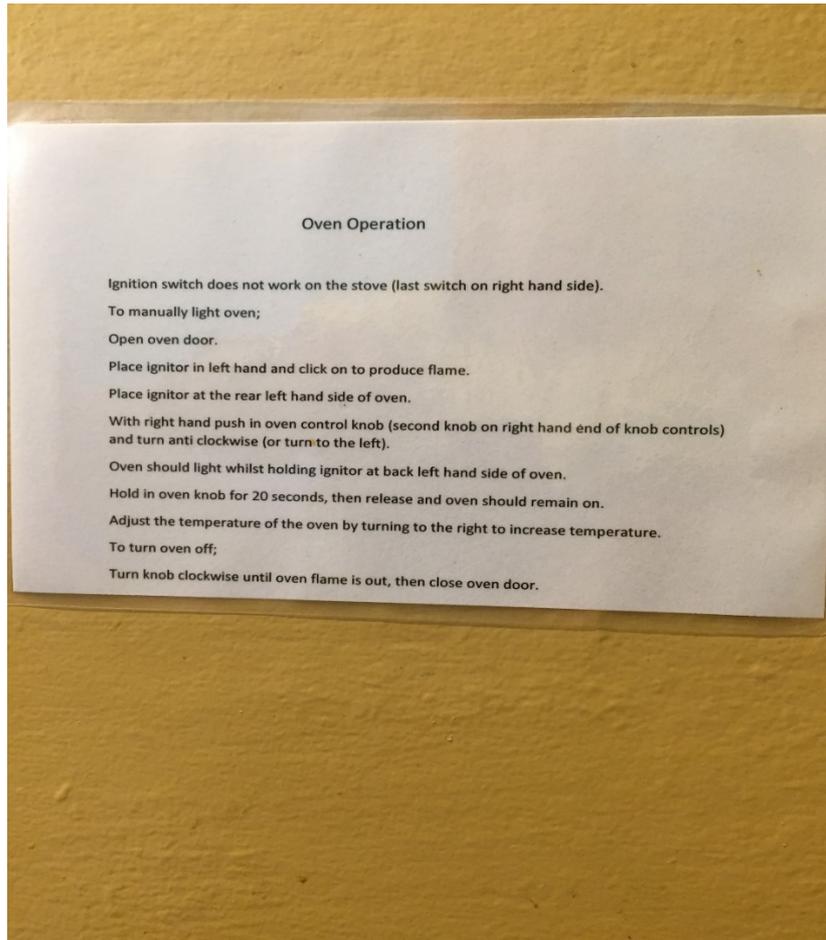
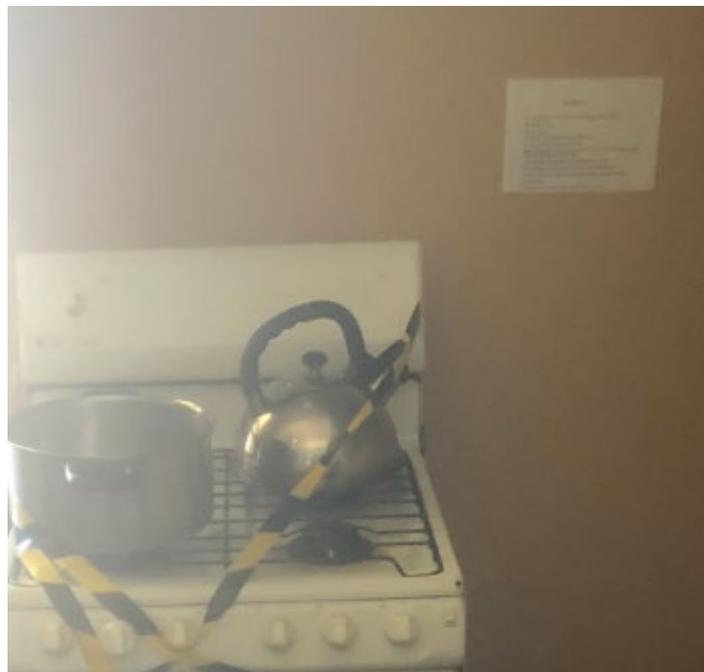
There were lighting instructions attached to the wall, however, they only covered the oven operation.

Oven lighting instructions

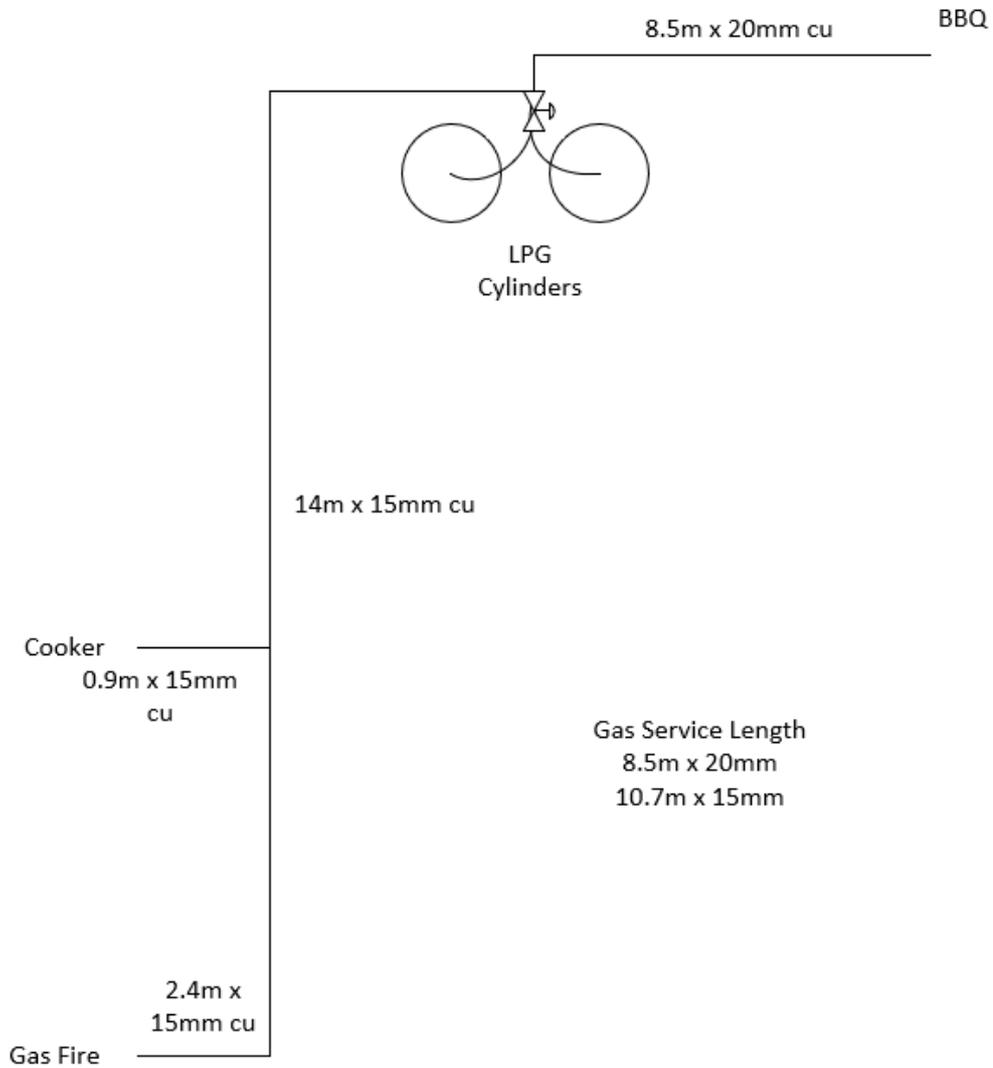
Appendix C

Approximate Dimensions
