REGULATION ROUNDUP

ISSUE 47 | March 2021

A bulletin for electrical, gas and plumbing industry workers brought to you by the Office of the Technical Regulator

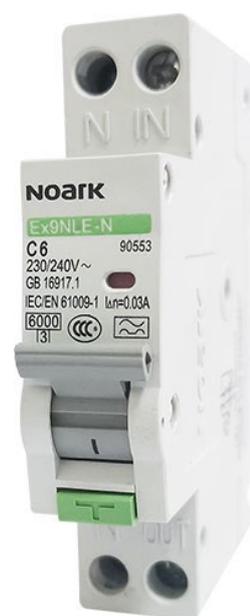
- 90552 - 1 module RCBO 10A 30mA
- 90553 - 1 module RCBO 16A 30mA
- 90554 - 1 module RCBO 20A 30mA
- 90555 - 1 module RCBO 25A 30mA
- 90556 - 1 module RCBO 32A 30mA
- 90703 - 1 module RCBO 40A 30mA

Defect: The products do not comply with the relevant mandatory electrical safety standard.

Hazard: Risk of electric shock, which can cause serious injury or death.

Action required: Consumers should immediately stop using the products and contact DKSH to arrange return of their product and for replacement product.

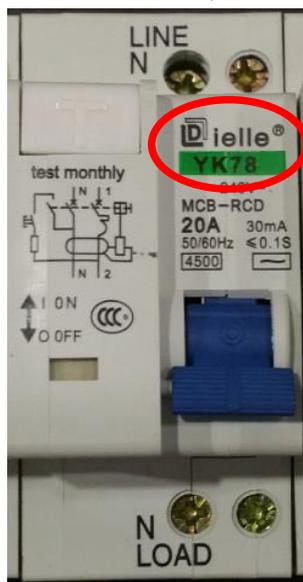
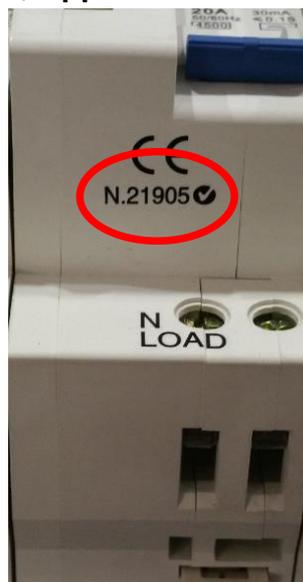
Residual Current Device (RCD)

Brand name Dielle, Model YK78, Approval mark N.21905

RCD may fail product standard test requirements. Approval mark N.21905 is not valid.

If you have or suspect you have the recalled RCD product installed within your premises, you should engage a licensed electrical contractor to examine the RCD/s and replace any affected product with an alternative RCD that has a valid Australian approval mark.
The distributor of the recalled RCD product, Dielle Electrical Distributors Pty Ltd, is no longer trading.

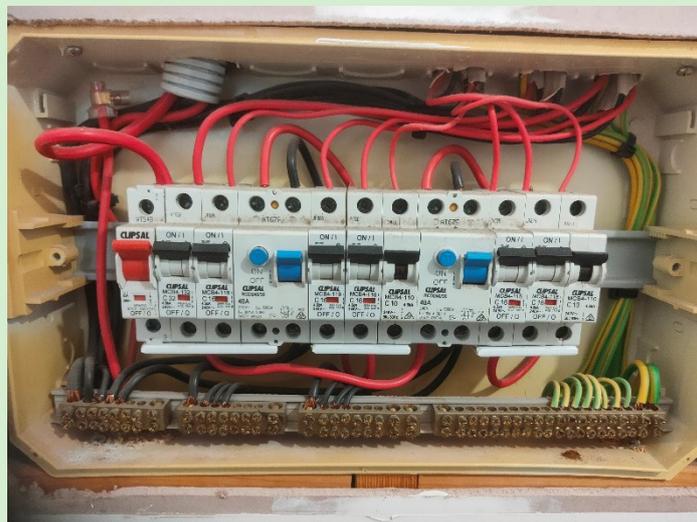
OTR has recently received a shock report identifying that the shock was caused by a non-compliant earthing system, installed by an electrical contractor.

The hot water service in the unit where the shock was received had shorted to earth, livening the water pipes. With no MEN at the switchboard in the unit, for a separate MEN installation, the only fault path was through the earth electrode to ground, which is a high impedance path, that would not operate the circuit protection for the hot water service.

In addition, if you look at the left-hand side of the photo, you will see a 6mm cable with a connector on the end of it. That cable is the Off-peak hot water sub main from the main switchboard/meter position. The contractor had connected the circuit breakers for the hot water services, in all 6 units, to the peak tariff, costing the occupants hundreds of dollars on their electricity bills.

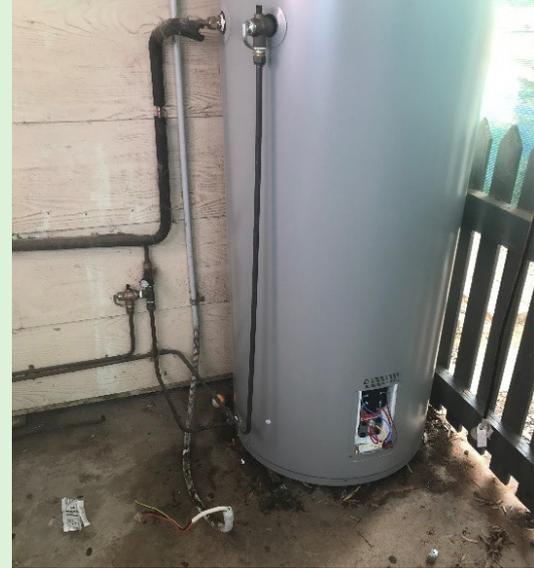
1. The off-peak tariff element of the electrical meter was programmed for a daytime controlled load which appears to have initiated and energised the HWS circuit just prior to the victim reconnecting the electrical supply to the new HWS unit. The generation of renewable energy such as solar has created a situation where far more electricity is now generated in the middle of the day which creates a condition where supply exceeds demand, consequently causing grid instability and reliability. In an effort to control this, a "soak" of the excess of generation can be programmed with certain types of meters.

[Incident 1 location - Active conductor for HWS supply cable exposed]

3. Although not required during the original installation or for repairs, a lockable isolation switch adjacent to the HWS would have provided ultimate control and isolation for the victim. The latest edition of AS/NZS 3000 now has this as mandatory requirement for new installations or alterations to directly connected water heaters.

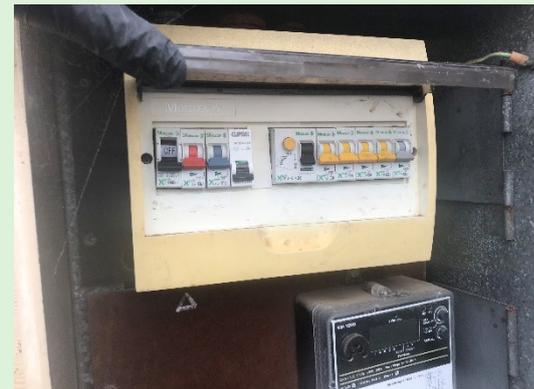
2. The circuits including the HWS circuit breaker were not labelled in the switchboard. The electrical workers licence restrictions and competency in identifying correct circuit isolation may have played a significant role.

[Incident 1 - Main switchboard - no circuit identification]

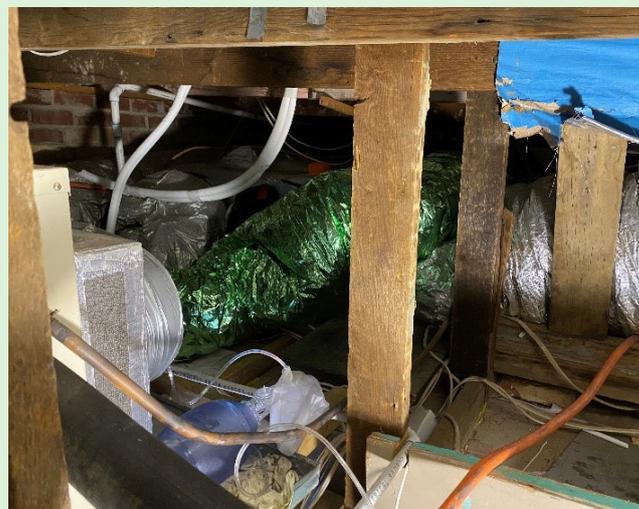
- Fault finding a noisy 240V zone control actuator and removing from service.
- There was no isolation of circuit.
- There were cramped working conditions.
- The cover was removed from the zone actuator, exposing live soldered connections on a printed circuit board (PCB).
- There were multiple conductive earth return paths in the area.
- The worker received an electrical shock, likely due to contact between the PCB's active soldered connection and earthed conductive part(s).

Working in confined locations particularly within roof spaces, without isolating the electrical supply or following safe work practices is risky and can expose oneself to unforeseen dangers. This could be existing unsafe wiring or just simply losing your balance and inadvertently coming into contact with a live part you are working on. The potential of electric shock is somewhat further increased if a return path through conductive earthed components is in the vicinity of the working area.

[Incident 2 location - Confined roof space and multiple conductive earthed parts]

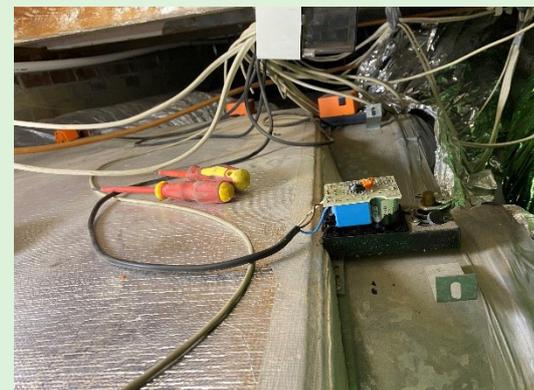
[Incident 2 - A/C zone actuator - live soldered connections exposed]

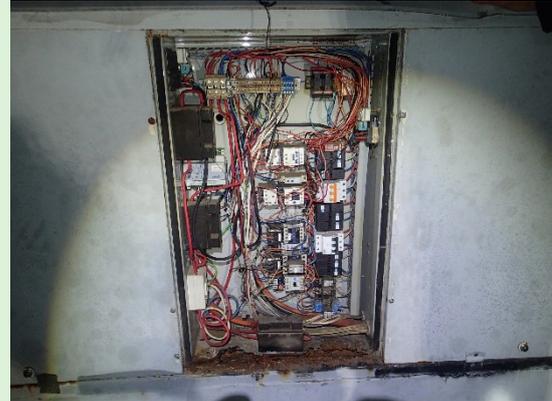
- The electrical worker was working on a condenser unit control board for a tenancy air conditioning system
- The multimeter onsite was set on the incorrect function for the desired test
- There was no positive isolation confirmed
- Non-insulated pliers were used to strip a live conductor
- The worker had Inadequate PPE
- There were multiple conductive earthed return paths in the area
- The worker received an electrical shock between an active conductor and a conductive earthed part (i.e. roofing material or A/C chassis) likely while using uninsulated pliers.

[Incident 3 location – condensing unit control board]

This situation reiterates the importance of positive isolation by proving the correct operation of meters on a known source before use and being familiar with the functional selections on the meter. During this investigation the multimeter onsite was found to be set on the Volts DC range, which when testing for AC voltages would have presented a misleading reading to the victim.

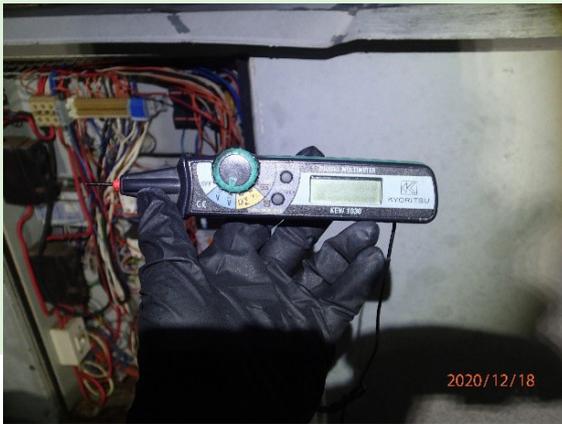
[Incident 3 - Electrical tester onsite]

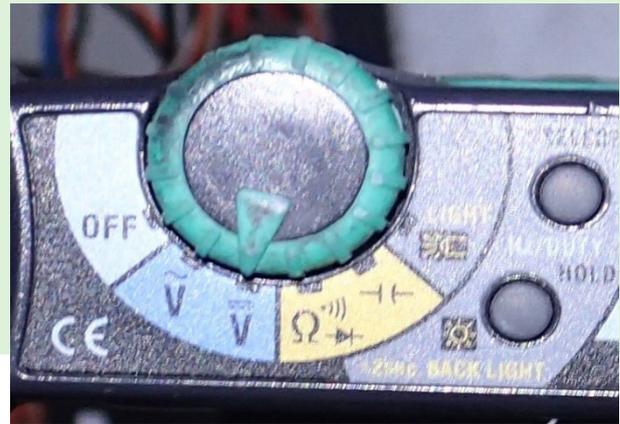
[Incident 3 - Electrical tester function selected to Volts DC]

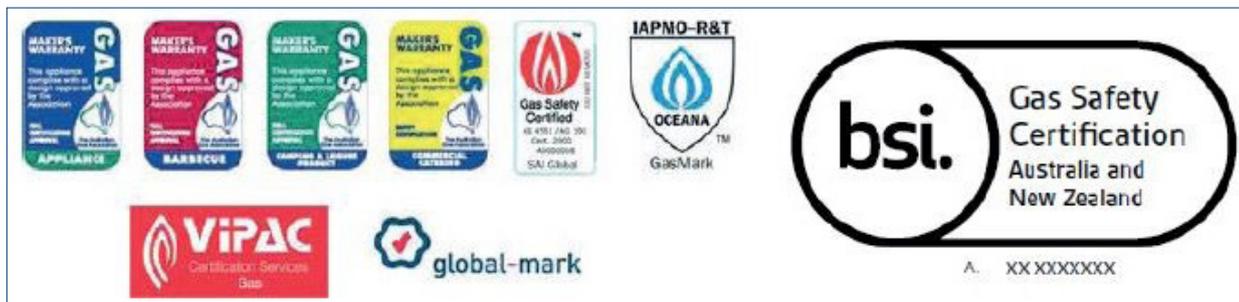
Type A certification Labels:

Note: VIPAC is no longer a Type A certifier. However, their label may still be found on appliances which is a valid proof of the appliance being certified.

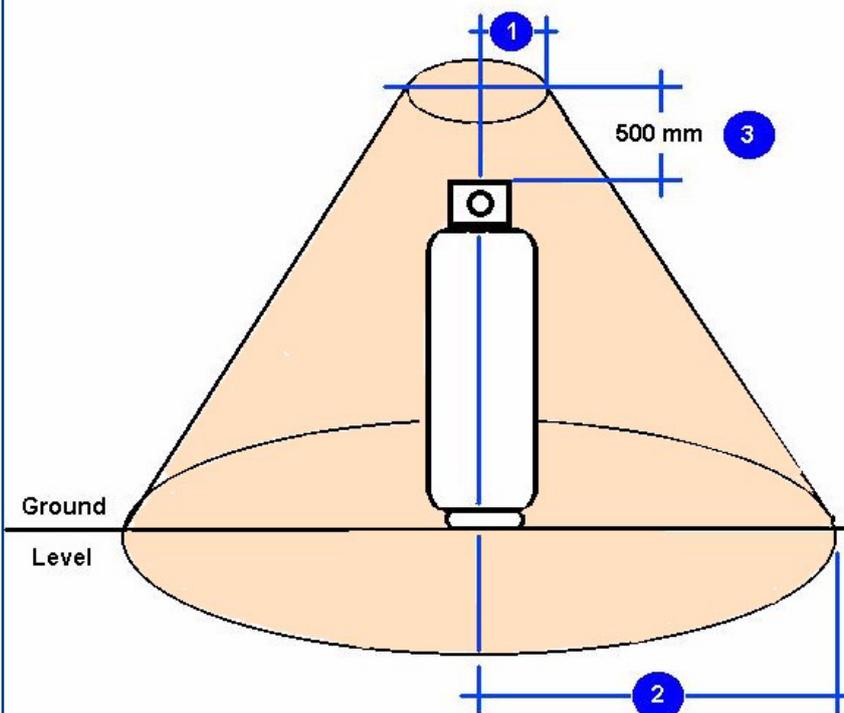
Minimum Clearance to Ignition Sources

- PV systems are considered an electrical ignition source as is an electrical meter or fuse box. Therefore the following applies;
 - As per the Figure 6.2, AS/NZS 5601.1-2013, the flue terminals and combustion air intakes of gas fired appliances must have a separation of 500mm to the PV system, (including panels, inverters DC or AC isolator switches).
 - For domestic and light commercial Gas billing meters, refer to the gas network operator documentation which refers to a 500mm separation from Electrical meter boxes and any ignition sources.
 - For LPG cylinder locations, the PV system must be outside the exclusion zone for ignition sources as per Appendix J Figure J3

Radius	Exchange cylinder (mm)	In-situ fill cylinder (mm)
1	500	1500
2	1500	3500
3	This distance is taken from the top of the cylinder valve

- For LPG cylinder locations, the AC condenser must be outside exclusion zone for ignition sources as per Appendix J Figure J3 (see above)
 - As for gas appliances, there must not be any obstruction horizontally within 500mm of the appliance, therefore the minimum distance from the casing of an A/C condenser unit to a gas appliance will be 500mm. Consideration shall also be made as the impact of air movement from the air conditioner's fan. This air movements shall not adversely impact the operation of the gas appliance, refer to AS/NZS5601.1:2020 clause 6.3.1

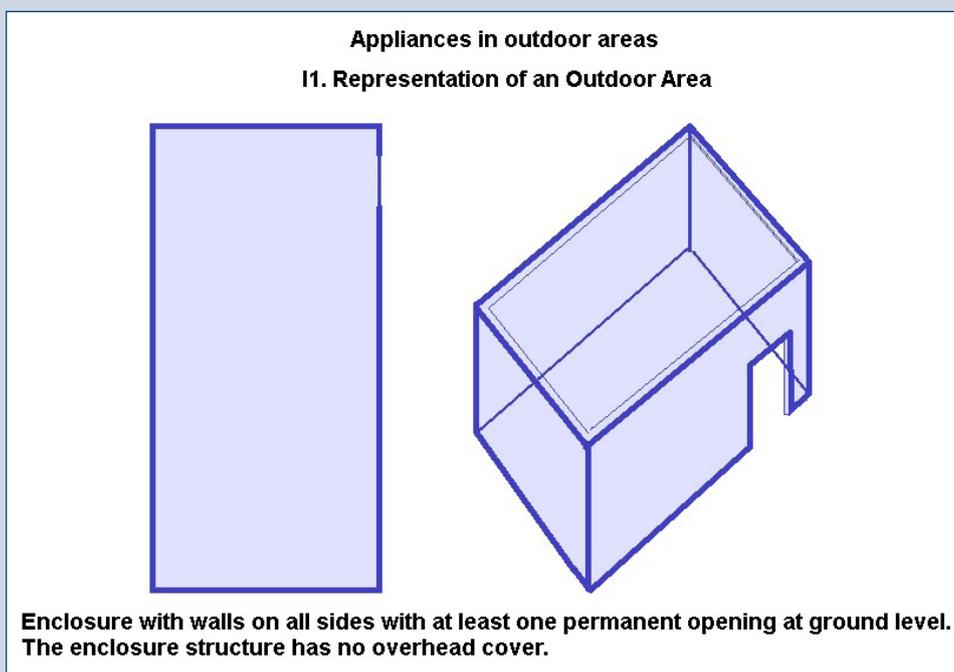
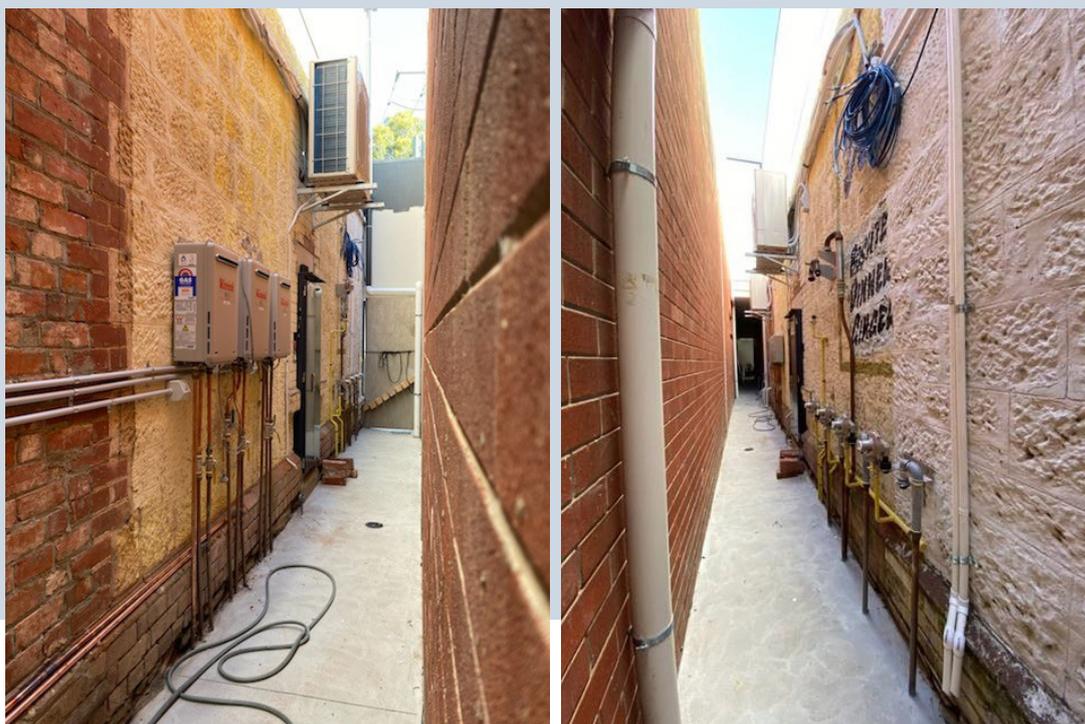
The photos below show a passage between two renovated buildings with no roof or eaves over hanging from either wall. The walls of these buildings are equivalent to two storeys high. The gas was not connected to the installation by the network because the buildings were only 1 metre apart and posed hazards for the accumulation of combustion products and hot flue gases from multiple heaters discharging in the face of occupants walking past the heaters. The installer had to return and relocate the HWHs' before the gas connection was made.

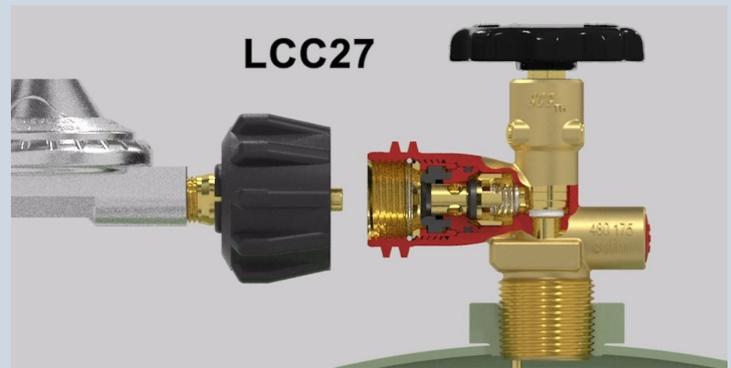
[Type 27 Leisure cylinder connection (LCC)]

- <http://www.gtrc.gov.au/resources/Technical-Guidance-Bulletin-14--LPG-Cylinder-connection-transition-v1.1.pdf>
- As of April 2021, and over the next 12 months there will be a transition to replacing valves on cylinders up to 10Kg and portable gas appliances' connections to Type 27 connections.
- The initial transition from April to October 2021 will be on cylinders only which will affect the use of POL fittings with rubber seals (elastomer). These POL fittings with elastomer seals are not to be used with the Type 27-cylinder valve
- As of April 2022, all new portable gas appliances will be provided by the manufacturer with Type 27 connectors.
- Those existing cylinders and appliances with the POL connector will be able to continue to use these POL fittings until the test date of the cylinder and throughout the life of the appliance.

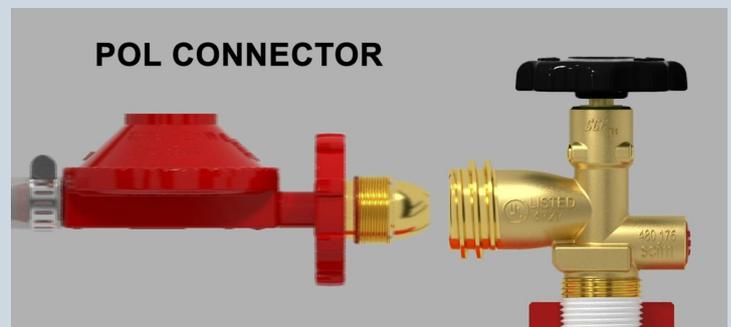
[Type 21 POL cylinder connection]

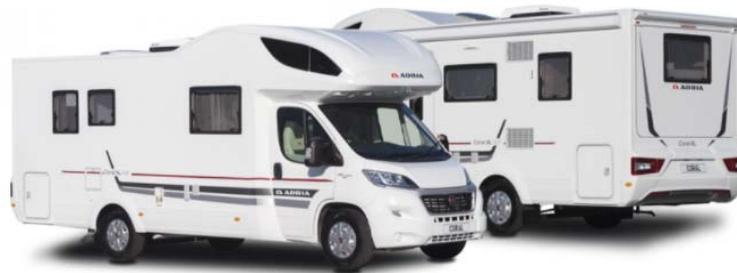
Adria Coral

Defect Liquefied Petroleum Gas (LPG) is a colourless, highly flammable gas that may leak and build up inside the caravan where the consumer gas piping is located inside the caravan.

The gas oven inside the motorhome may not be securely mounted, which could cause a possible rupture of the oven inlet gas line, resulting in a possible gas leak.

Hazard In the event of an LPG gas leak, gas may accumulate within the caravan and may present a risk of poisoning or a fire, which could cause serious illness, injury or death.

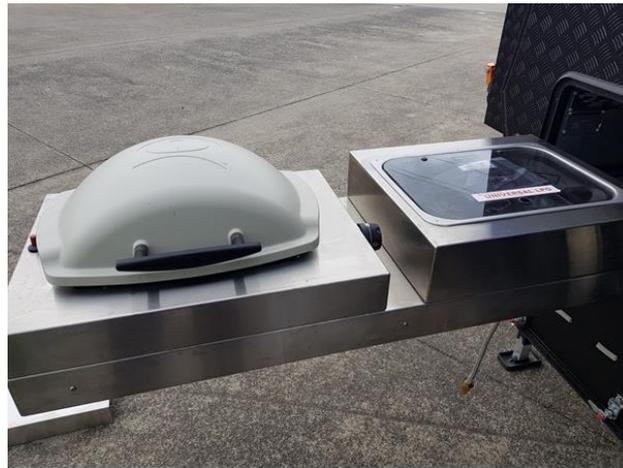
Slide Out Kitchen

Defect The barbeque was modified to facilitate its installation. This has resulted in the temperature of the surrounding stainless steel surfaces exceeding the relevant gas standard's requirements.

Hazard If the surfaces overheat, there is an increased risk of burn injuries.

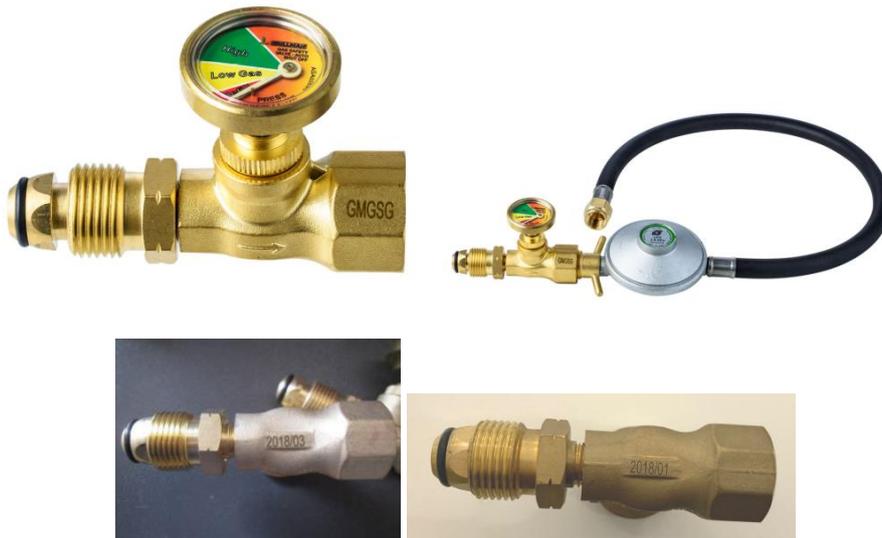
**GRILLMAN Gas Safety Shut-Off Valve and
GRILLMAN Gas Safety Shut-Off Valve with Hose and Regulator**

IDENTIFICATION: Gas safety Shut Off Valve with POL flitting, suitable for gas barbecues and outdoor gas heaters.

Batches GMGSG 2018/01 and GMGSG 2018/03

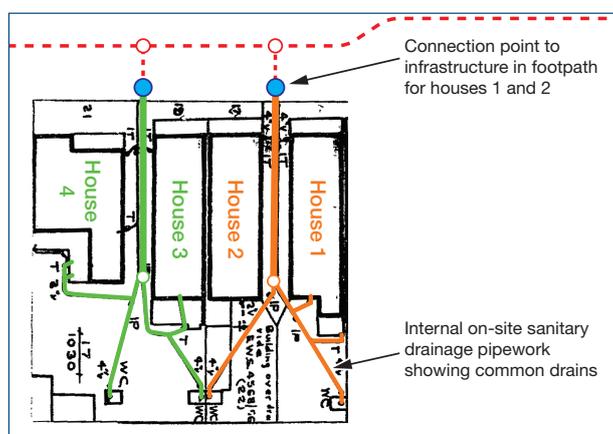
Image 1: Typical common drains.

When the Office of the Technical Regulator (OTR) becomes aware of a common drain which is interconnected with drains from adjoining properties, a notice letter is sent to all affected property owners. This notice is provided to interested parties (on application) under the *Land and Business (Sale and Conveyancing) Act 1994*.

If the opportunity arises to connect your internal sanitary drain to the sewerage infrastructure by means of a separate sewer connection, you are advised to do so accordingly.

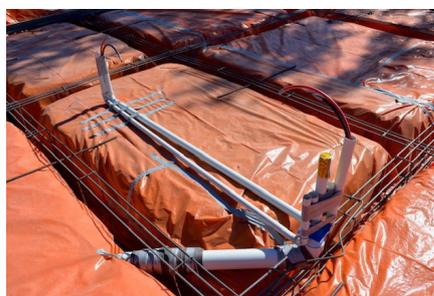
Figure 1 - Acceptable island bench installation using sleeve

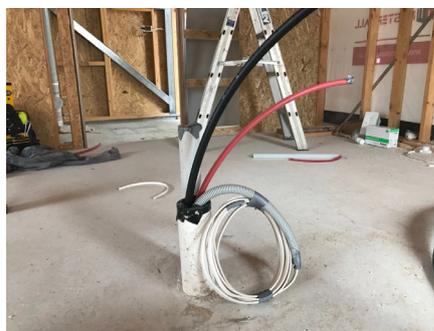
Figure 2 - Non-compliant installation (electrical cable in sleeve with water pipes)
