Department for Energy and Mining

Caroline-1 Tubing and Casing

Report

August 2019

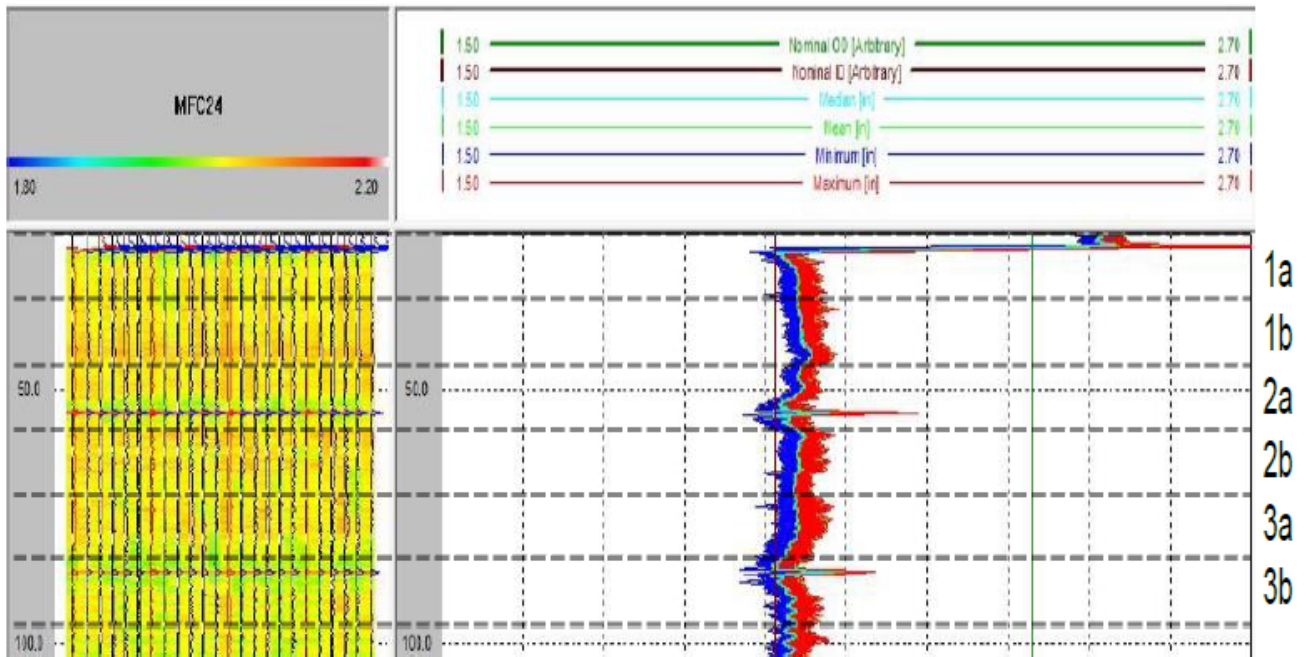
Figure 8: Joints 1-3 MFC log

Joint Range	Est. Depth Range (m (ft))	Reason for Interest
1 - 3	Surface – 28.62 (0 – 94)	Near surface

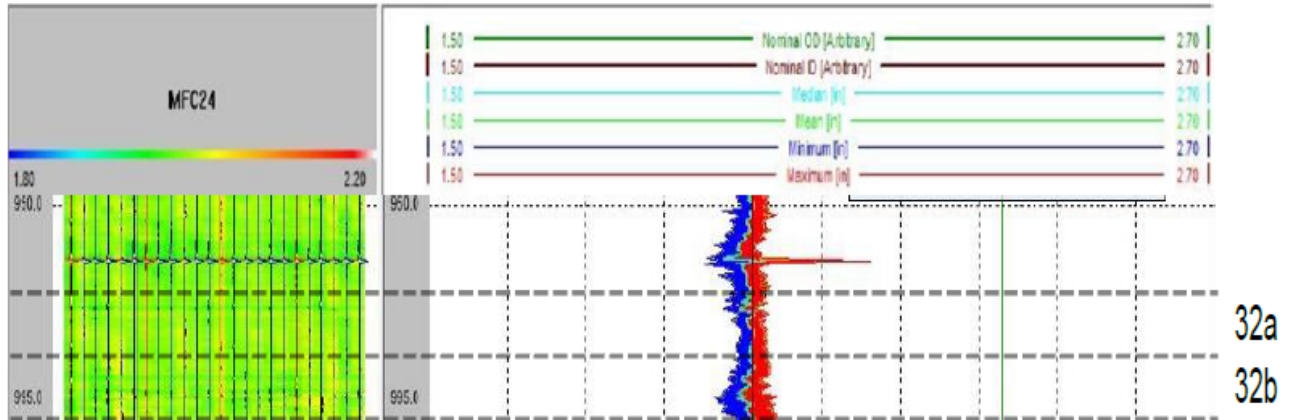
Figure 14: Joint 32 MFC Log

Joint Range	Est. Depth Range (m (ft))	Reason for Interest
32	295.74 – 305.28 (970 – 1002)	Sample point

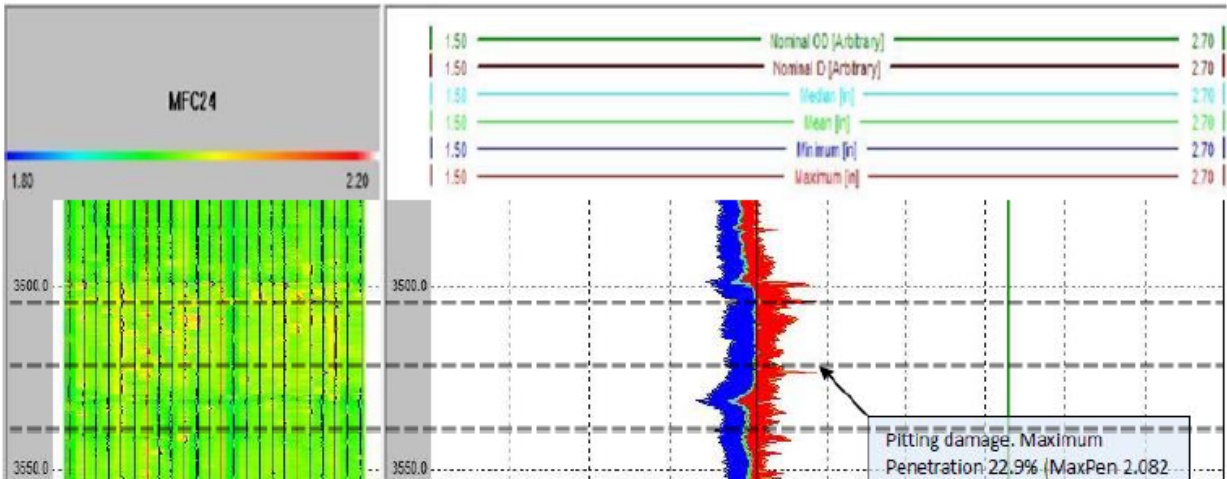
Figure 30: Joint 113 MFC log

Joint Range	Est. Depth Range (m (ft))	Reason for Interest
113	1068.48 – 1078.02 (3506 – 3537)	Good pipe

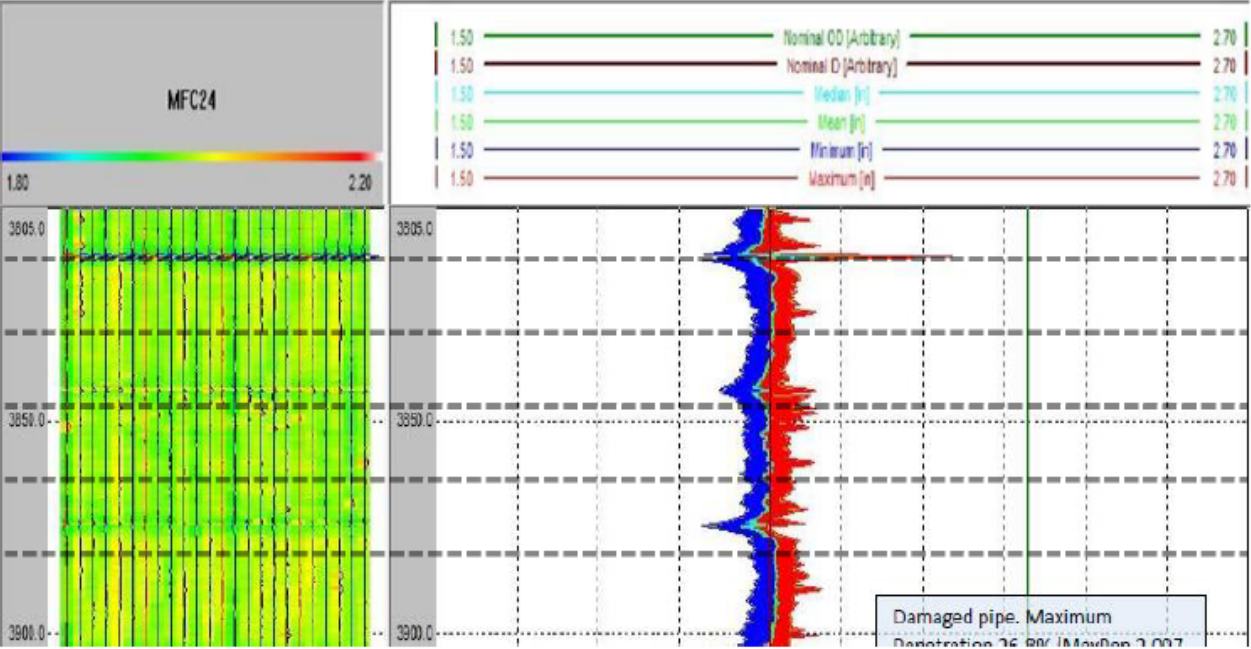
Figure 32: Joints 123-124 MFC log

Joint Range	Est. Depth Range (m (ft))	Reason for Interest
123 - 124	1163.88 – 1182.96 (3819 – 3881)	Good pipe

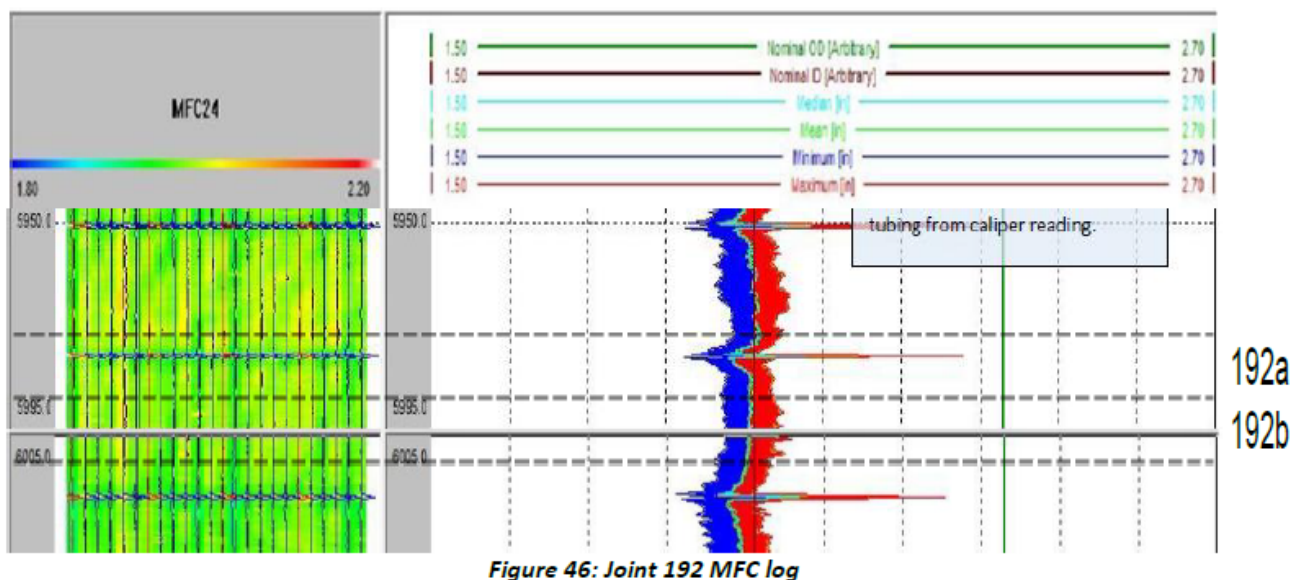
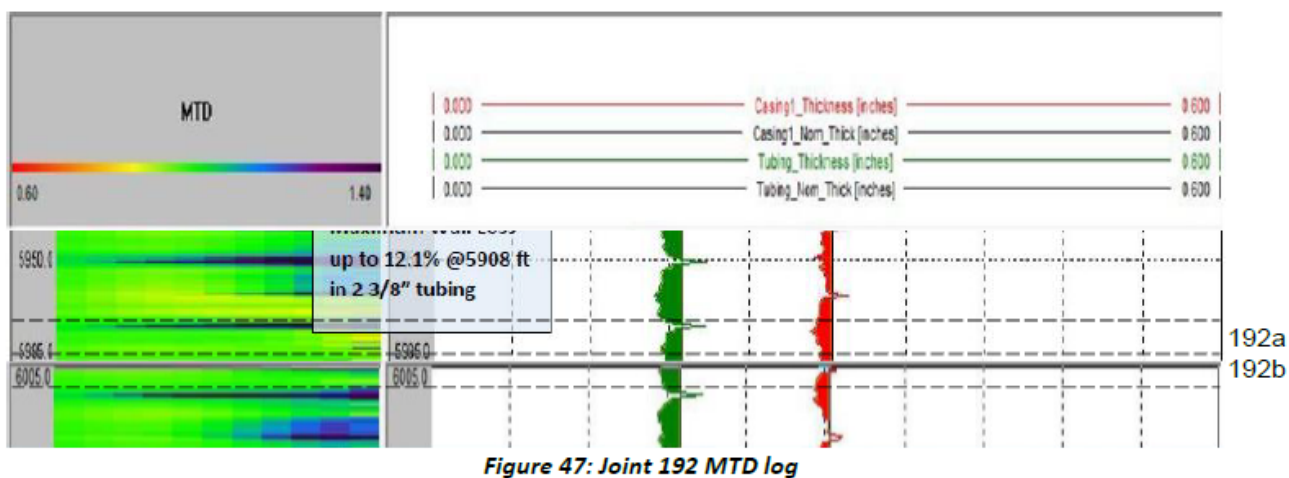
Joint Range	Est. Depth Range (m (ft))	Reason for Interest
192	1822.14 – 1831.68 (5978 – 6009)	Sample point

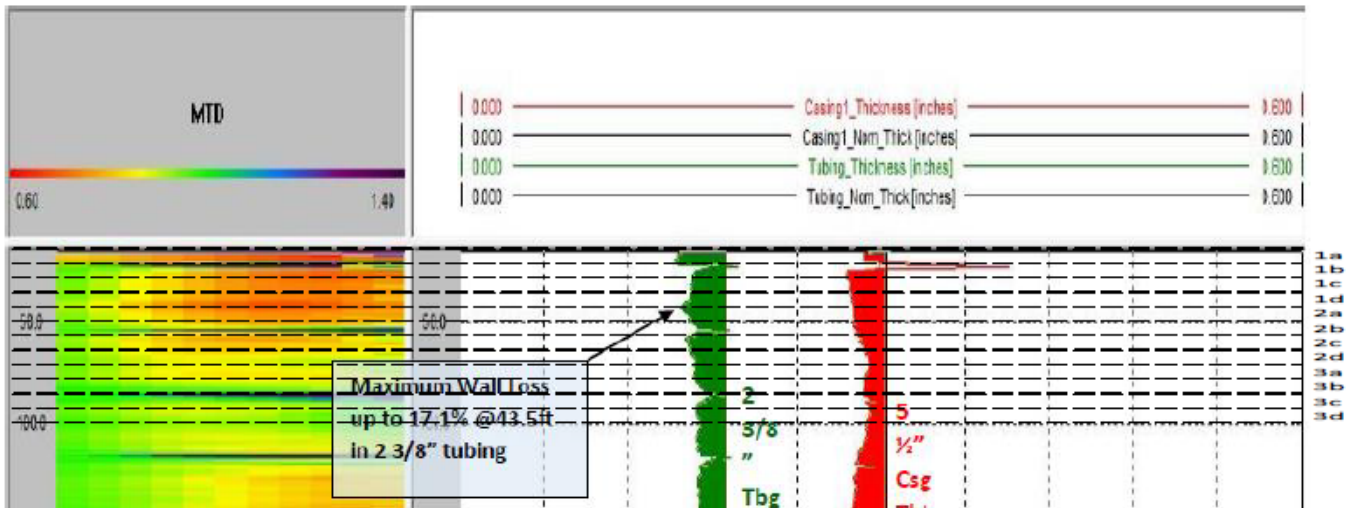
Figure 52: Joints 1-3 MTD log

Joint Range	Est. Depth Range (m (ft))	Reason for Interest
1 - 3	Surface – 30.0 (0 – 98)	Near Surface

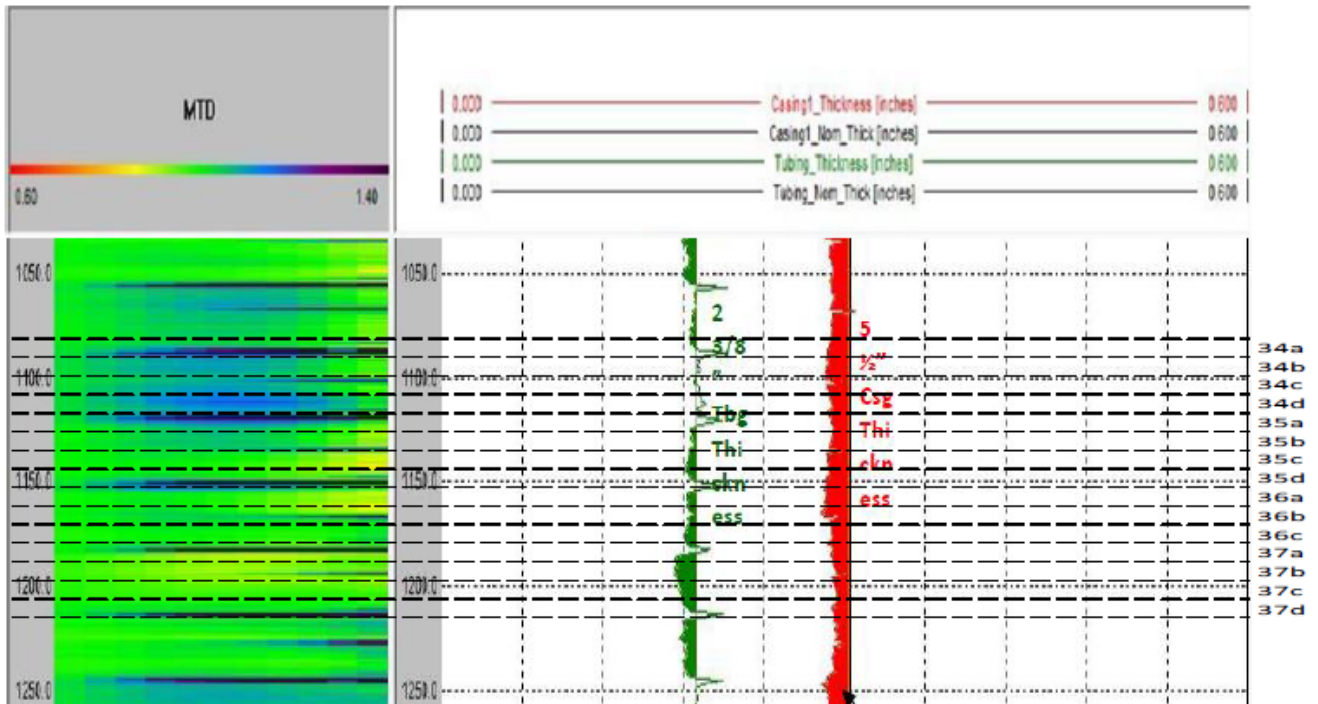
Figure 56: Joints 34-37 MTD log

Joint Range	Est. Depth Range (m (ft))	Reason for Interest
34 - 37	330.0 – 370.0 (1083 – 1214)	J55/N80 crossover

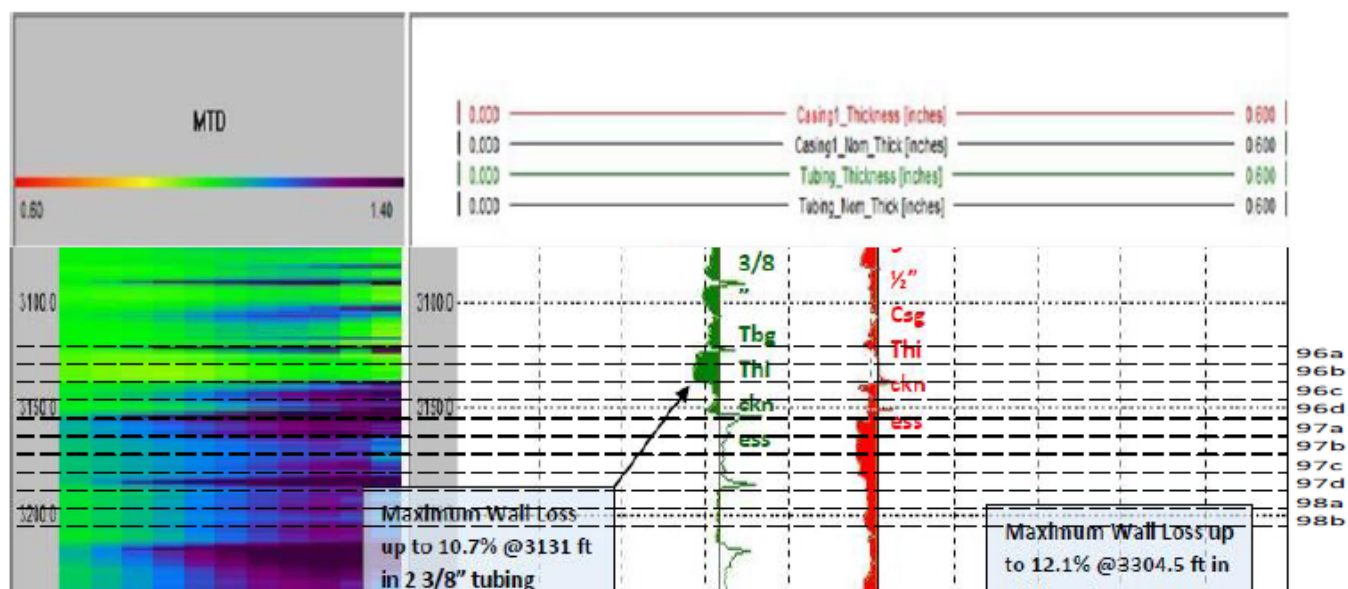
Figure 58: Joints 96-98 MTD log

Joint Range	Est. Depth Range (m (ft))	Reason for Interest
96 – 98	950.0 – 976.0 (3117 – 3202)	Last joints cut & pulled
