## **2004 ANNUAL REPORT**

**Pipeline Licence 3 & 4**

## **SOUTH EAST PIPELINE SYSTEM**

**Document Number S-31-107-AR-G-001**

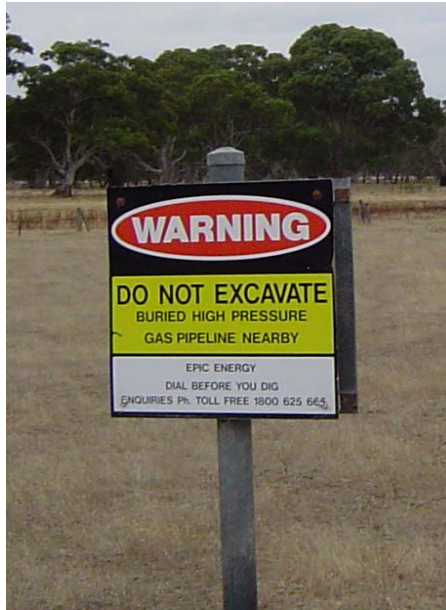
As a result, pipeline warning signs and sign posts were replaced/repared throughout the year to maintain good line of sight.

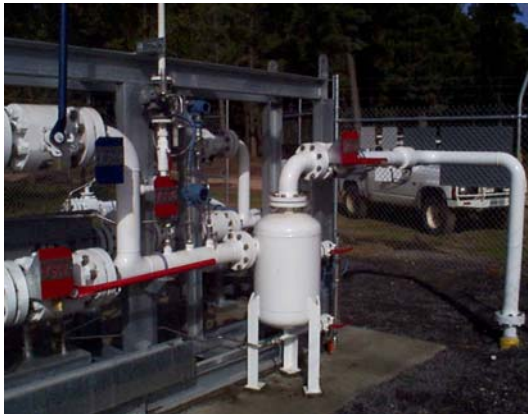
- All routine mechanical maintenance activities were completed as scheduled on the South East Pipeline system during 2004. This work involved MLV servicing, station dust filter inspection/replacement, door closure maintenance, coalescing filter inspection/maintenance and pig launcher/receiver maintenance.

A test between the compatibility of a “Plidco” split sleeve and “Zaplock” field joint was conducted. The conclusion was that as a result of the Zaplock jointing method and the associated flares, the existing 6” Plidco repair sleeve is not suitable to be used as a temporary repair strategy, as the clamp contacts the pipe-work Zaplock flare section, leaving too large a gap for the sealing faces. An alternative method/ clamp is to be investigated. A leaking Zaplock joint will be treated the same as any major pipeline leak and the emergency repair method will be to cut out and replace a section of pipeline.
