**APA Group**

**2007 ANNUAL REPORT**

**Pipeline Licence No 16**

**SESA PIPELINE**

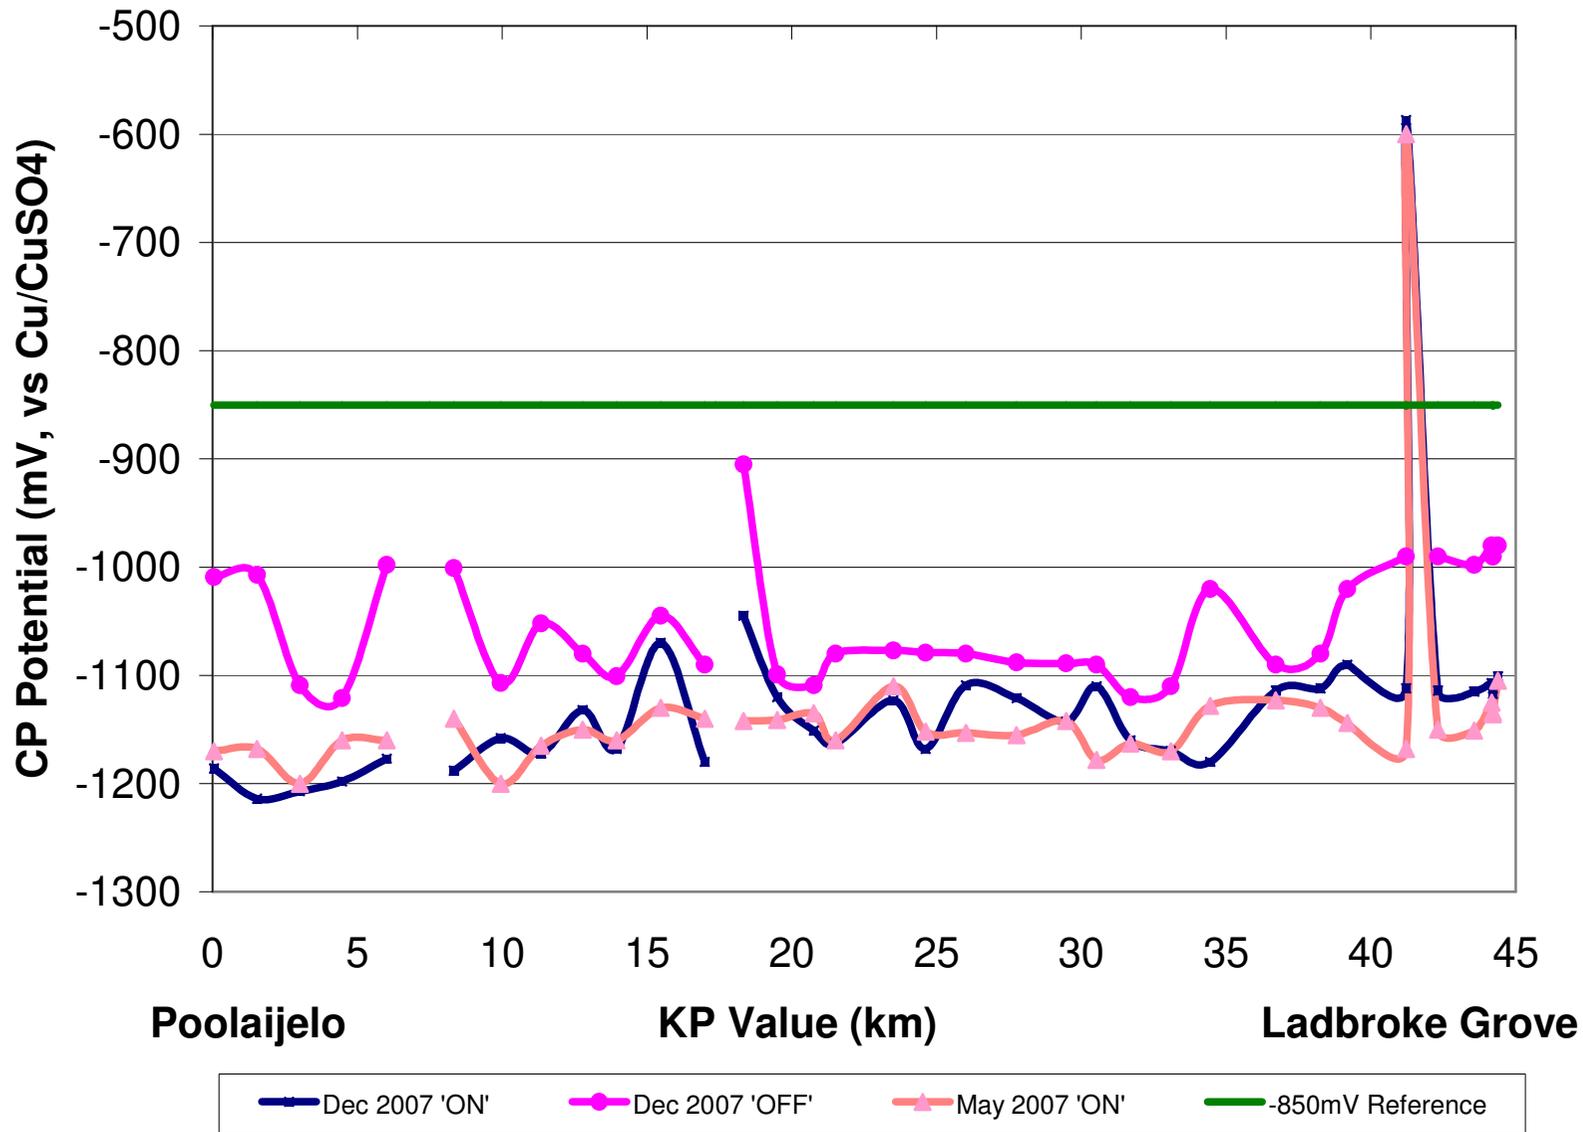
**APPENDIX 3 - GRAPHICAL RESULTS FROM CATHODIC PROTECTION POTENTIAL SURVEY DECEMBER 2007**

The effectiveness of the cathodic protection system is monitored by carrying out regular potential surveys. Routine checks of test points along the pipeline in 2007 demonstrated that all sections of the pipeline were at fully protected potentials. A summary of the CP potential survey results carried out December 2007 have been tabulated in Appendix 2 with the associated graphical summary in Appendix 3.

The next complete cathodic protection survey is scheduled to be carried out in June 2008.
