## Electric Shock Report

INCIDENT DETAILS	
Job Number: INC 354011569	QS Notification number: 100895295
Incident address / location: Street: [REDACTED] [REDACTED]	Owner or Responsible person for the installation: Name: [REDACTED] Contact Ph: [REDACTED]
Date/Time of incident: 16.11.2021 11:30	Date/Time reported to SAPN: 16.11.2021 12:10
Date/Time of investigation: 16.11.2021 12:54	Date/Time reported to OTR: 17.11.2021 13:53
Embedded generation installed: Yes <input type="checkbox"/> No <input checked="" type="checkbox"/>

ELECTRIC SHOCK DETAILS	
What was contacted to cause the shock: DIT LIGHT COLUMN	
What were the two contact surfaces: DIT LIGHT COLUMN & HYDROVAC EXTRACTION HOSE	
Which of the the two was the voltage source coming from: DIT LIGHT COLUMN	
What were the two body contact points: HAND & HAND	
VOLTAGE MEASUREMENT DETAILS	
Pre-repair contact voltage: 239.00 V	Post-repair contact voltage: 0.40 V
Pre-repair installtion load: 0.00 kW	Post-repair installtion load: 2.40 kW
Pre-repair impedance: 0.23 Ohm	Post-repair impedance: 0.23 Ohm
What was the victim doing at time of shock:  Leaning against light column and touched hose.

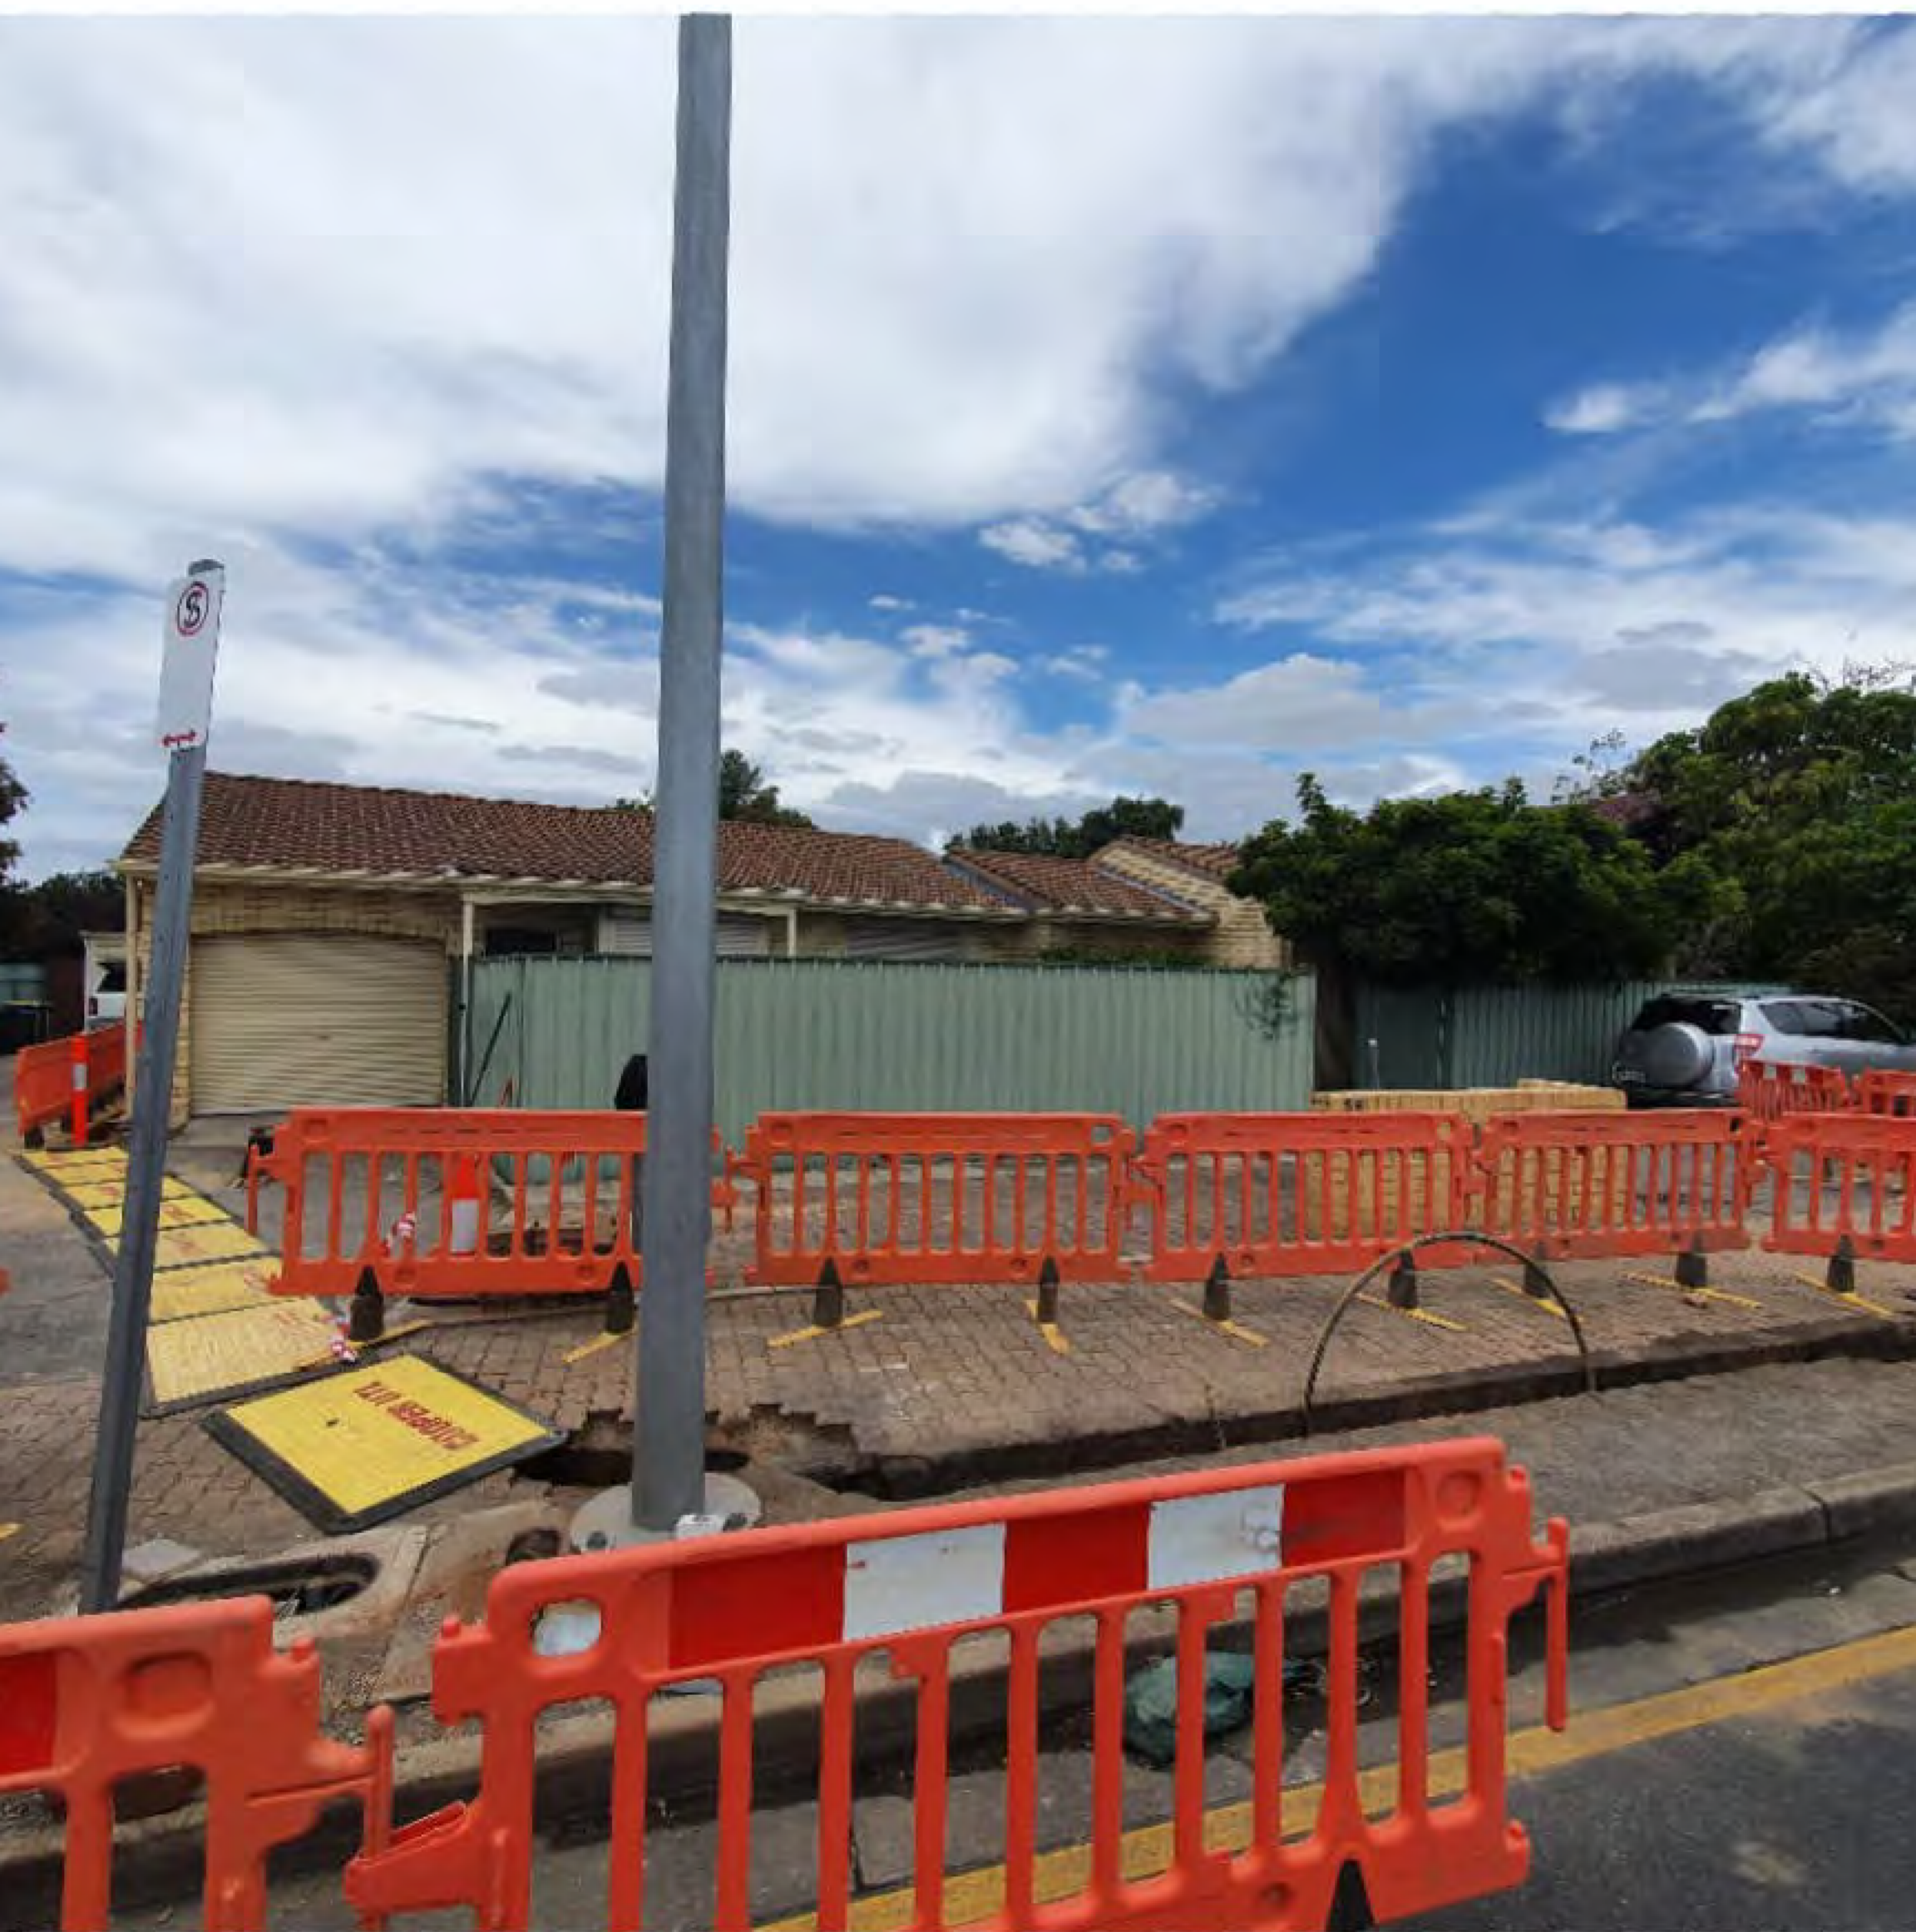
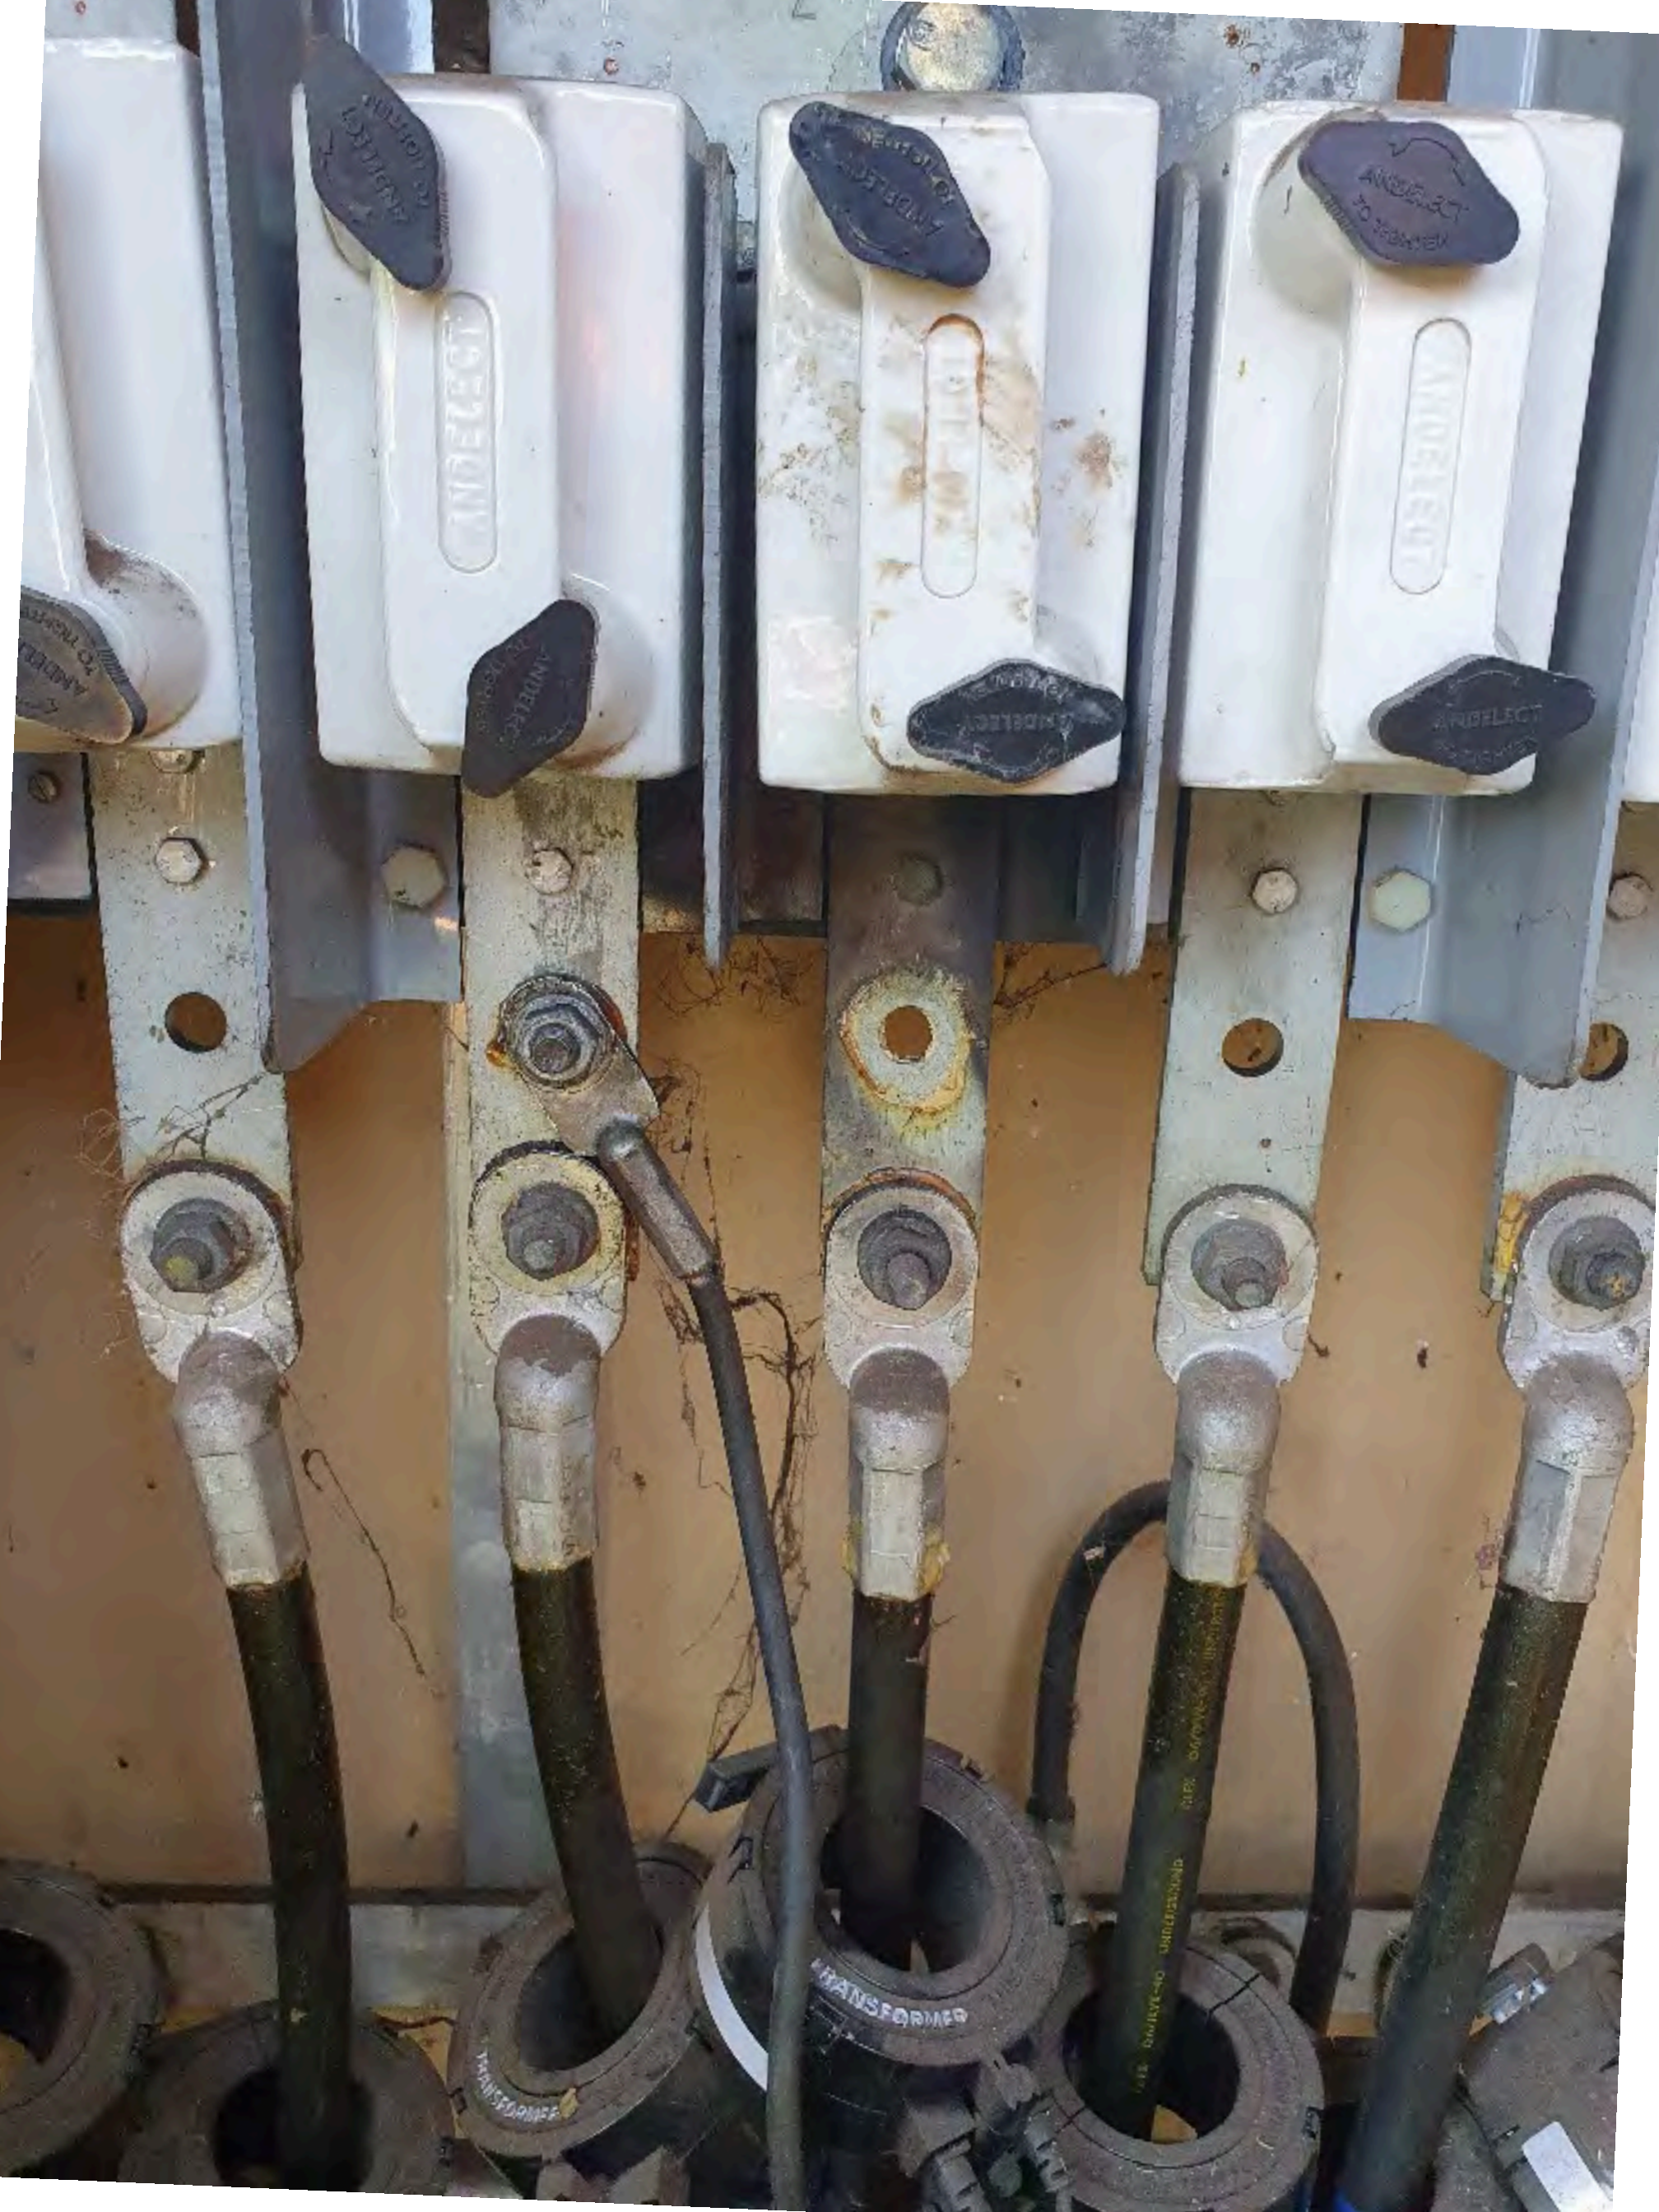
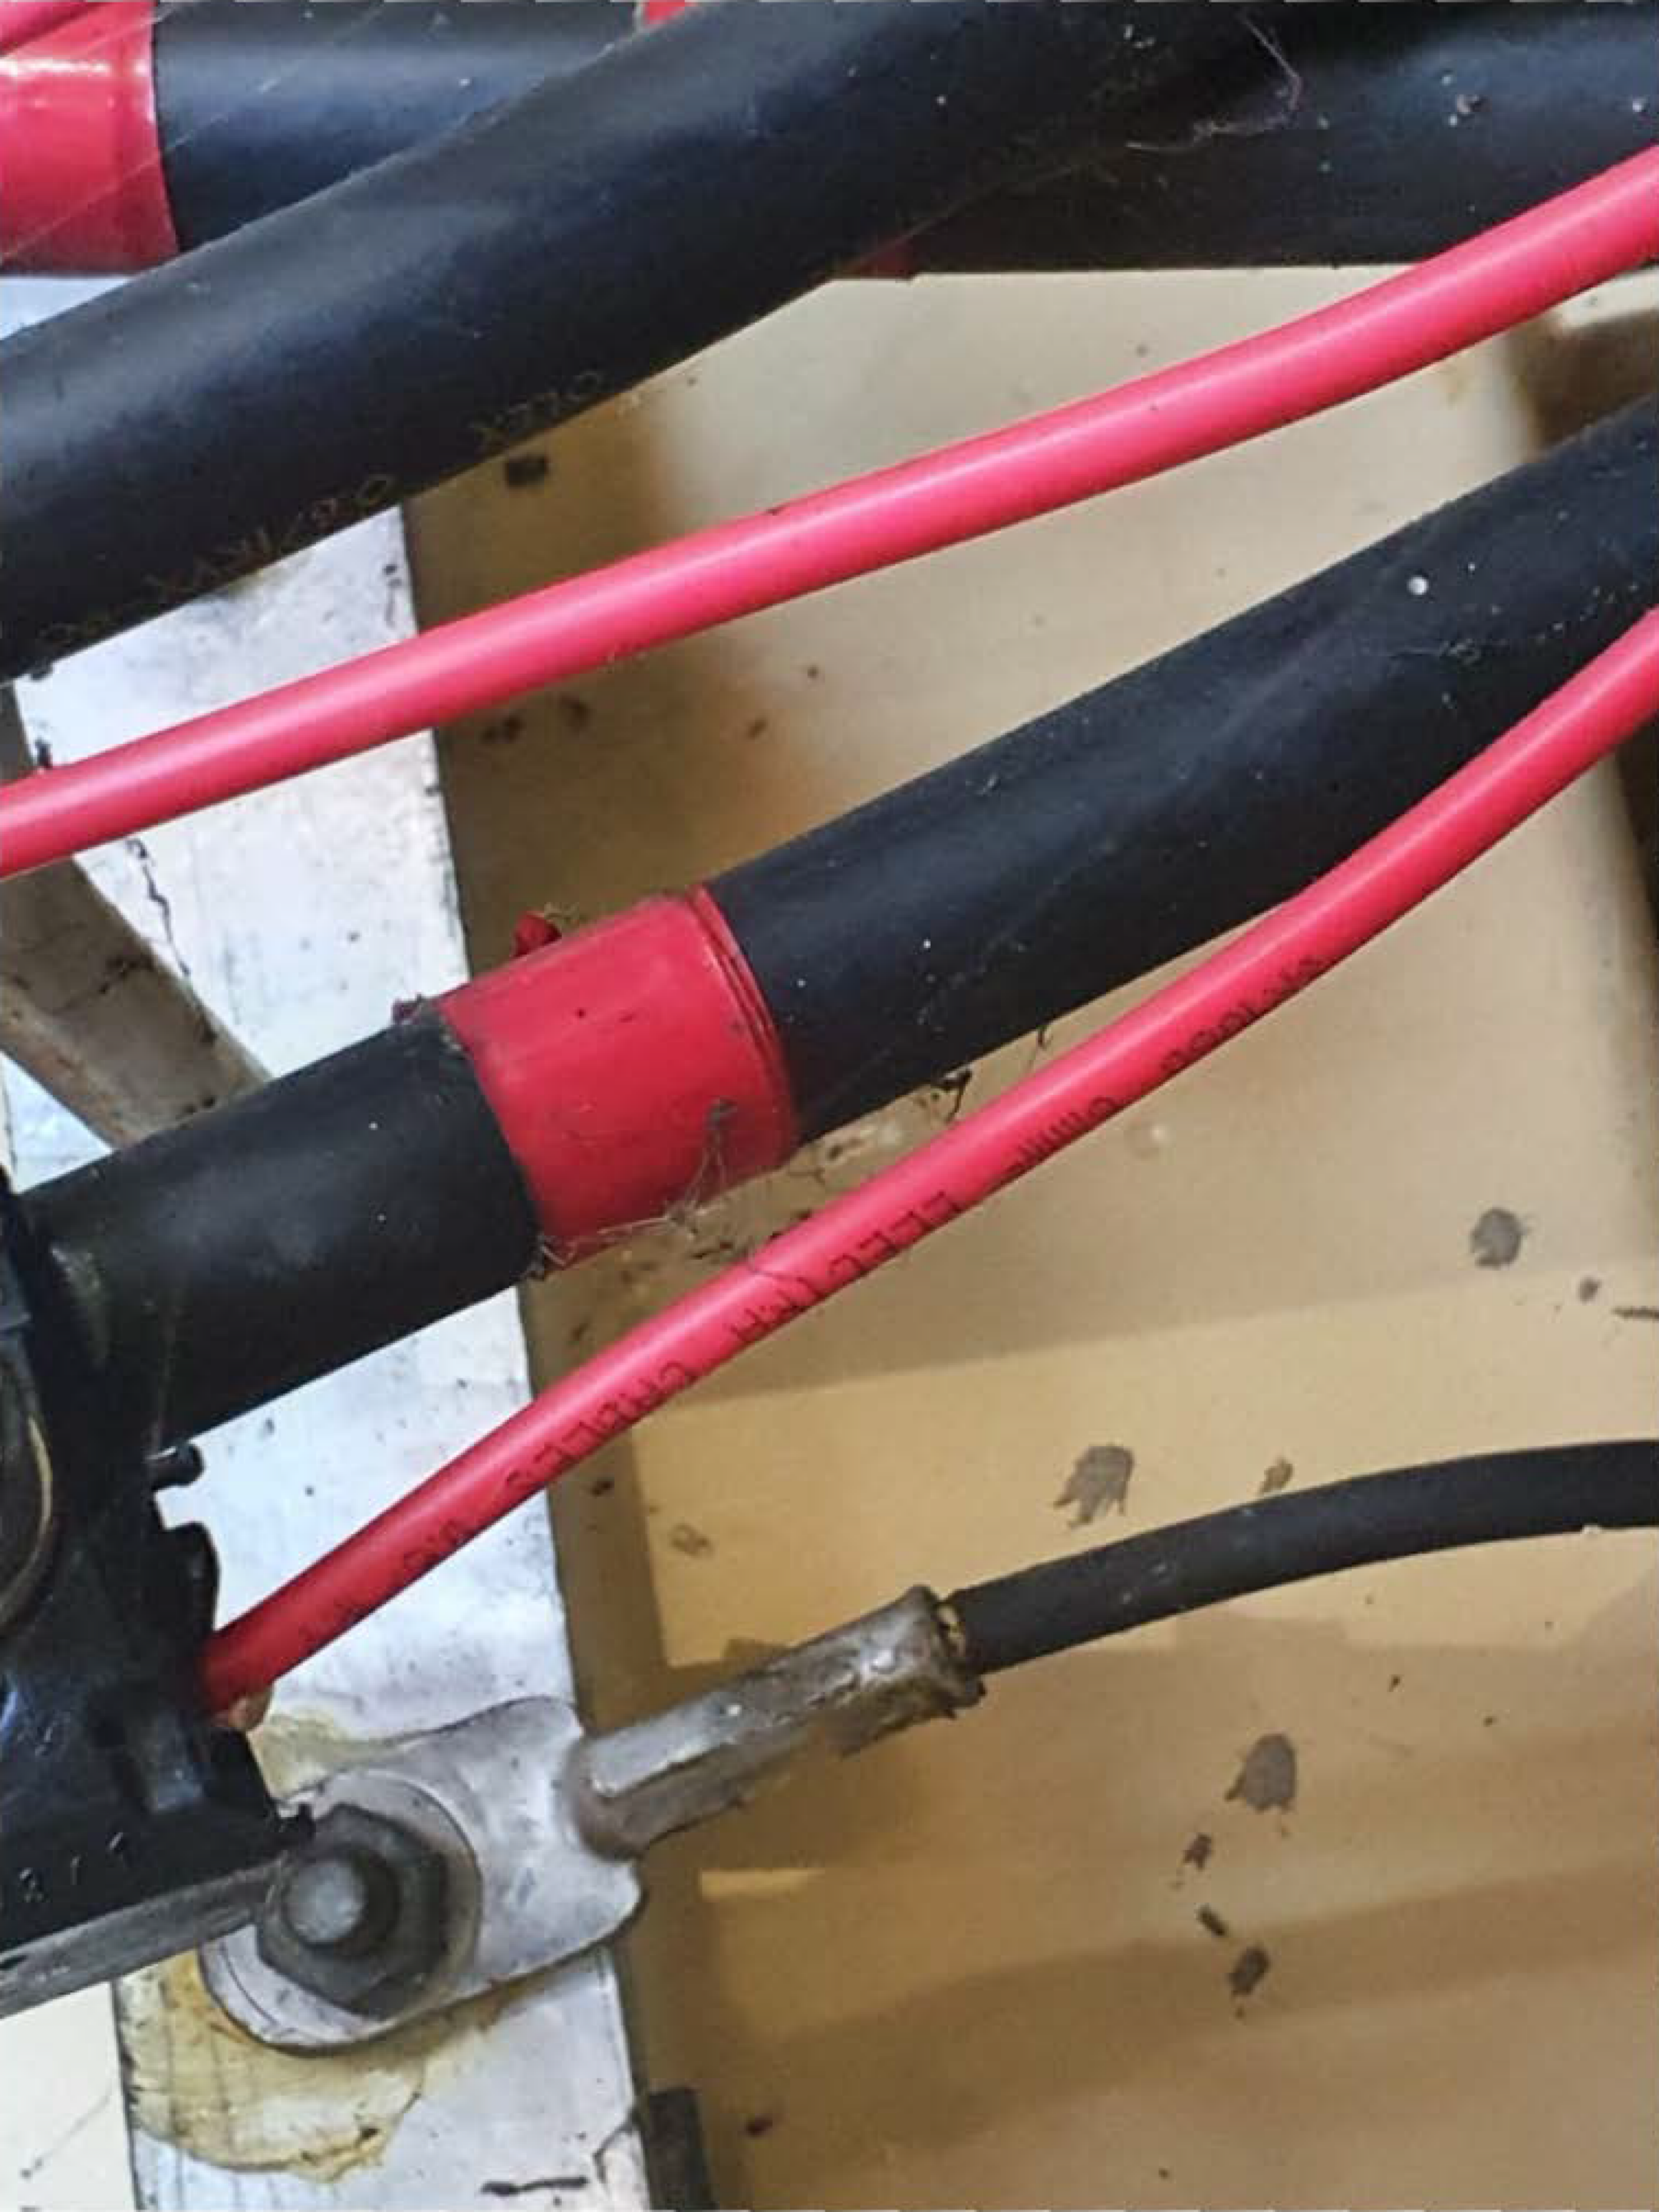
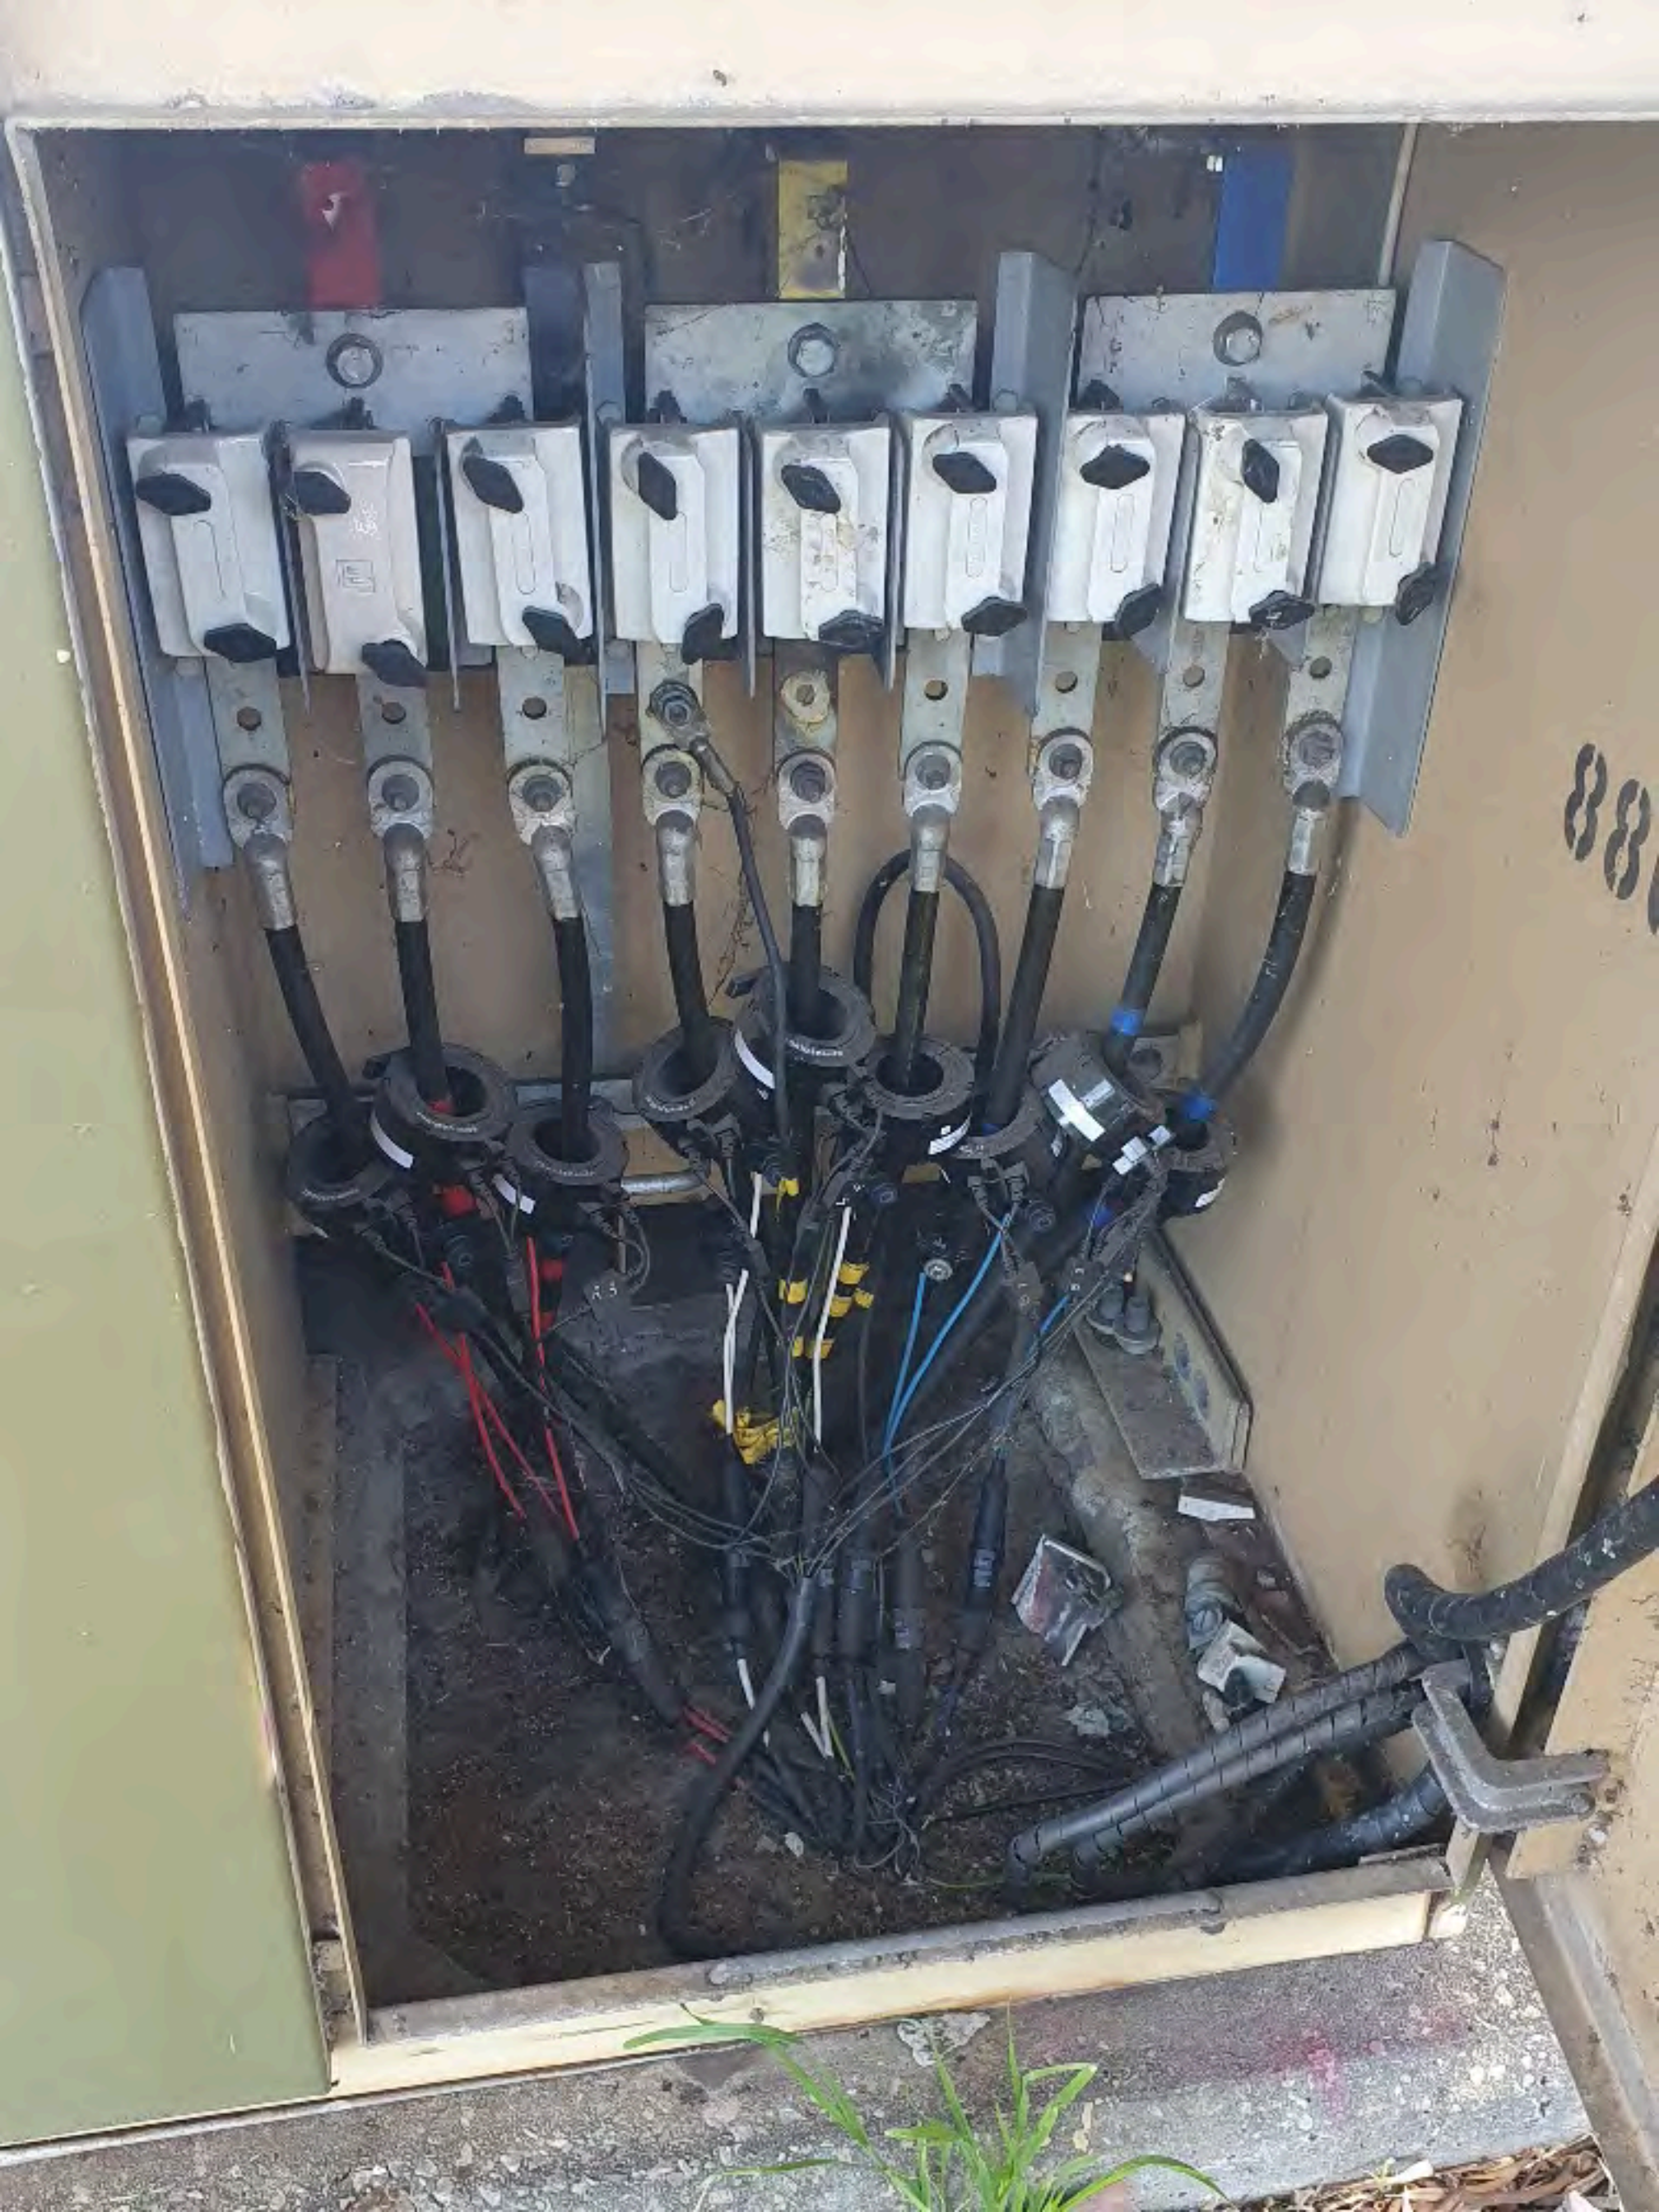
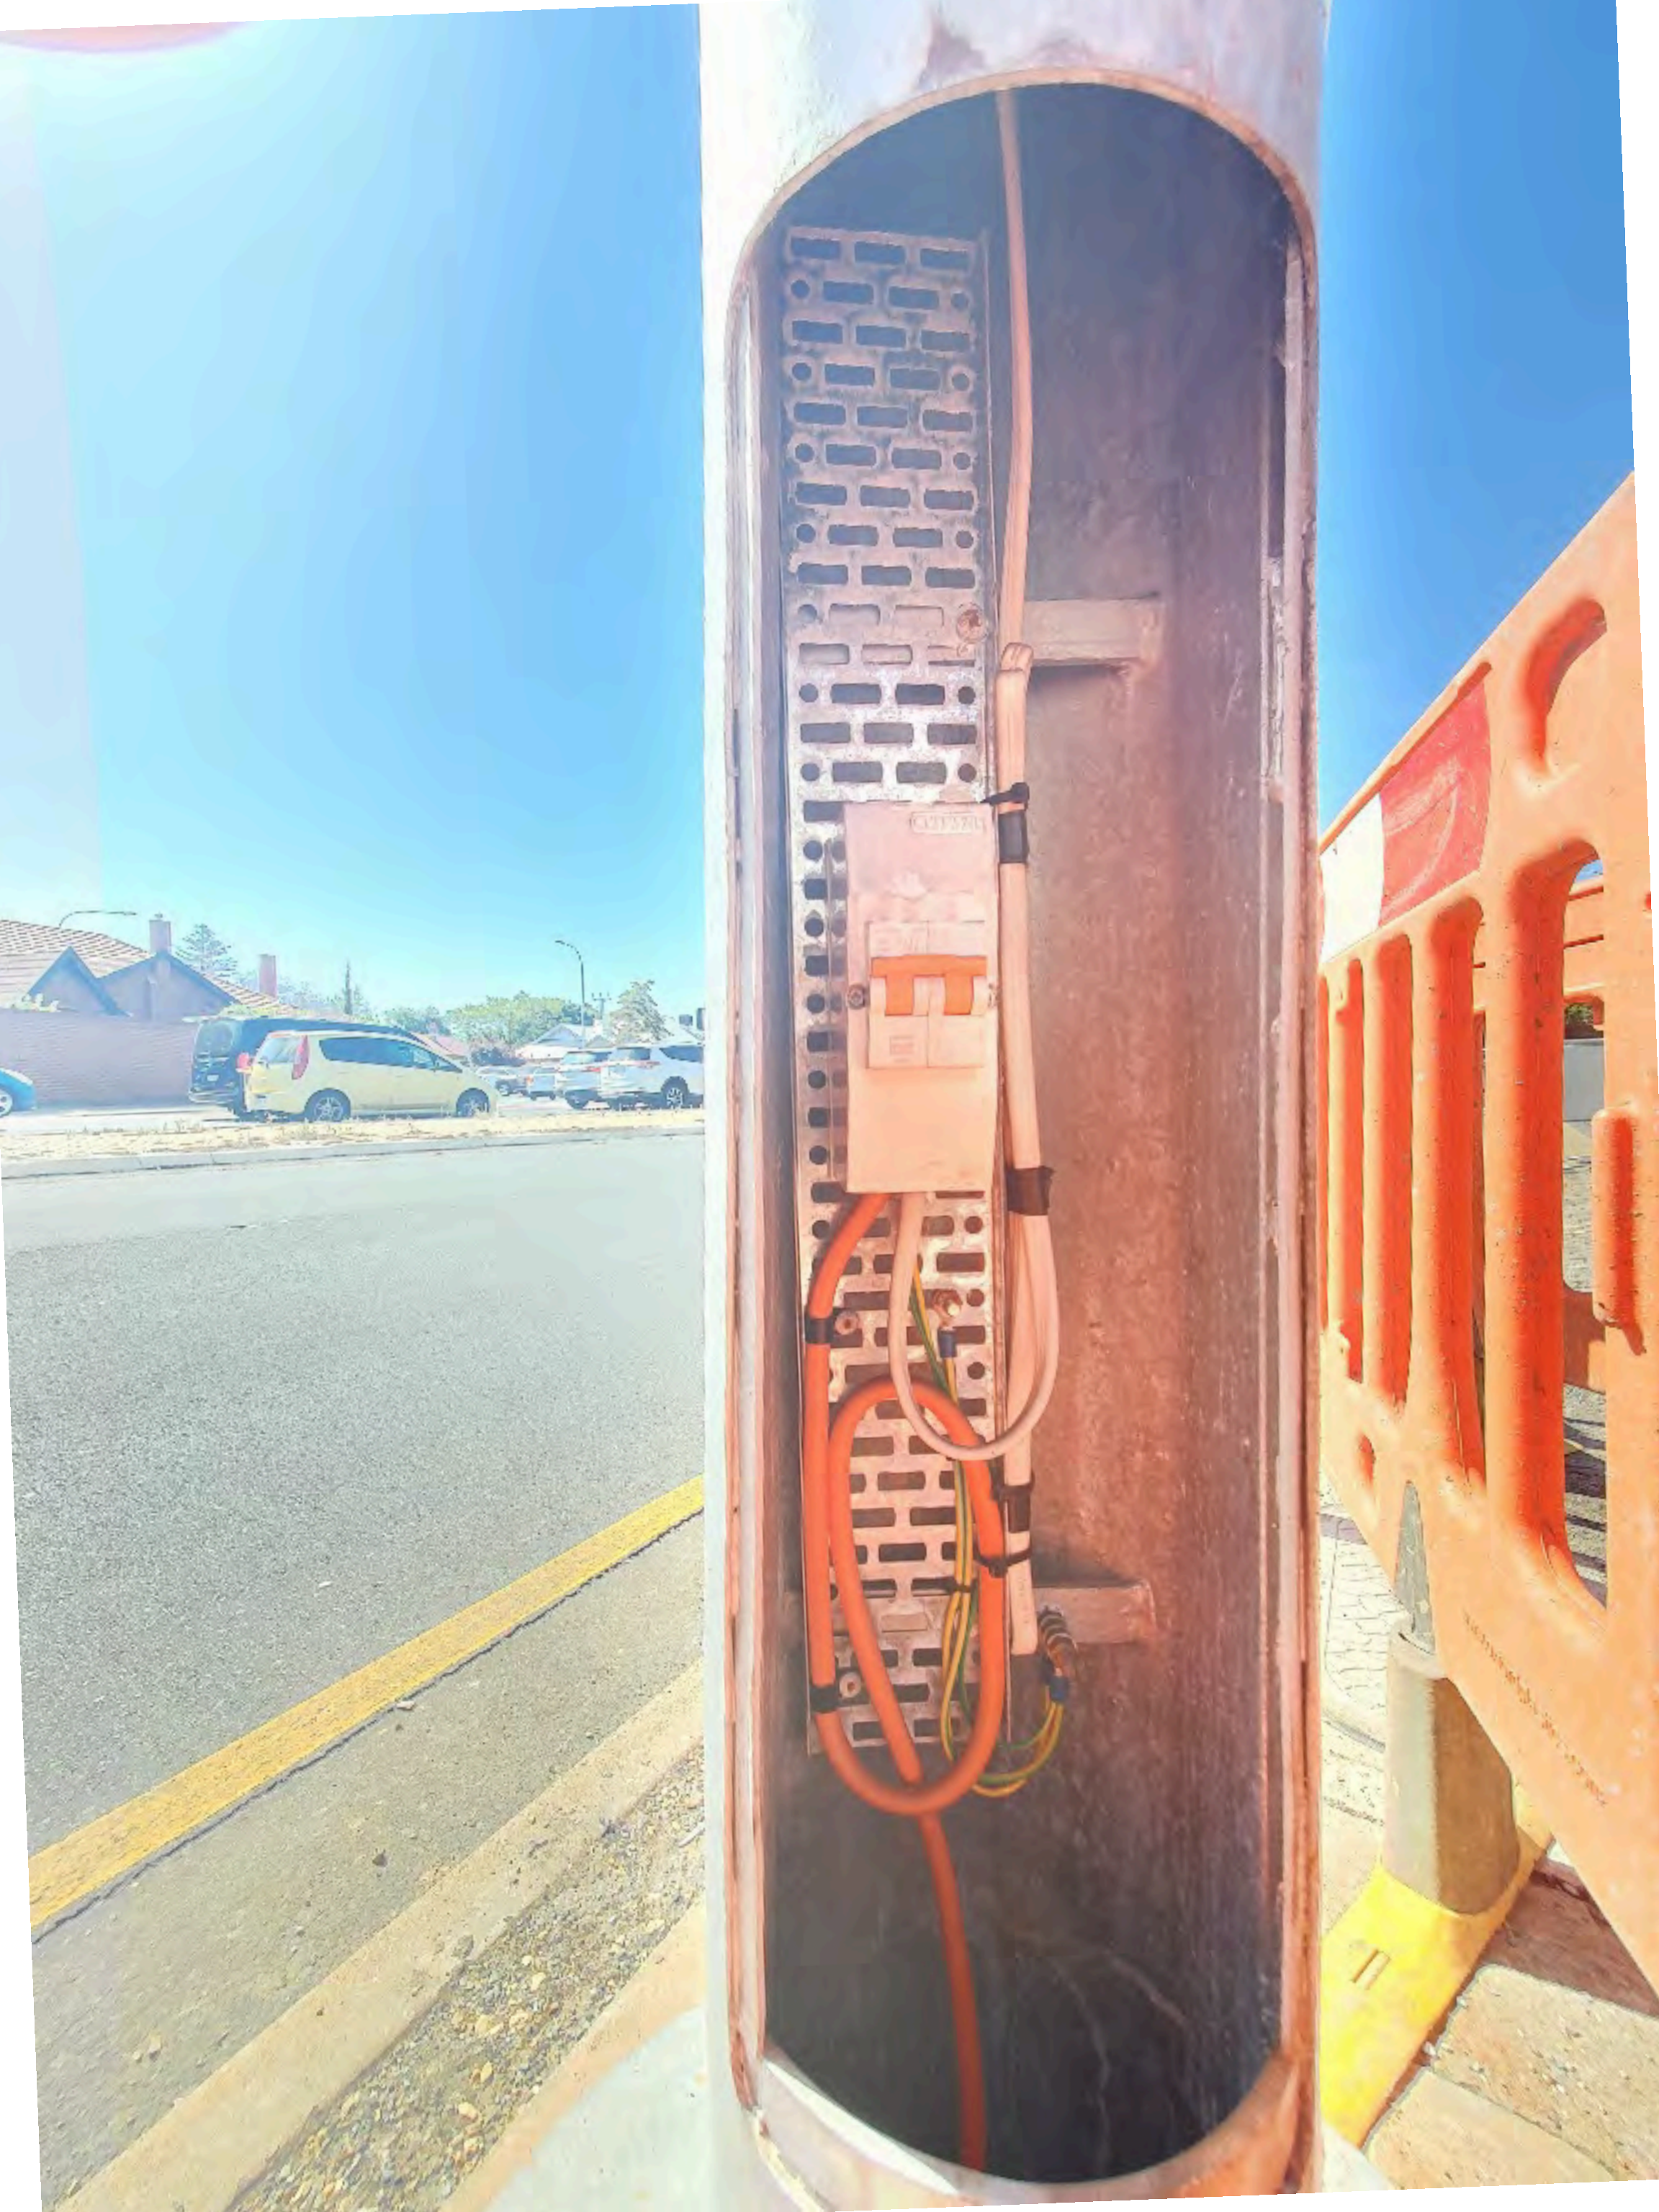
Supply is fed from padmount transformer 19028 in reserve on the corner or [REDACTED]  
Terrace.

Connected through 2 much newer DPTI pits right on the corner as shown in photos, to the main switchboard in a pit next to column as seen in photos, to a singular column outside [REDACTED].

We found reversed polarity in the main switchboard when tested.

The Traffic controller received a shock when touching column as the gas contractors were hydrovaccing to replace gas mains alongside column in footpath.
